NC DEPARTMENT OF TRANSPORTATION  
DIVISION OF HIGHWAYS  
STRUCTURE MANAGEMENT UNIT

## Structure Safety Report

### Routine Element Inspection - Contract

COUNTY: CALDWELL STRUCTURE NUMBER: 130262 FREQUENCY: 24 MONTHS

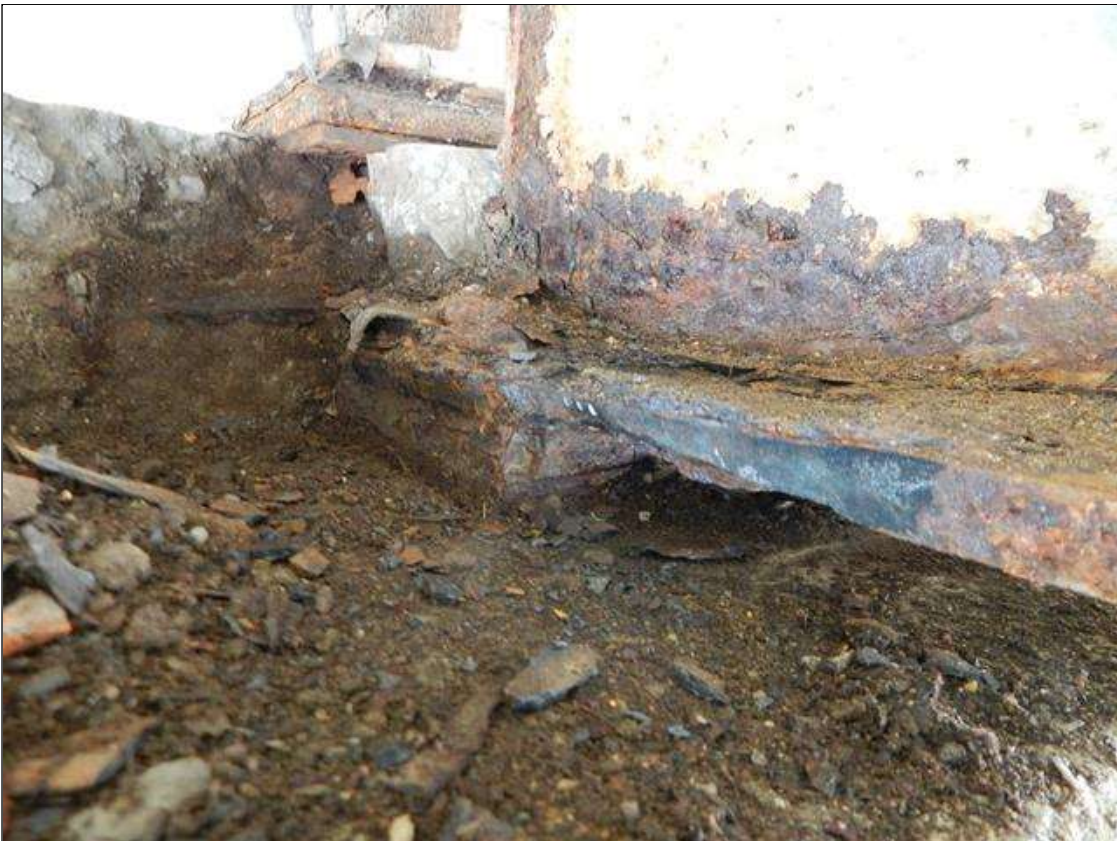
Span 8 Beam 2: 8" x 4" area of 1/4" section loss (1/2" remaining) with 1/4" loss of width on both sides of bottom flange at Bent 8

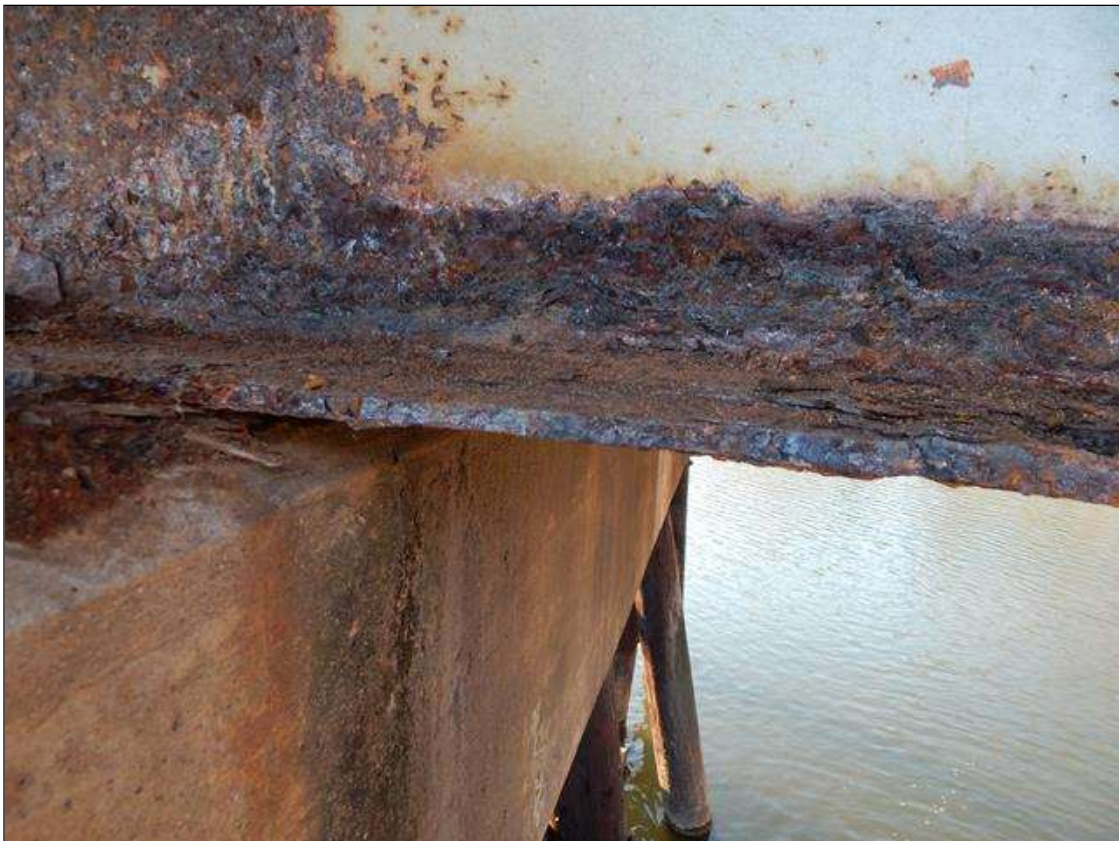
Span 12 Beam 4: 6" x 3" area of 1/4" section loss (1/2" remaining) in left side of bottom flange at End Bent 2

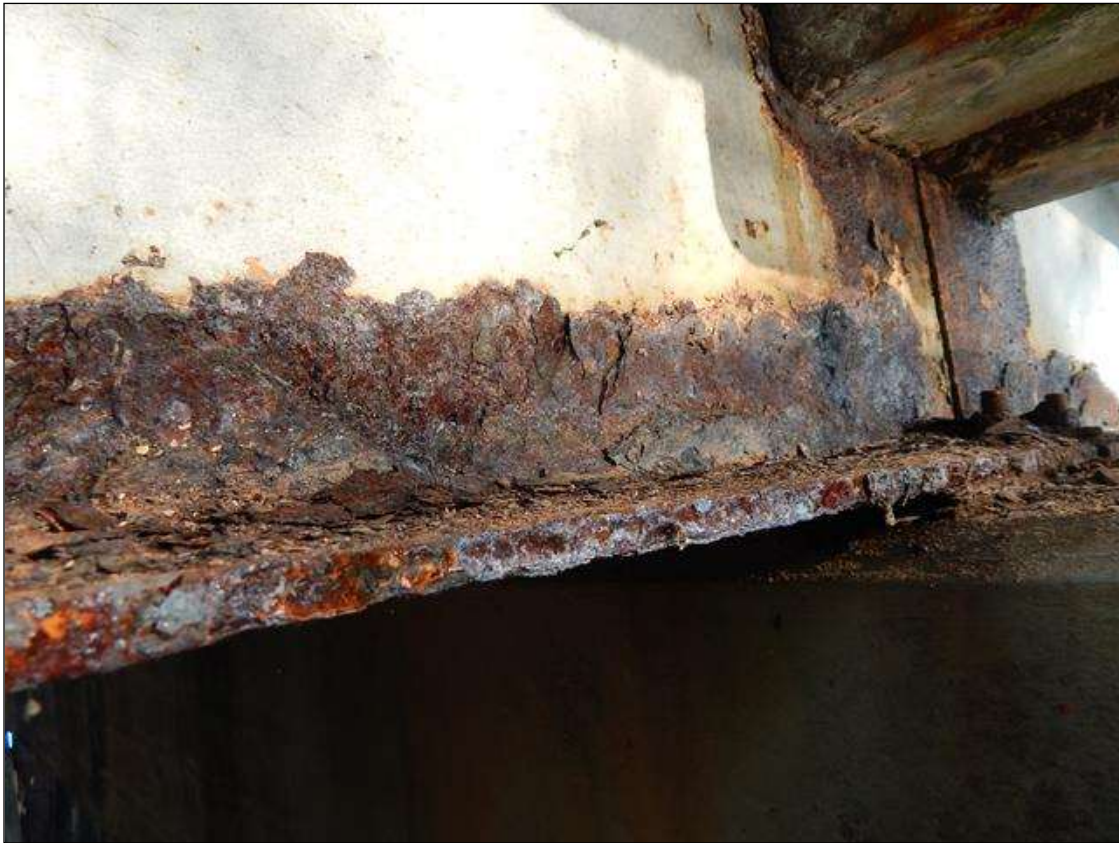
SPAN 1 BEAM 4: 25" X 4" AREA OF 1/4" SECTION LOSS (1/2" REMAINING) ON BOTH SIDES OF BOTTOM FLANGE

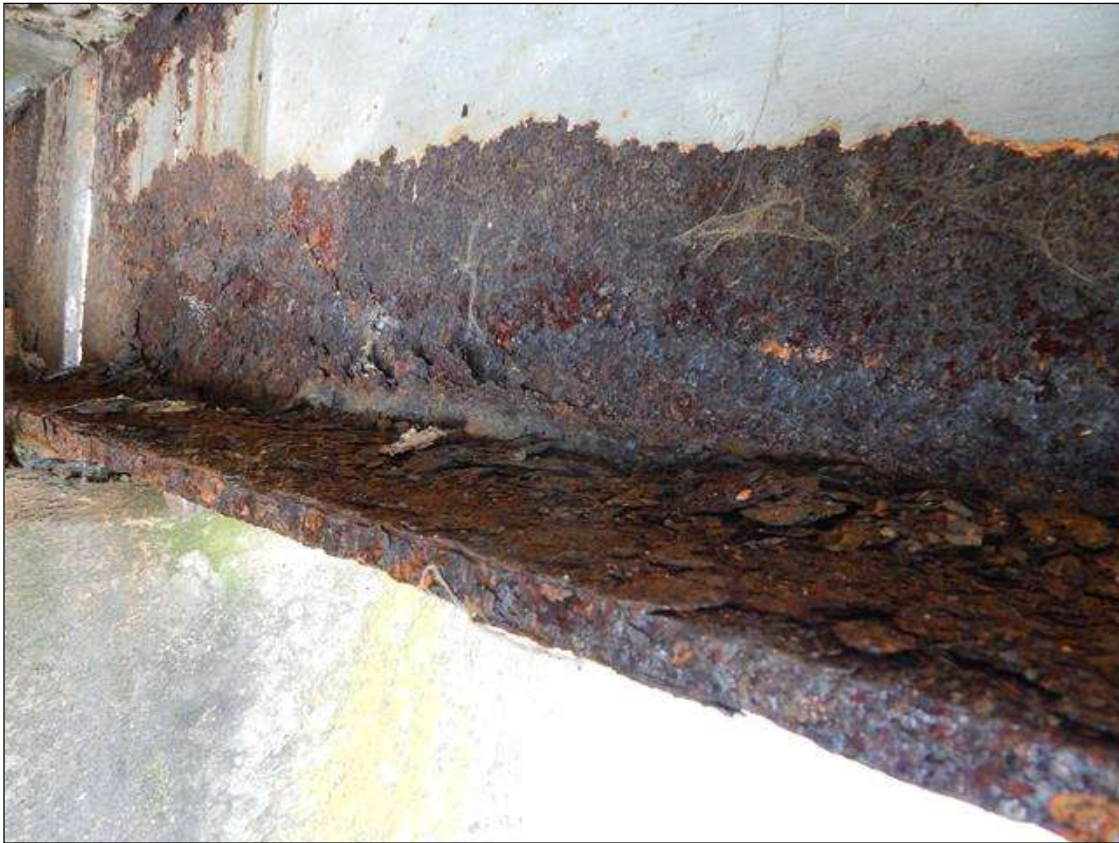
SPAN 2 BEAM 1: 21" X 3" AREA OF 1/4" SECTION LOSS (1/2" REMAINING) ON BOTH SIDES OF BOTTOM FLANGE AT BENT 1

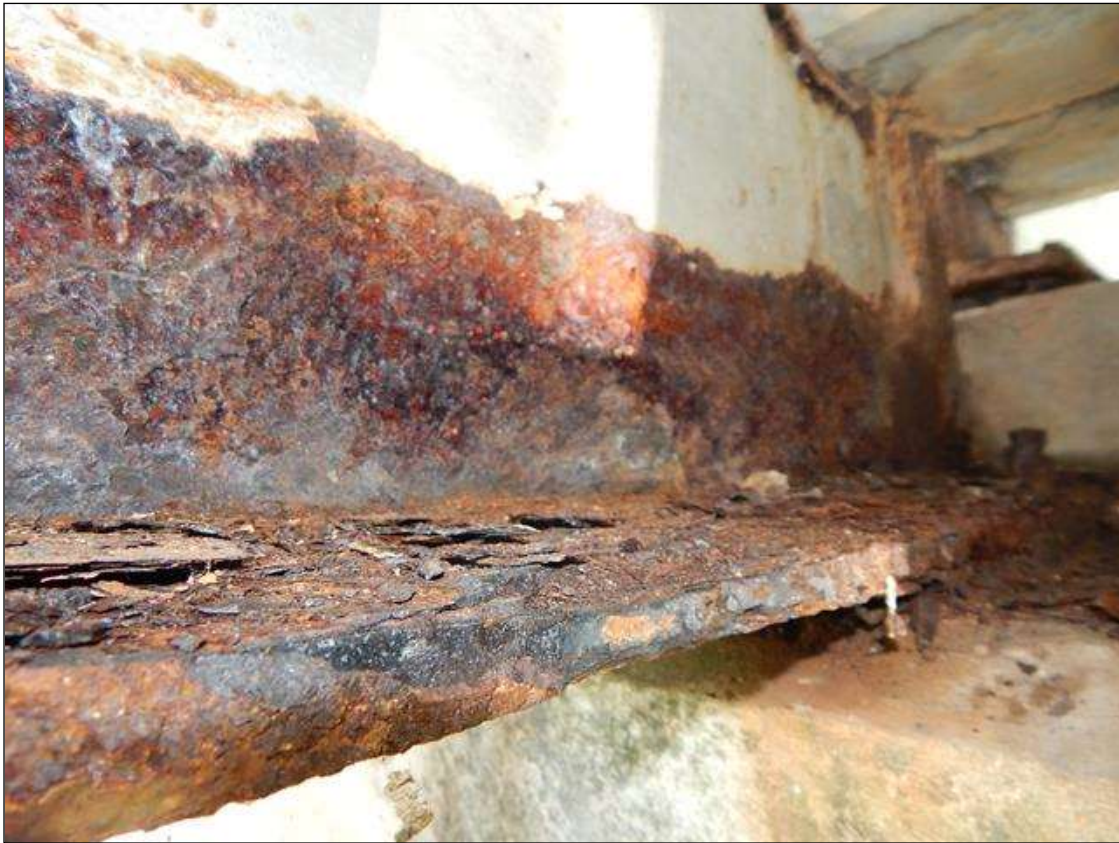
SPAN 2 BEAM 1: 20" X 3" AREA OF 1/4" SECTION LOSS (1/2" REMAINING) ON BOTH SIDES OF BOTTOM FLANGE AT BENT 2

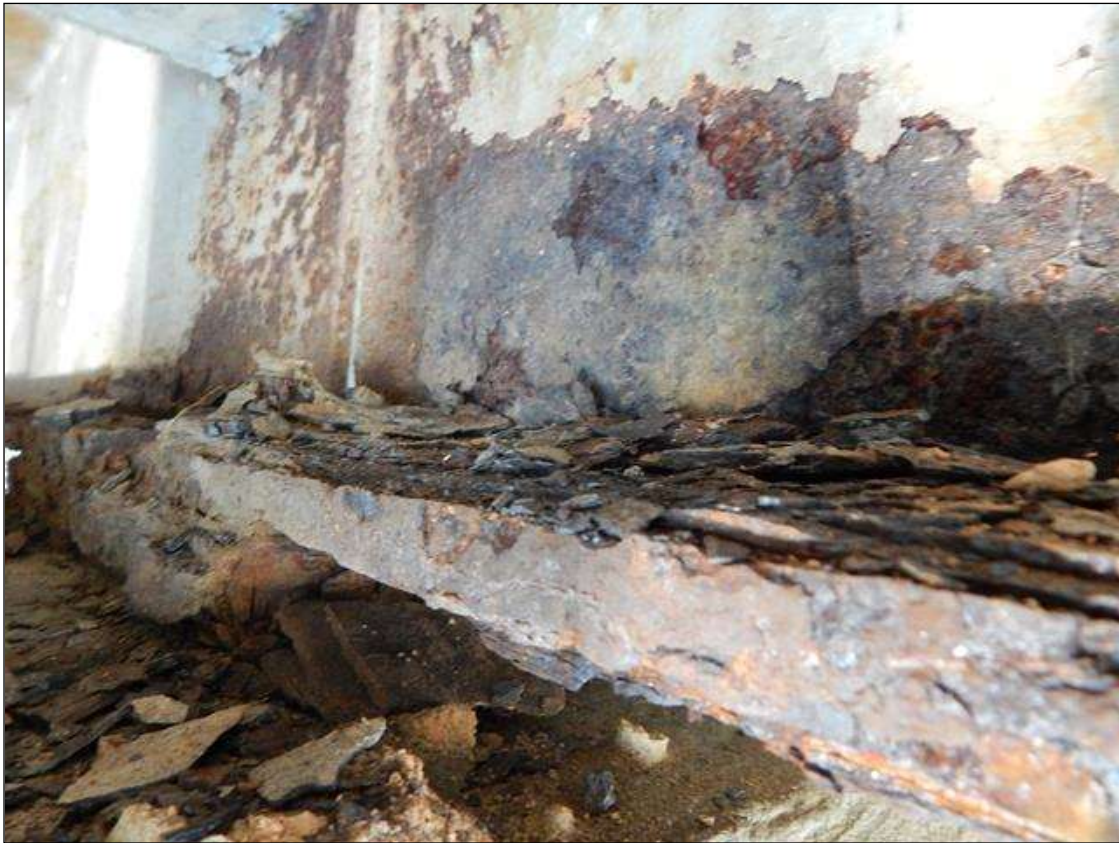
SPAN 2 BEAM 2: 6" X 3" AREA OF 1/4" SECTION LOSS (1/2" REMAINING) ON BOTH SIDES OF BOTTOM FLANGE  
AT BENT 1

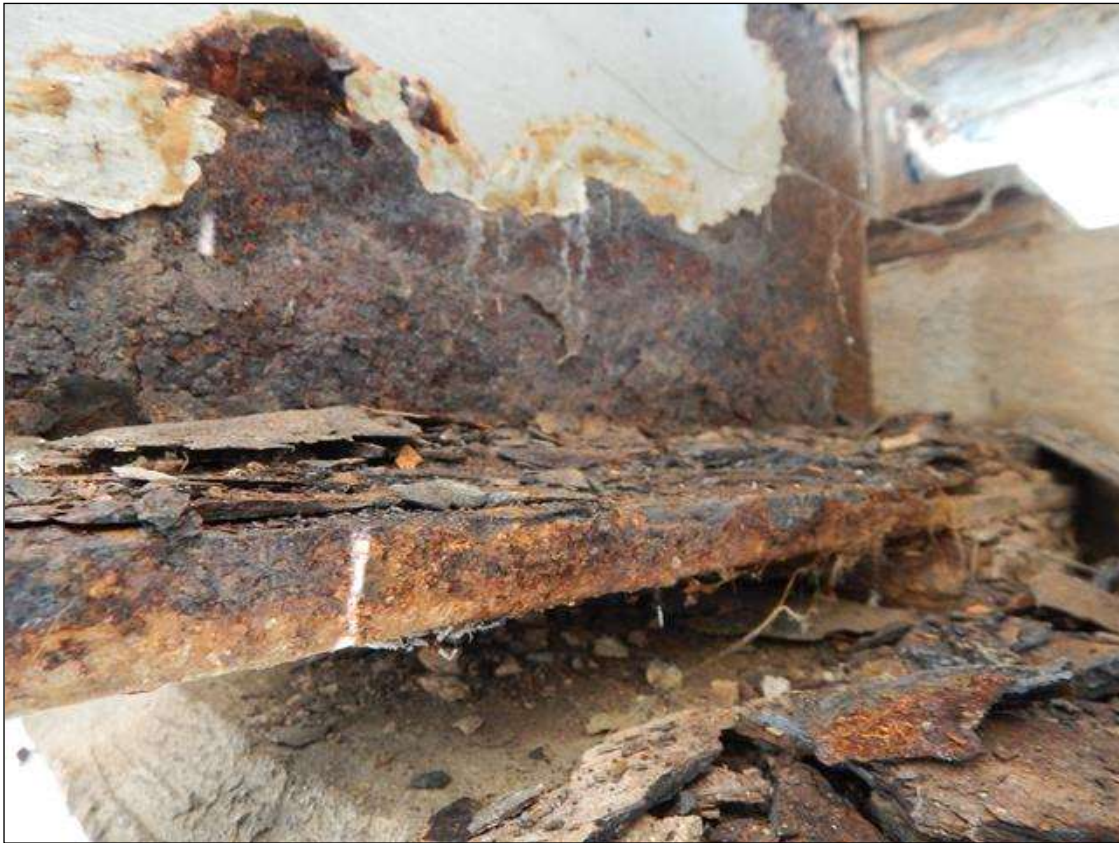
SPAN 2 BEAM 3: 10" X 3" AREA OF 1/8" SECTION LOSS (5/8" REMAINING) ON RIGHT SIDE OF BOTTOM FLANGE AT BENT 2

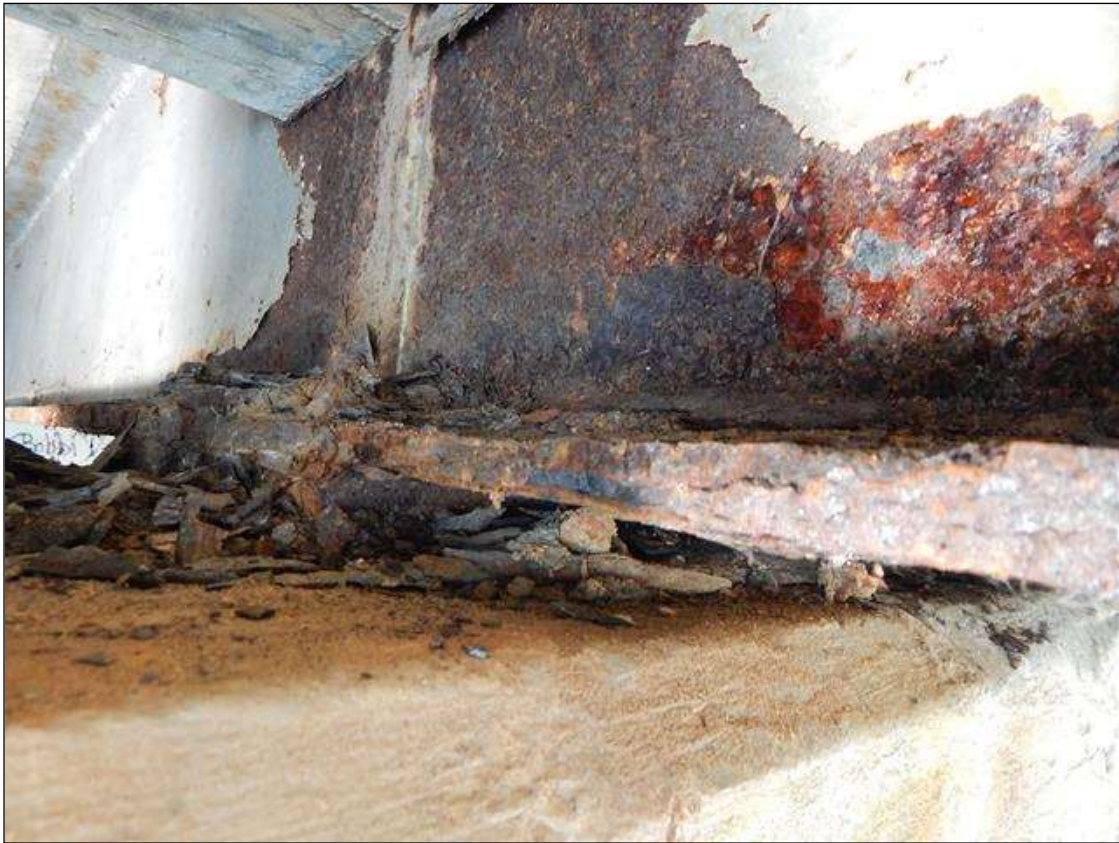
SPAN 2 BEAM 3: 9" X 3" AREA OF 1/4" SECTION LOSS (1/2" REMAINING) ON BOTH SIDES OF BOTTOM FLANGE  
AT BENT 1

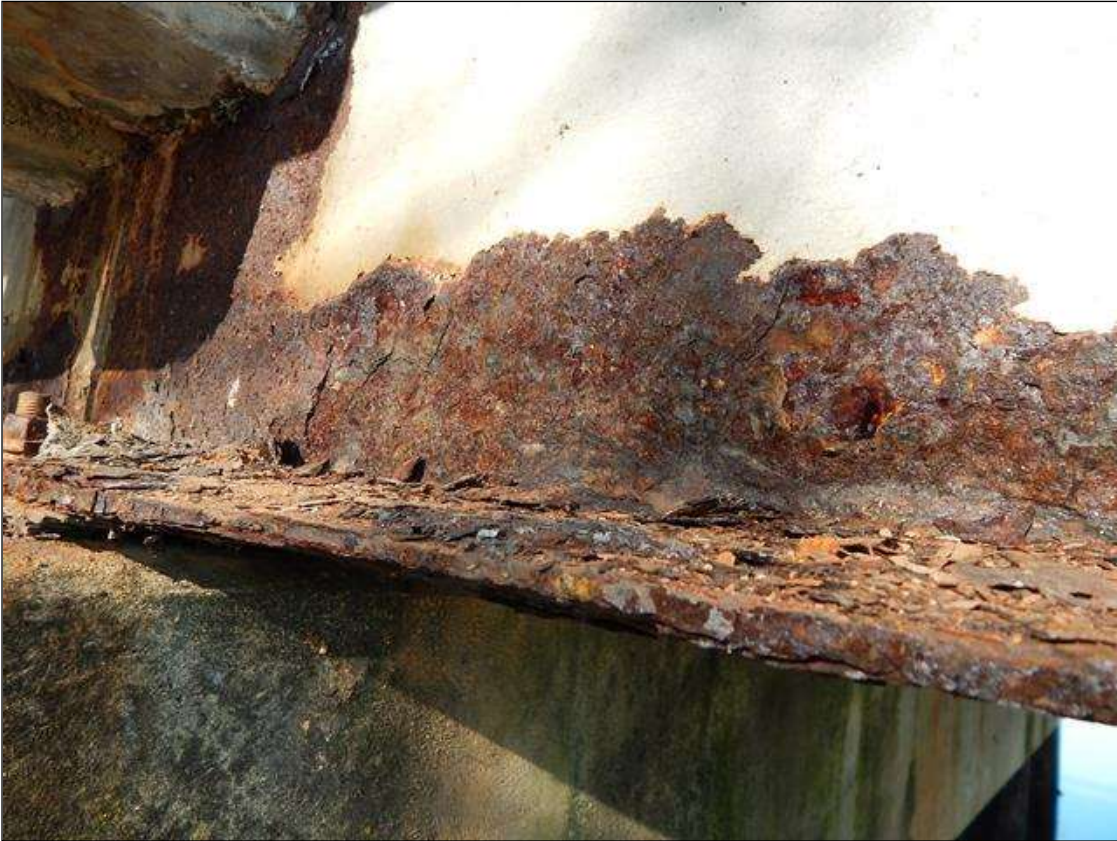
SPAN 2 BEAM 4: 24" X 3" AREA OF 1/2" SECTION LOSS (1/4" REMAINING) ON BOTH SIDES OF BOTTOM FLANGE AT BENT 1

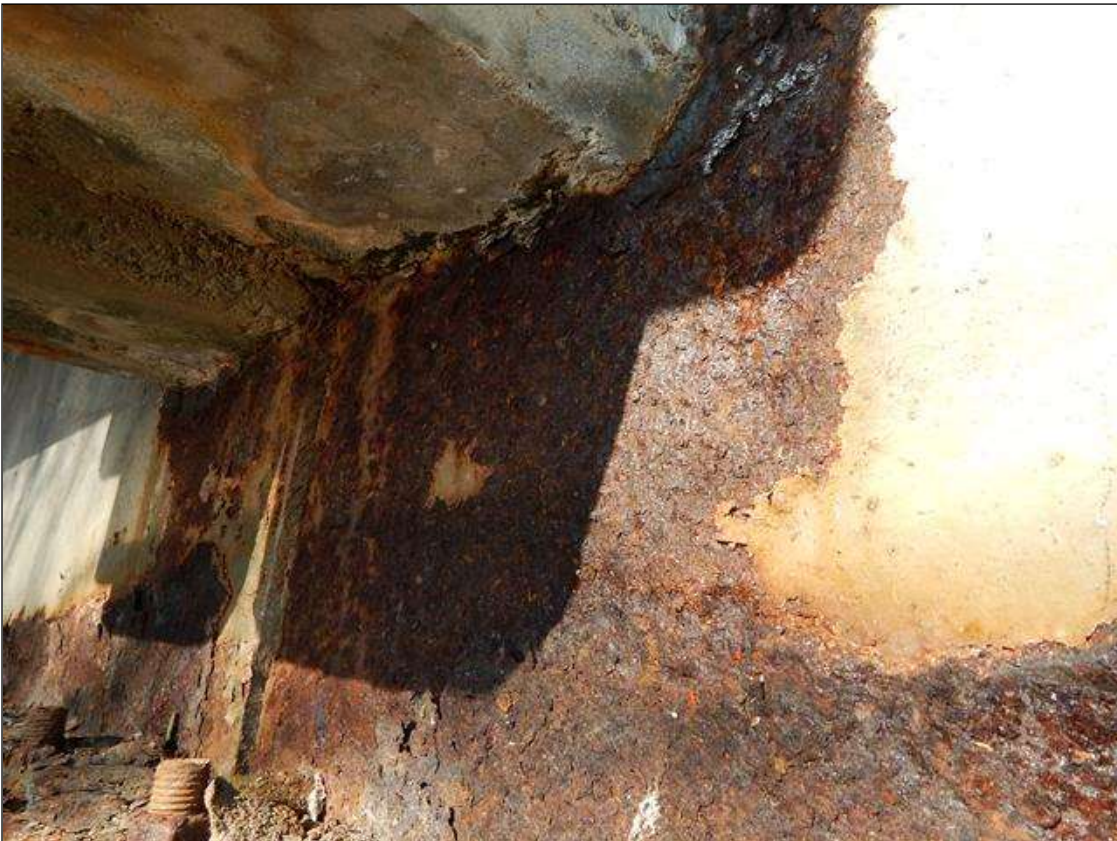
SPAN 2 BEAM 4: 12" X 10" AREA OF 1/8" SECTION LOSS (3/8" REMAINING) ON WEB AT BENT 1

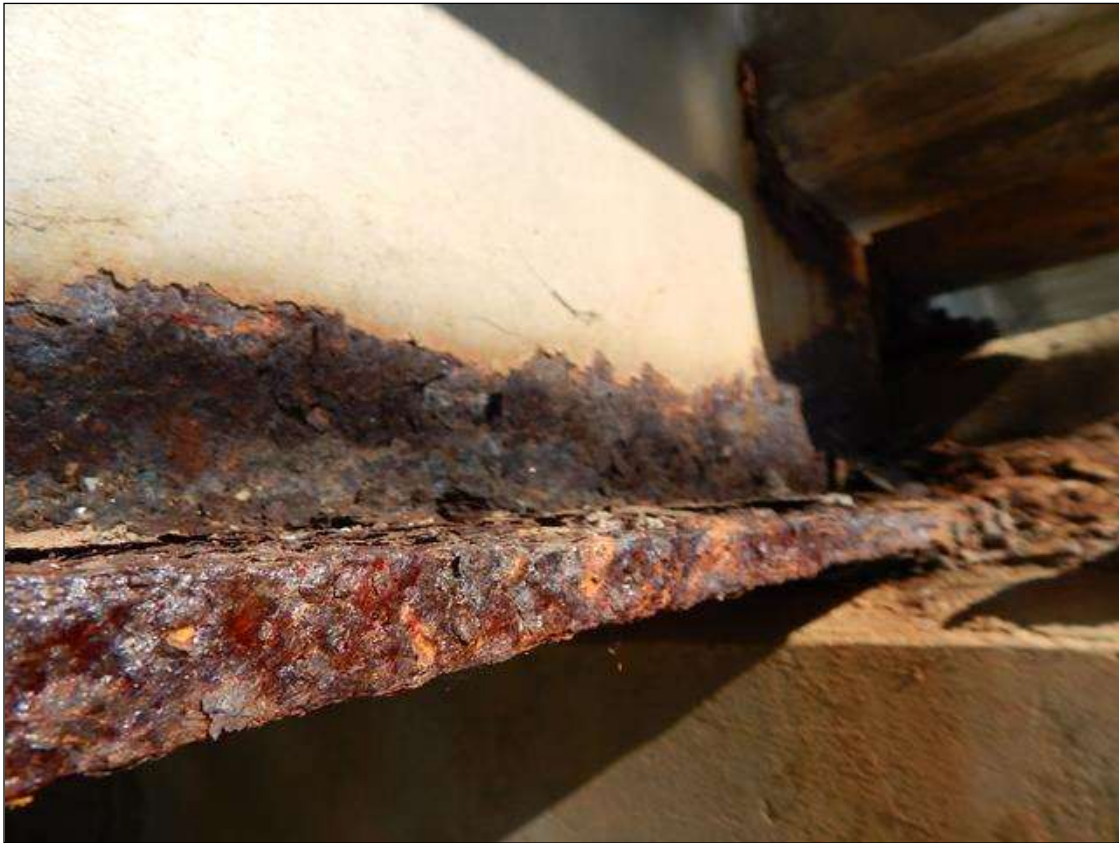
SPAN 2 BEAM 4: 20" X 3" AREA OF 1/4" SECTION LOSS (1/2" REMAINING) ON BOTH SIDES OF BOTTOM FLANGE AT BENT 2

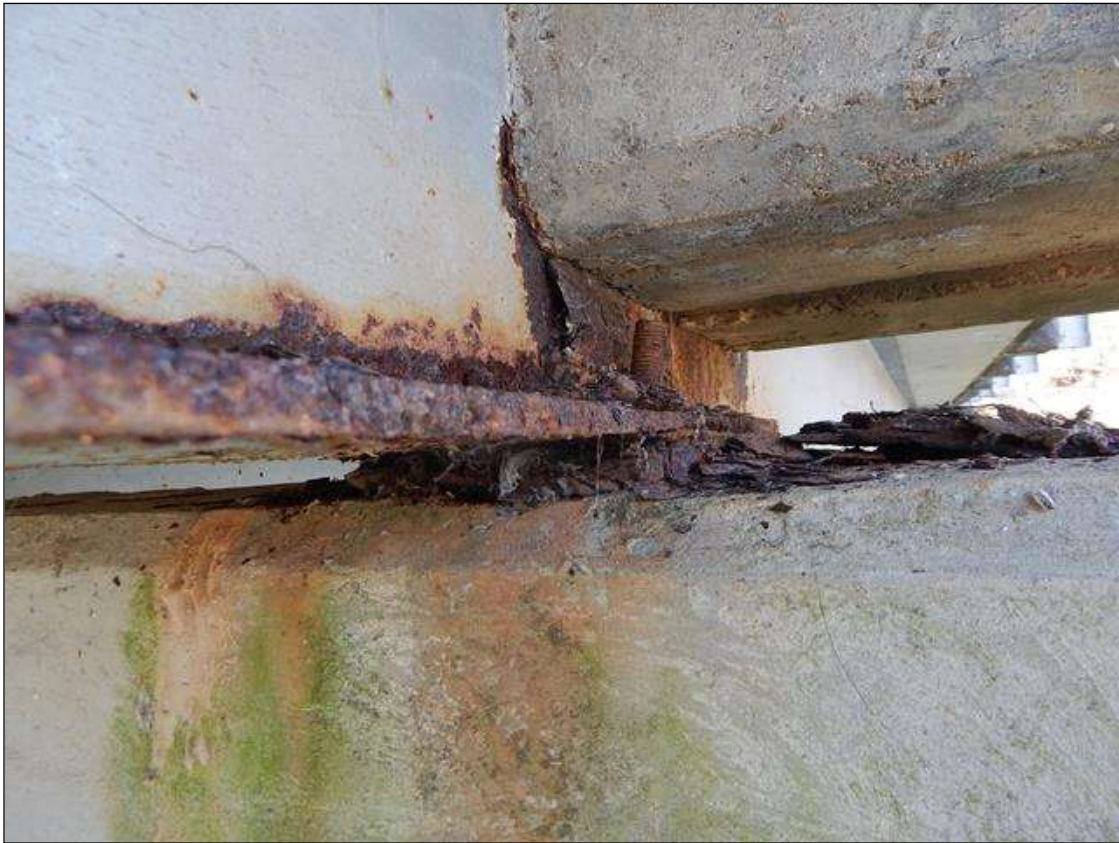
SPAN 3 BEAM 1: 10" X 3" AREA OF 1/4" SECTION LOSS (1/4" REMAINING) FOR BOTH SIDES OF BOTTOM FLANGE AT BENT 2

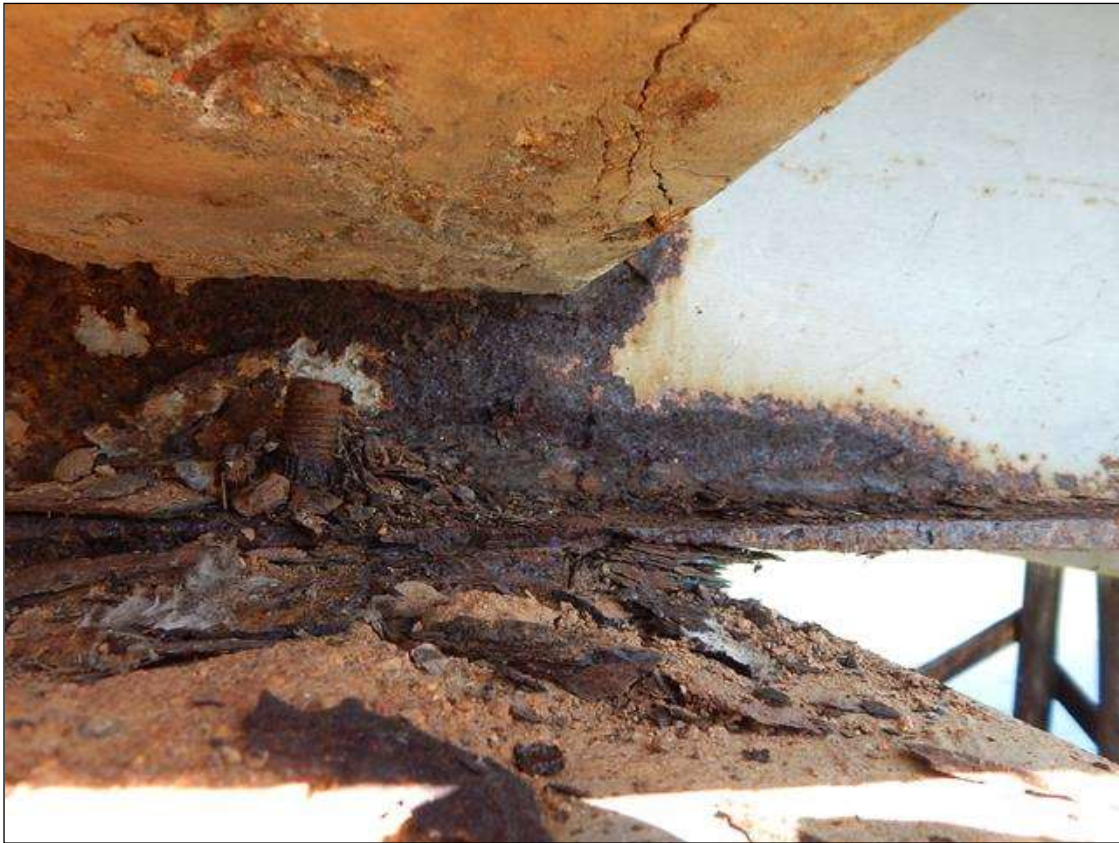
SPAN 3 BEAM 4: 9" X 3" AREA OF 1/4" SECTION LOSS (1/4" REMAINING) FOR RIGHT SIDE OF BOTTOM FLANGE AND WEB AT BENT 2

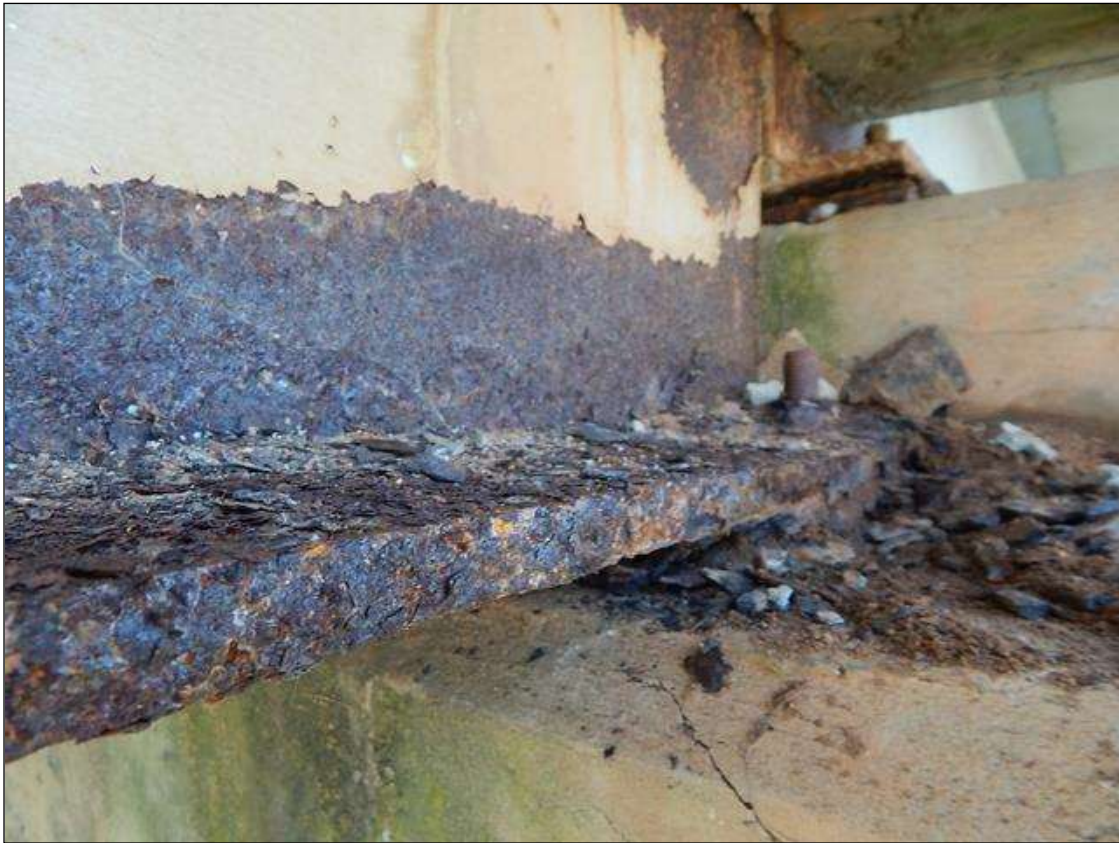
SPAN 4 BEAM 1: 9" X 2" AREA OF 1/8" SECTION LOSS (5/8" REMAINING) ON LEFT SIDE OF BOTTOM FLANGE AT BENT 3

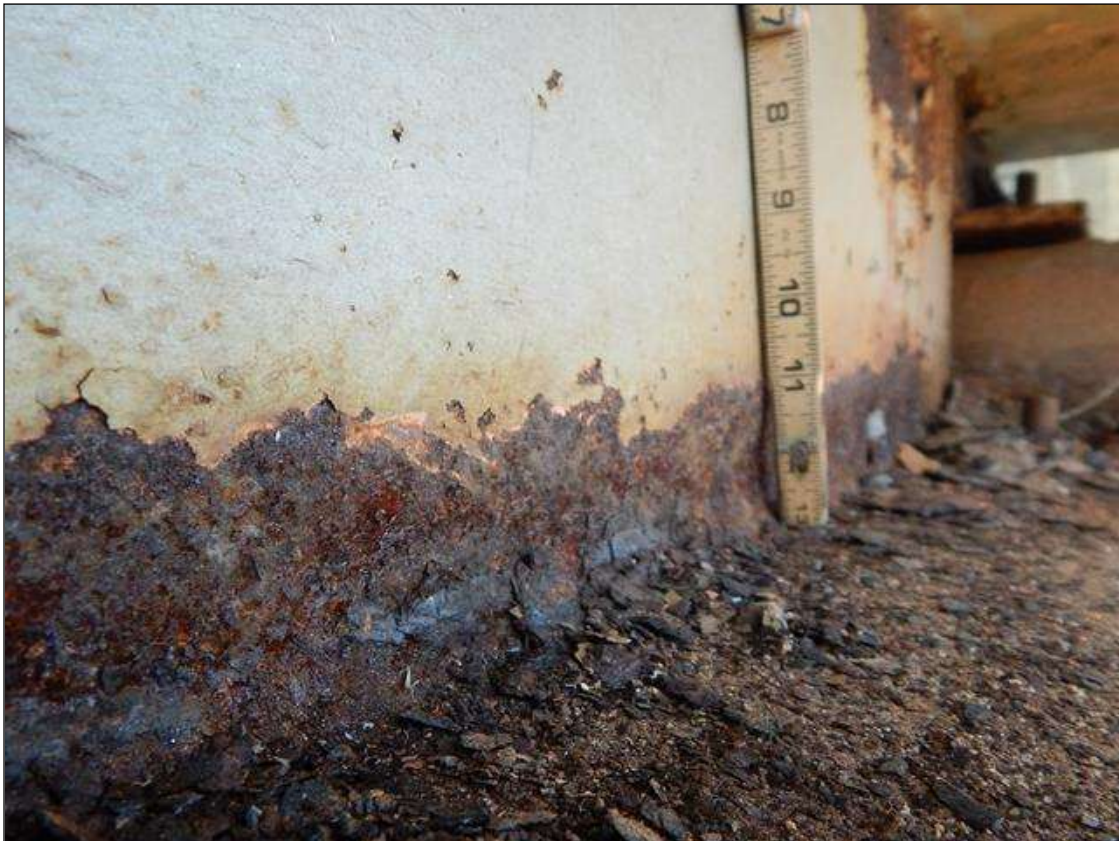
SPAN 4 BEAM 4: 27" X 2" AREA OF 1/8" SECTION LOSS (3/8" REMAINING) IN WEB AT BENT 4

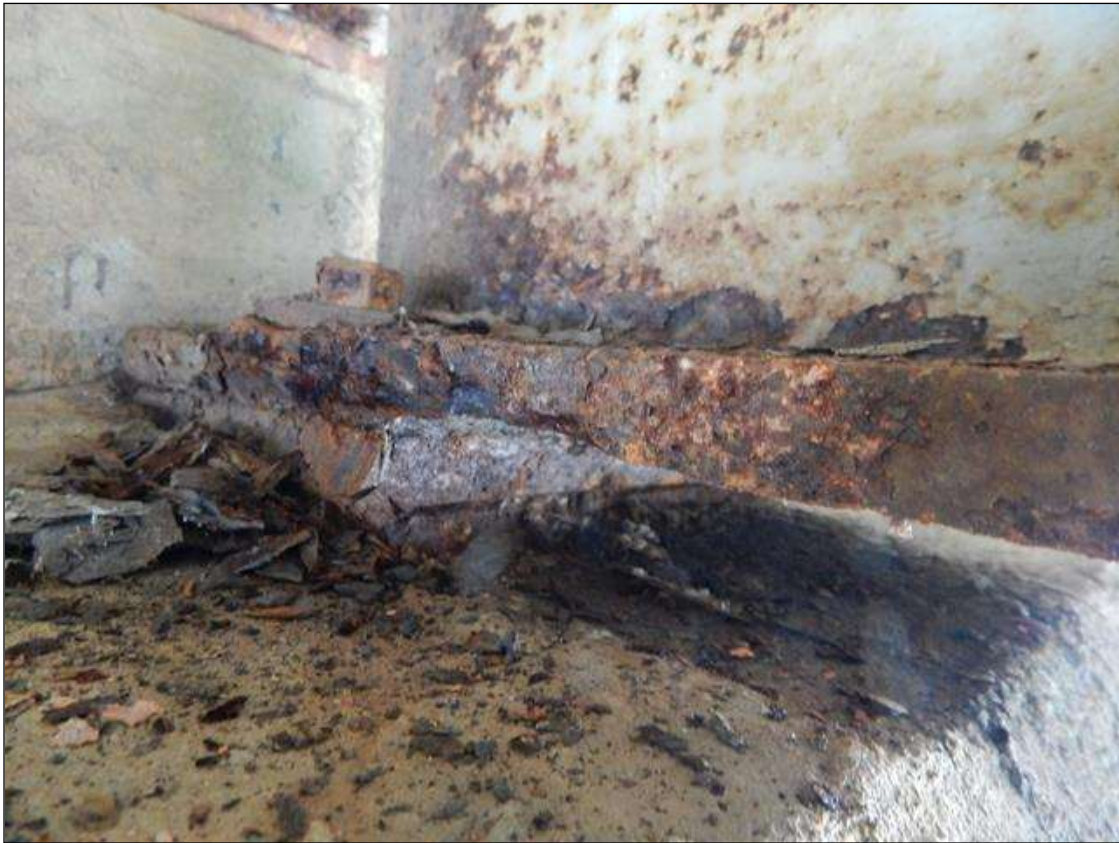
SPAN 6 BEAM 2: 3" X 3" AREA OF 1/8" SECTION LOSS (5/8" REMAINING) ON BOTH SIDES OF BOTTOM FLANGE  
AT BENT 5

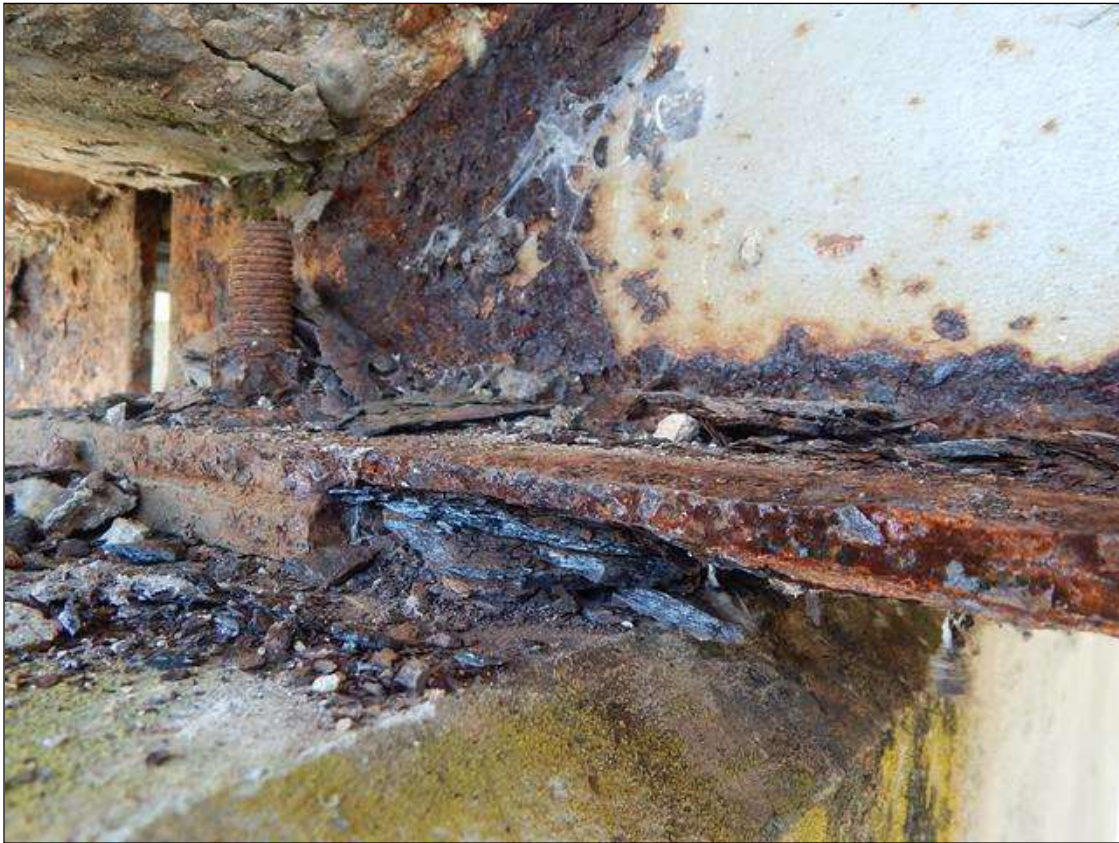
SPAN 7 BEAM 4: 3" X 3" AREA OF 1/4" SECTION LOSS (1/4" REMAINING) ON BOTH SIDES OF BOTTOM FLANGE  
AT BENT 6

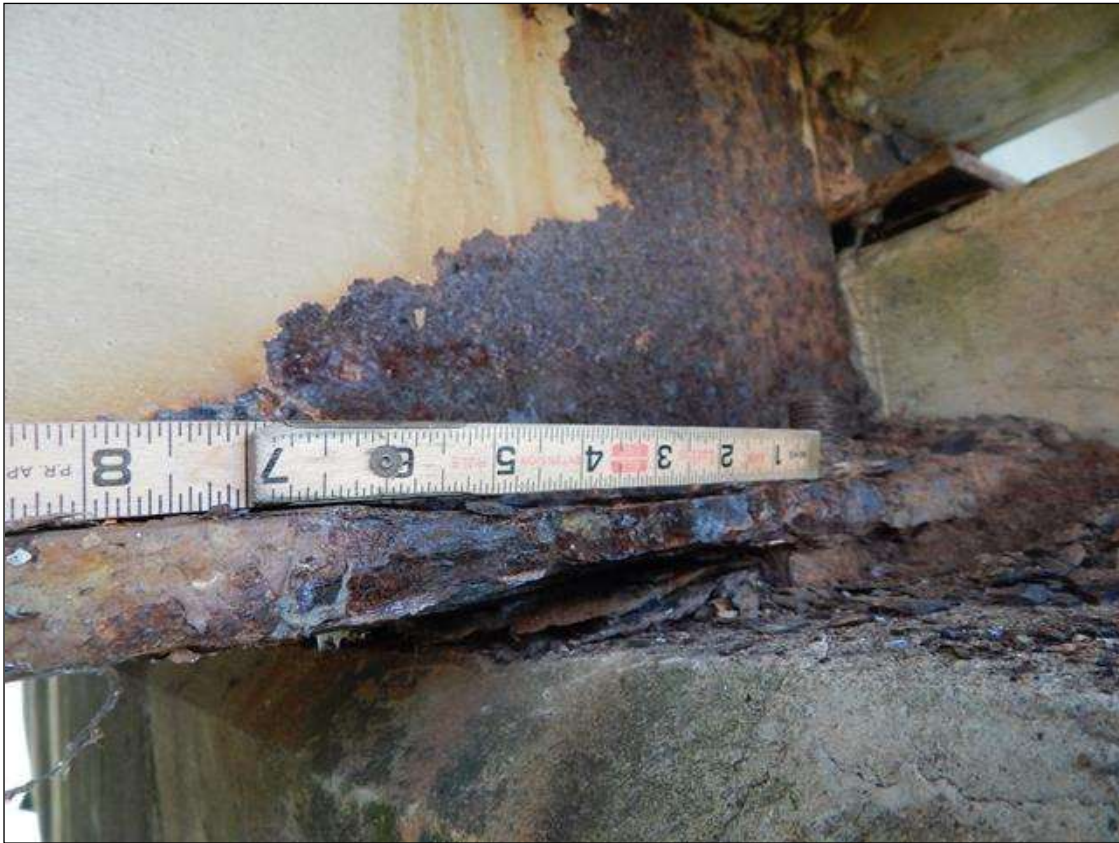
SPAN 8 BEAM 1: 5" X 2" AREA OF 1/4" SECTION LOSS (1/2" REMAINING) ON LEFT SIDE OF BOTTOM FLANGE  
AT BENT 7

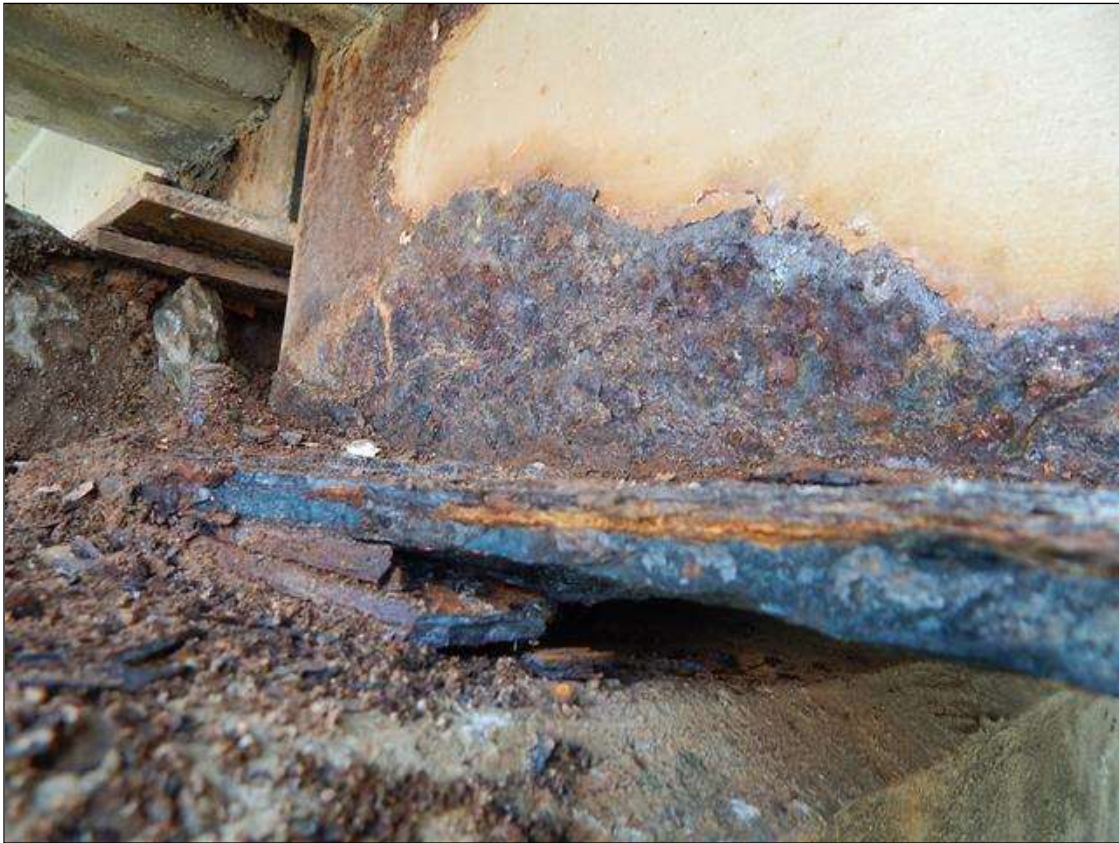
SPAN 8 BEAM 1: 12" X 4" AREA OF 1/4" SECTION LOSS (1/2" REMAINING) WITH 1/4" LOSS OF WIDTH ON LEFT SIDE OF BOTTOM FLANGE AT BENT 8

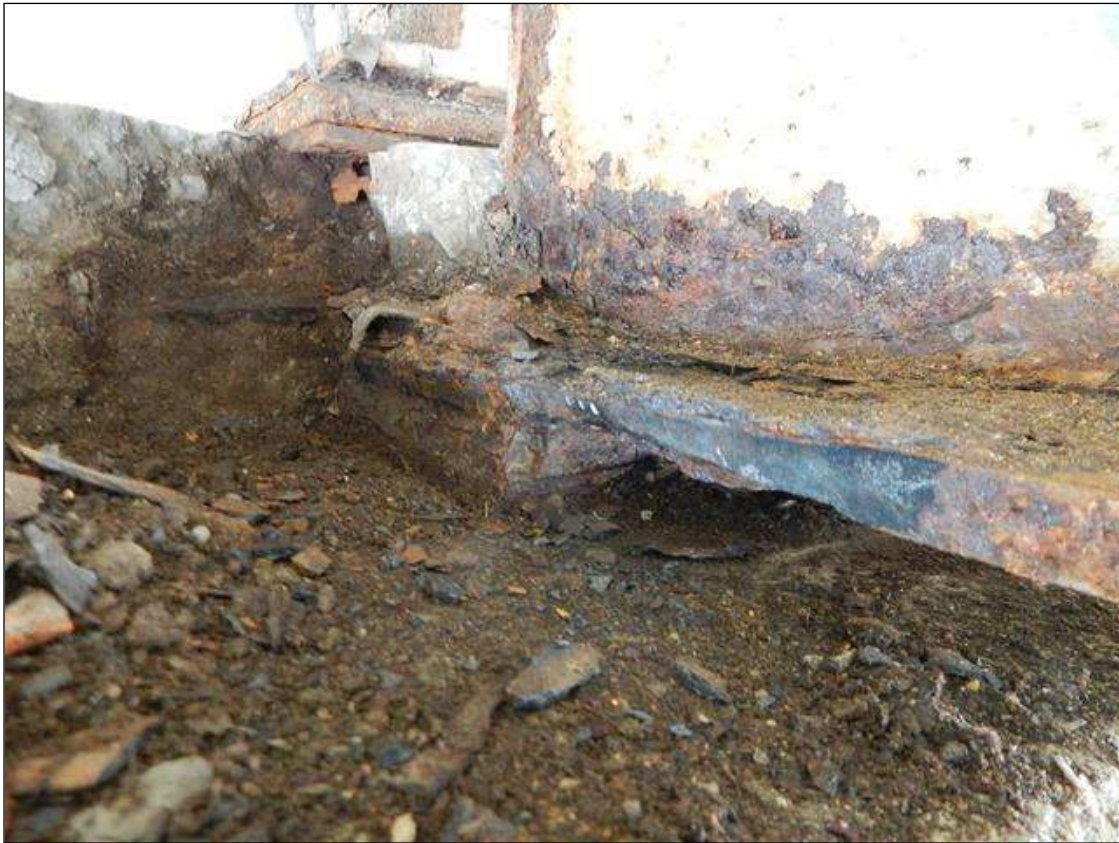
SPAN 8 BEAM 2: 8" X 4" AREA OF 1/4" SECTION LOSS (1/2" REMAINING) WITH 1/4" LOSS OF WIDTH ON BOTH SIDES OF BOTTOM FLANGE AT BENT 8

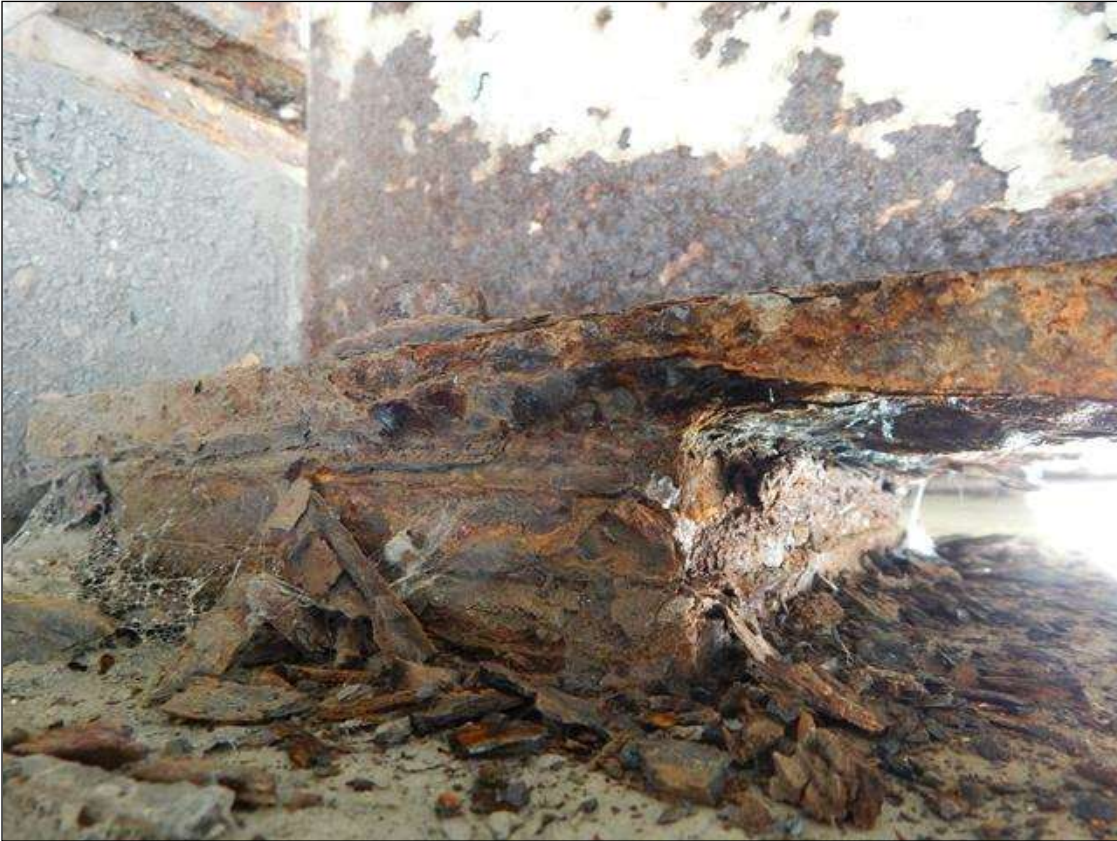
SPAN 8 BEAM 2: 4" X 2" AREA OF 1/4" SECTION LOSS (1/2" REMAINING) ON BOTH SIDES OF BOTTOM FLANGE AT BENT 7

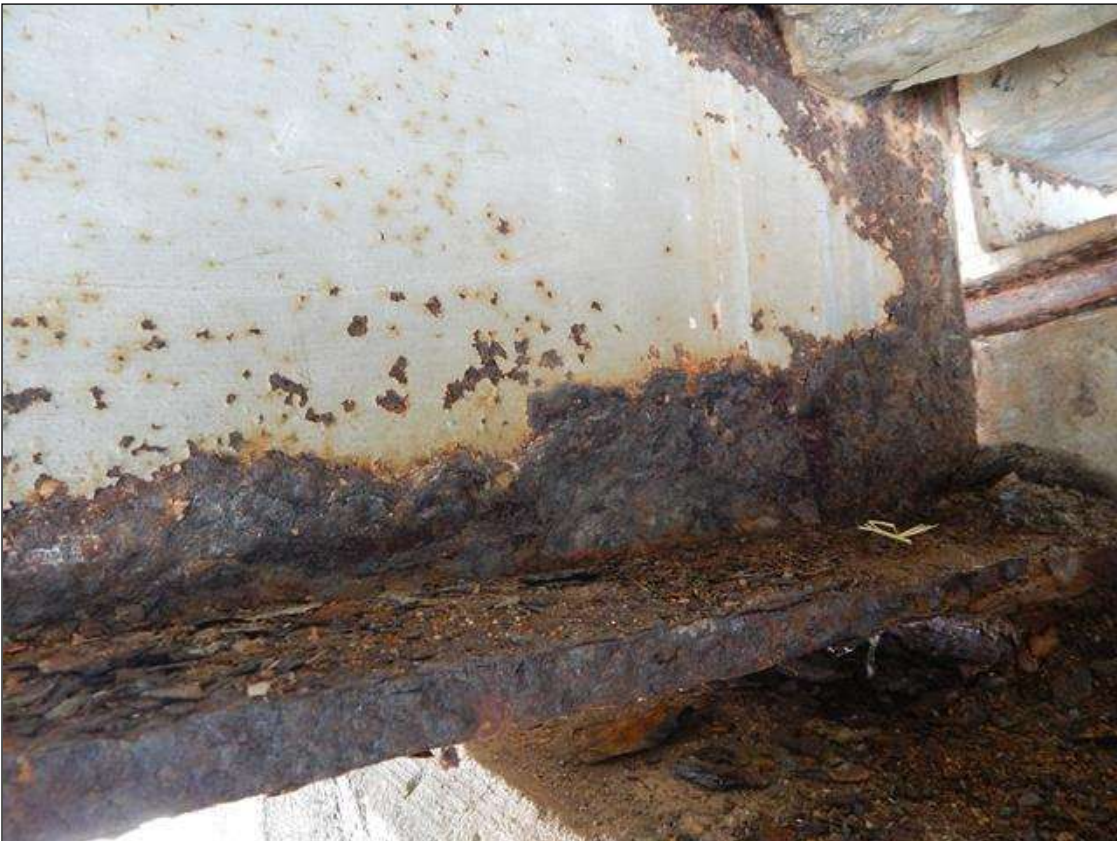
SPAN 8 BEAM 3: 18" X 3" AREA OF 1/4" SECTION LOSS (1/2" REMAINING) ON RIGHT SIDE OF WEB AT BENT 8

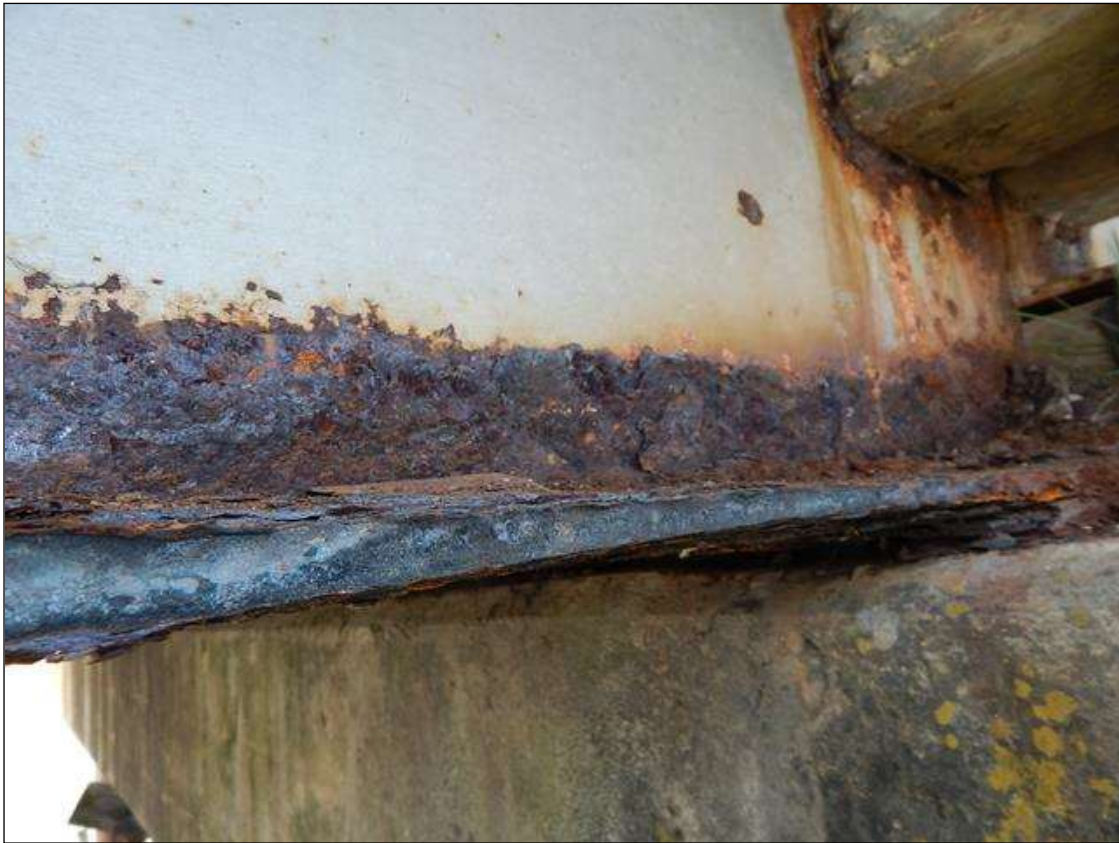
SPAN 8 BEAM 4: 16" X 4" AREA OF 3/8" SECTION LOSS (3/8" REMAINING) ON RIGHT SIDE OF BOTTOM FLANGE AT BENT 8

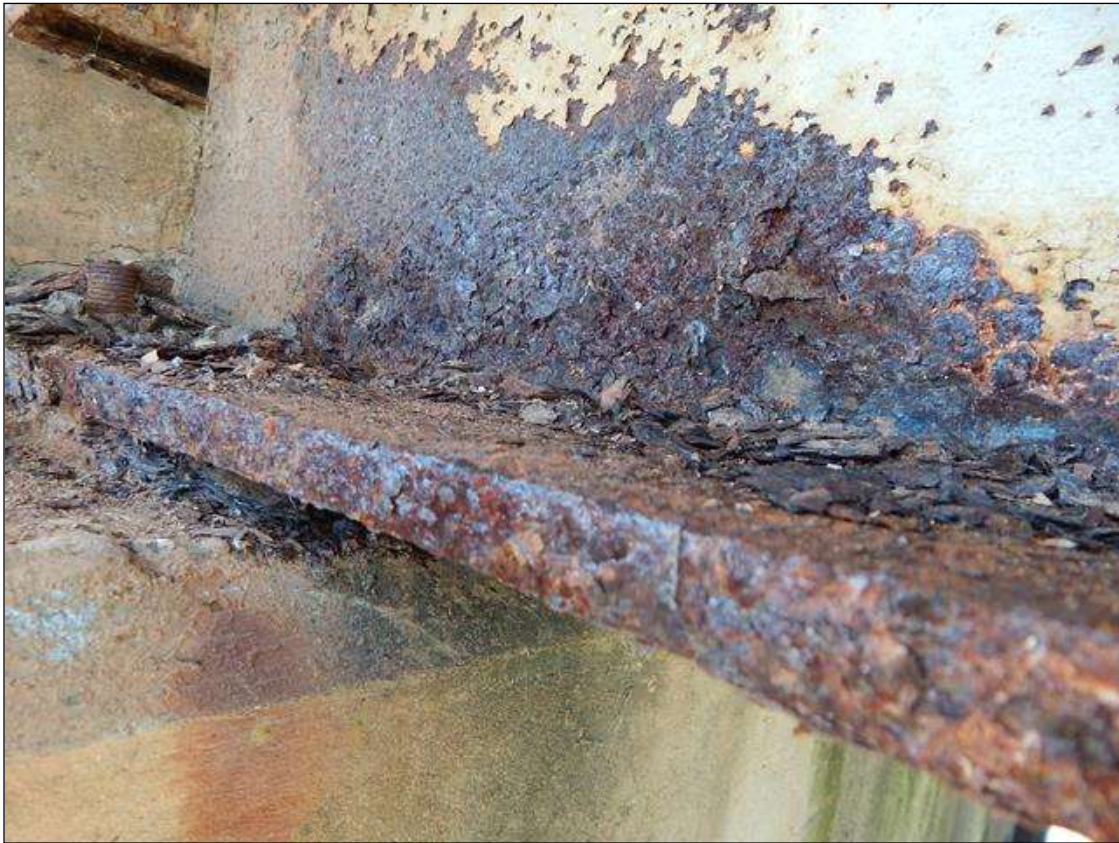
SPAN 8 BEAM 4: 10" X 2" AREA OF 1/8" SECTION LOSS (5/8" REMAINING) ON BOTH SIDES OF BOTTOM FLANGE AT BENT 7
