NC DEPARTMENT OF TRANSPORTATION  
DIVISION OF HIGHWAYS  
STRUCTURE MANAGEMENT UNIT

## Structure Safety Report

### Routine Element Inspection - Contract

COUNTY: CALDWELL STRUCTURE NUMBER: 130262 FREQUENCY: 24 MONTHS

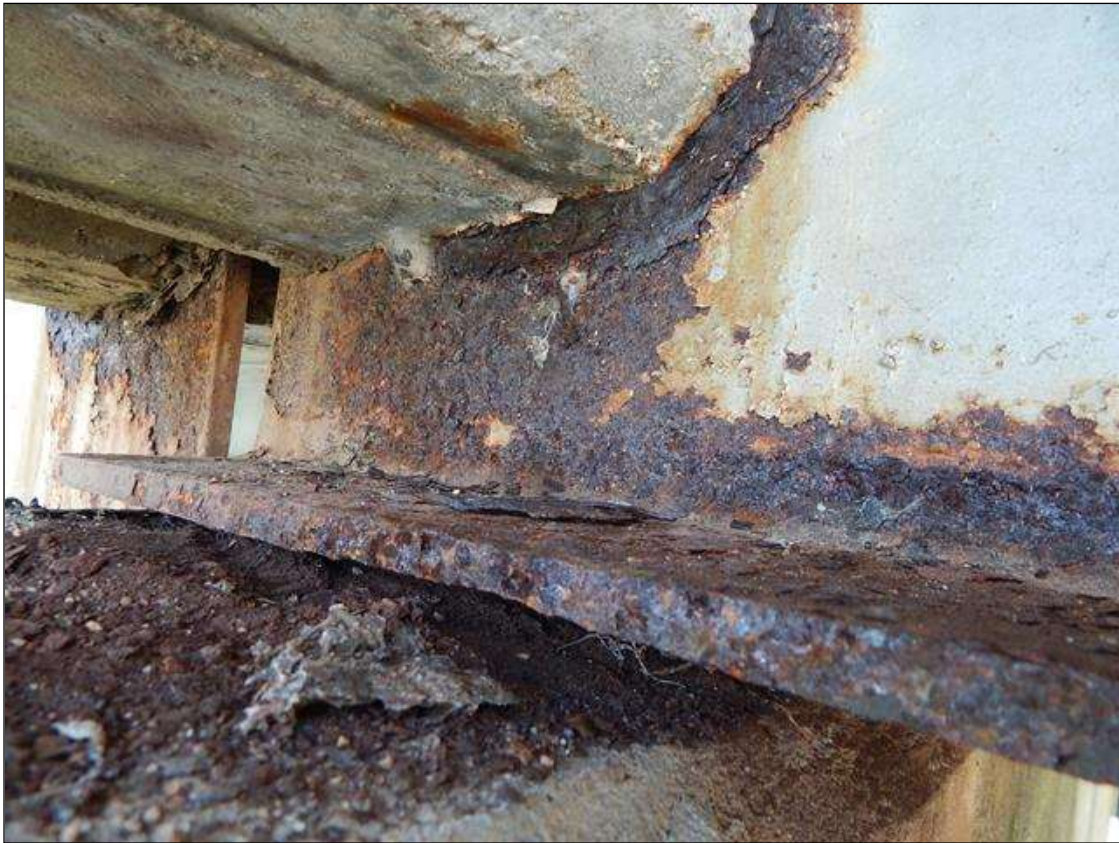
SPAN 9 BEAM 4: 7" X 3" AREA OF 3/16" SECTION LOSS (5/16" REMAINING) RIGHT SIDE BOTTOM FLANGE AT BENT 8

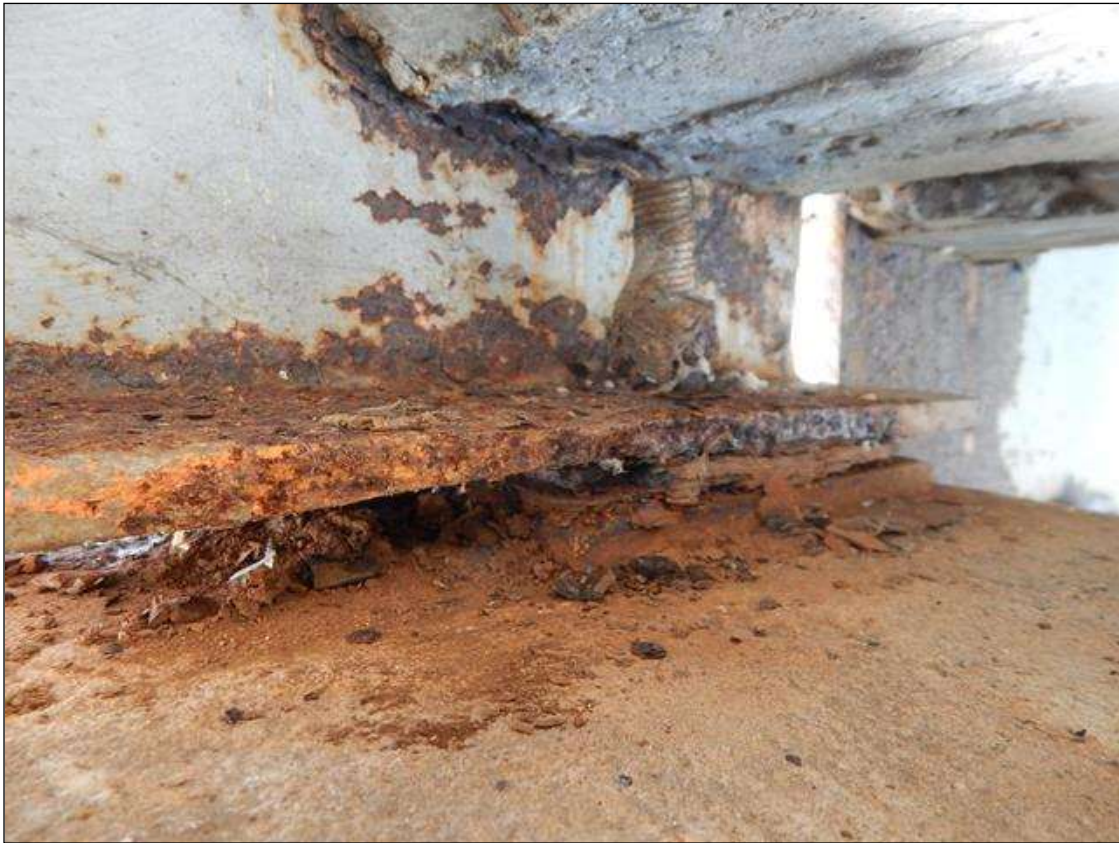
SPAN 9 BEAM 4: 4" X 2" AREA OF 1/16" SECTION LOSS (7/16" REMAINING) ON BOTH SIDES OF BOTTOM FLANGE AT BENT 9

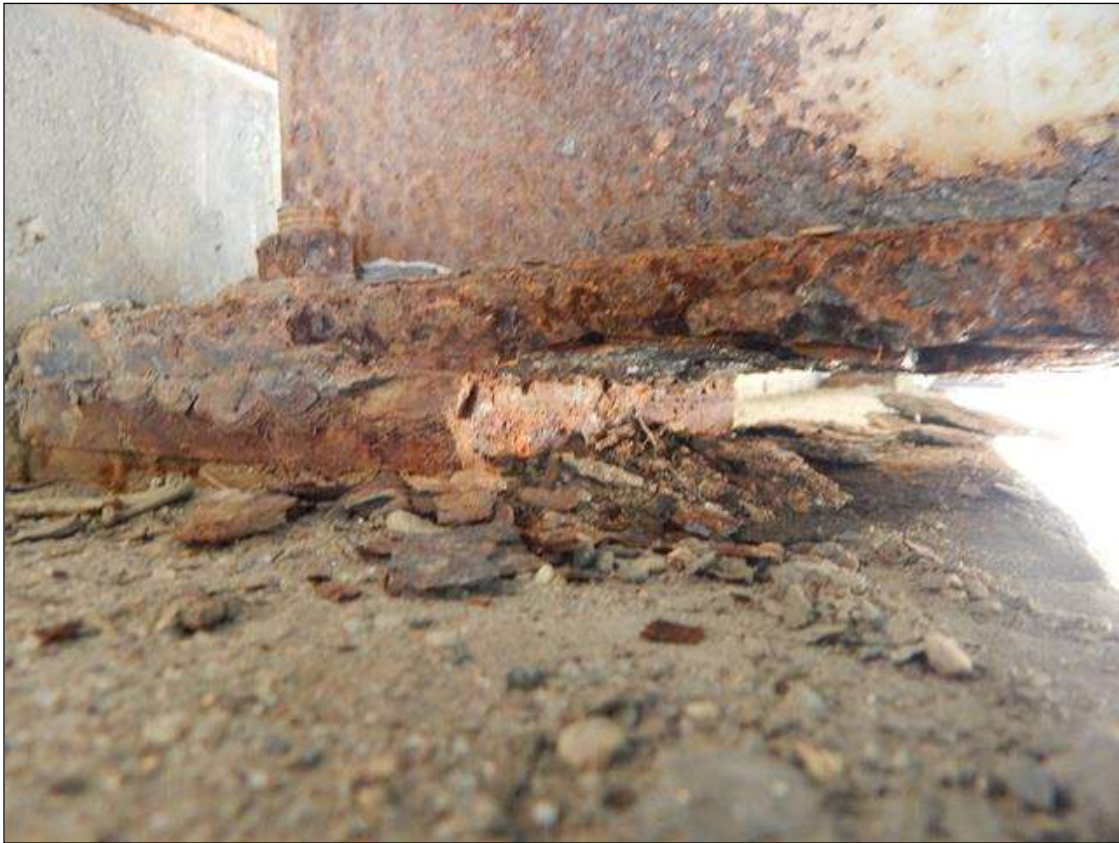
SPAN 10 BEAM 1: 11" X 4" AREA OF 1/16" SECTION LOSS (11/16" REMAINING) ON BOTH SIDES OF BOTTOM FLANGE AT BENT 9

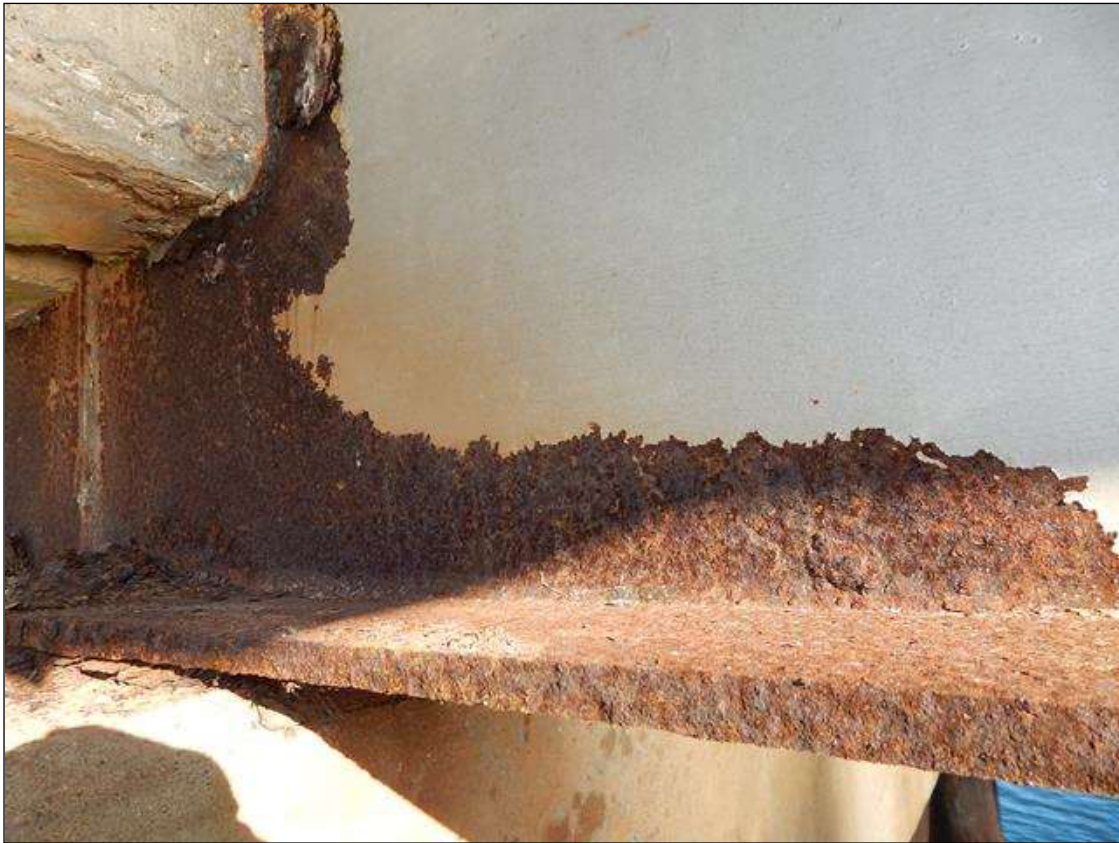
SPAN 10 BEAM 1: 12" X 4" AREA OF 1/16" SECTION LOSS (11/16 REMAINING) OF BOTH SIDES OF BOTTOM FLANGES AT BENT 10

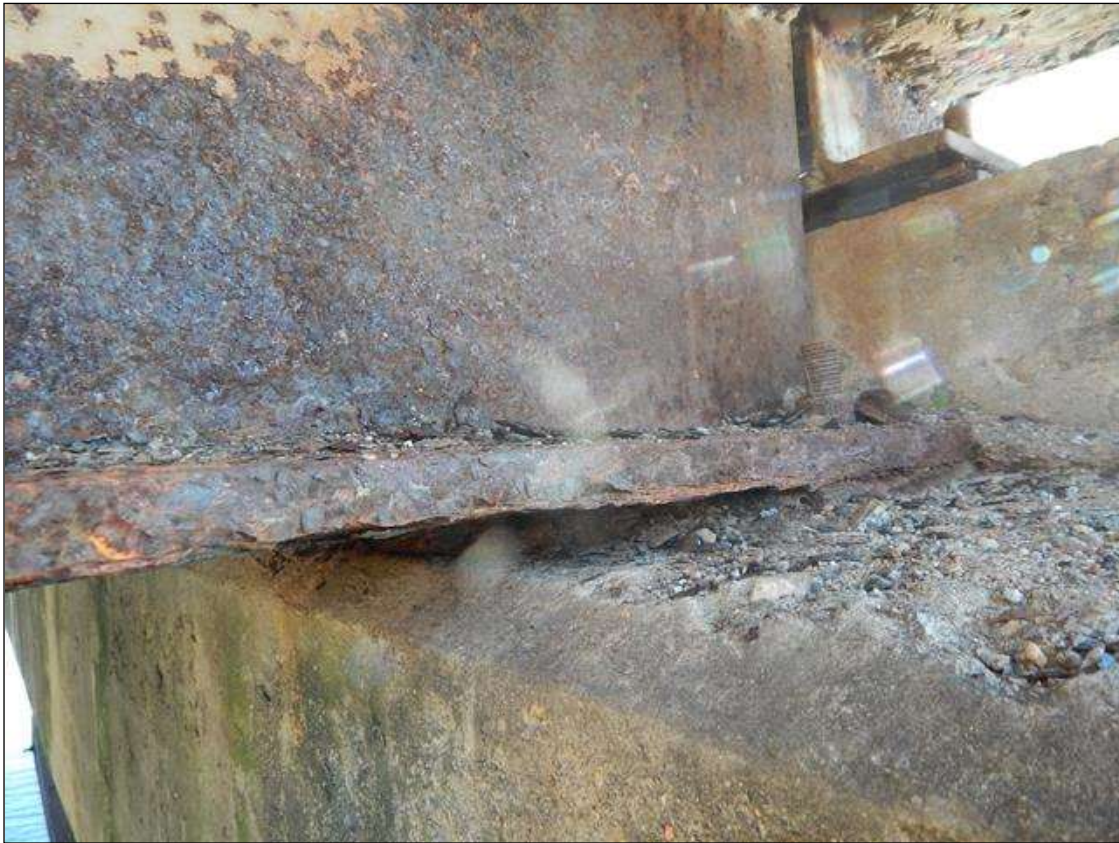
SPAN 10 BEAM 2: 4" X 4" AREA OF 1/16" SECTION LOSS (11/16" REMAINING) ON BOTH SIDES OF BOTTOM FLANGE AT BENT 9

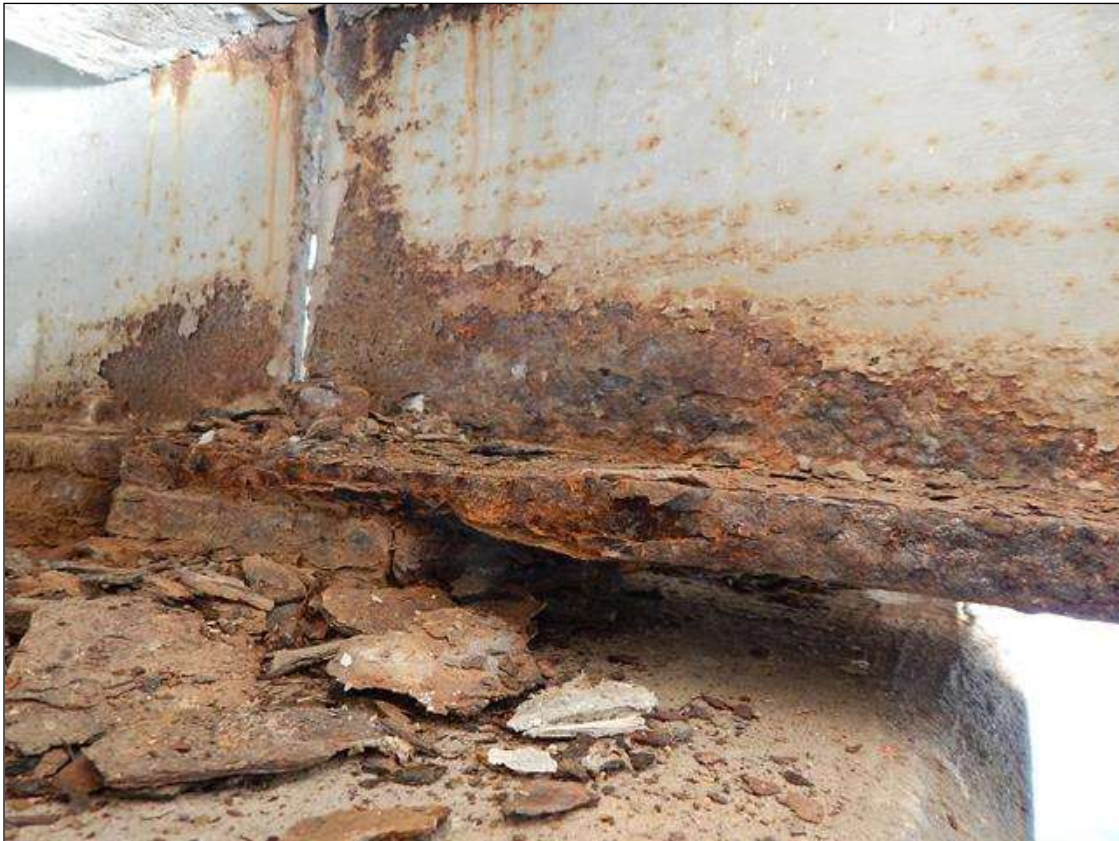
SPAN 10 BEAM 2: 5" X 4" AREA OF 1/8" SECTION LOSS (5/8" REMAINING) ON BOTH SIDES OF BOTTOM FLANGE AT BENT 10

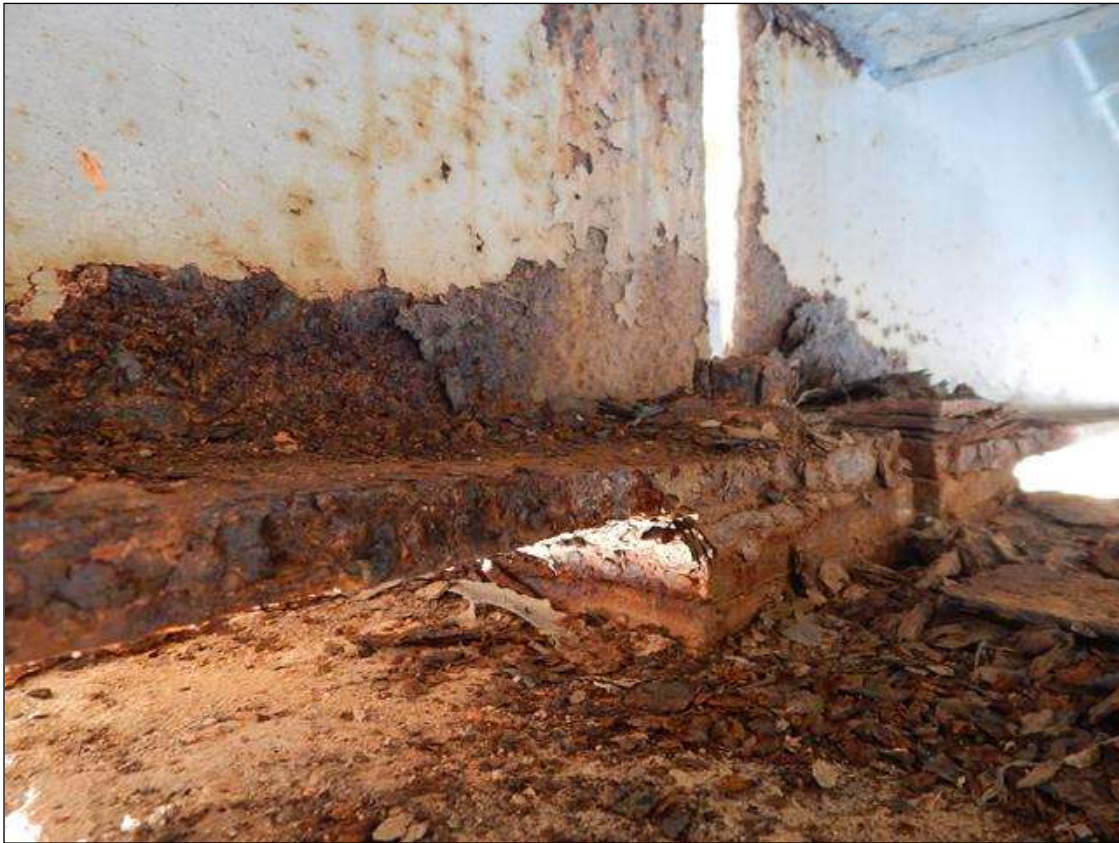
SPAN 10 BEAM 3: 7" X 4" AREA OF 1/4" SECTION LOSS (1/2" REMAINING) BOTH SIDES OF BOTTOM FLANGE  
AT BENT 10

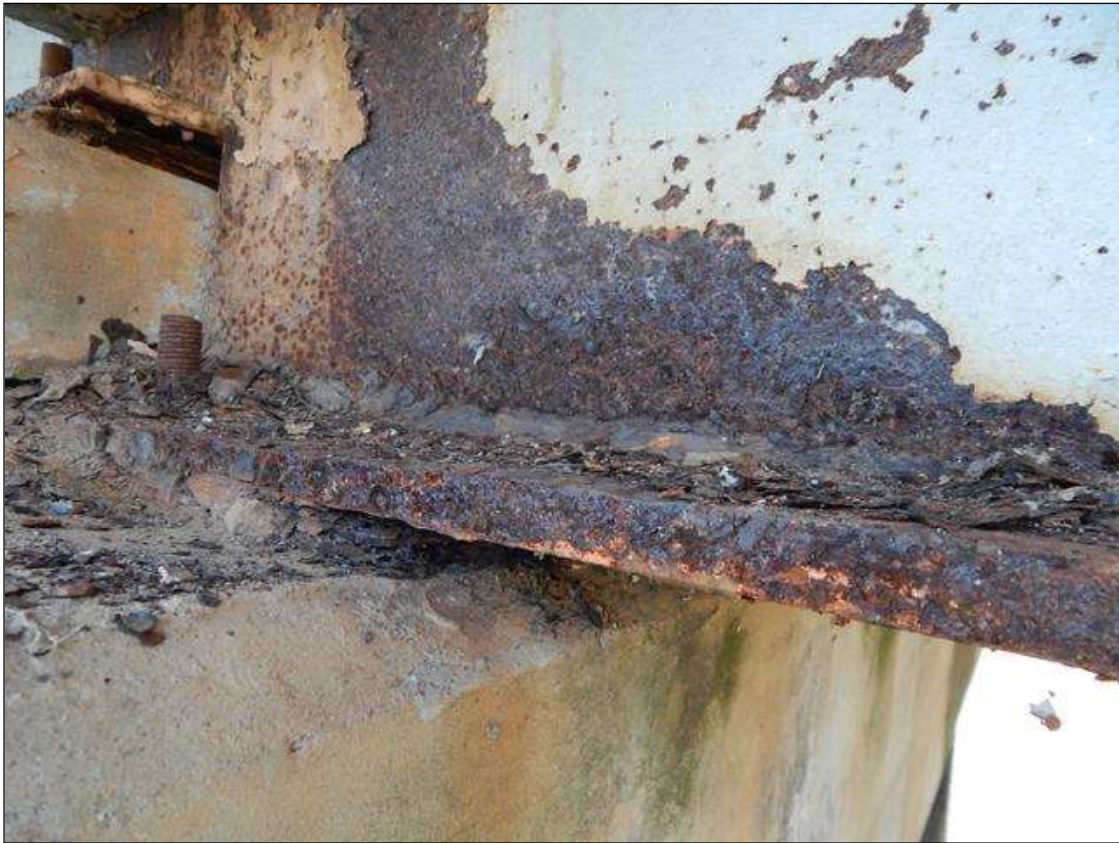
SPAN 10 BEAM 4: 12" X 3" AREA OF 1/16" SECTION LOSS (11/16" REMAINING) ON RIGHT SIDE OF BOTTOM FLANGE

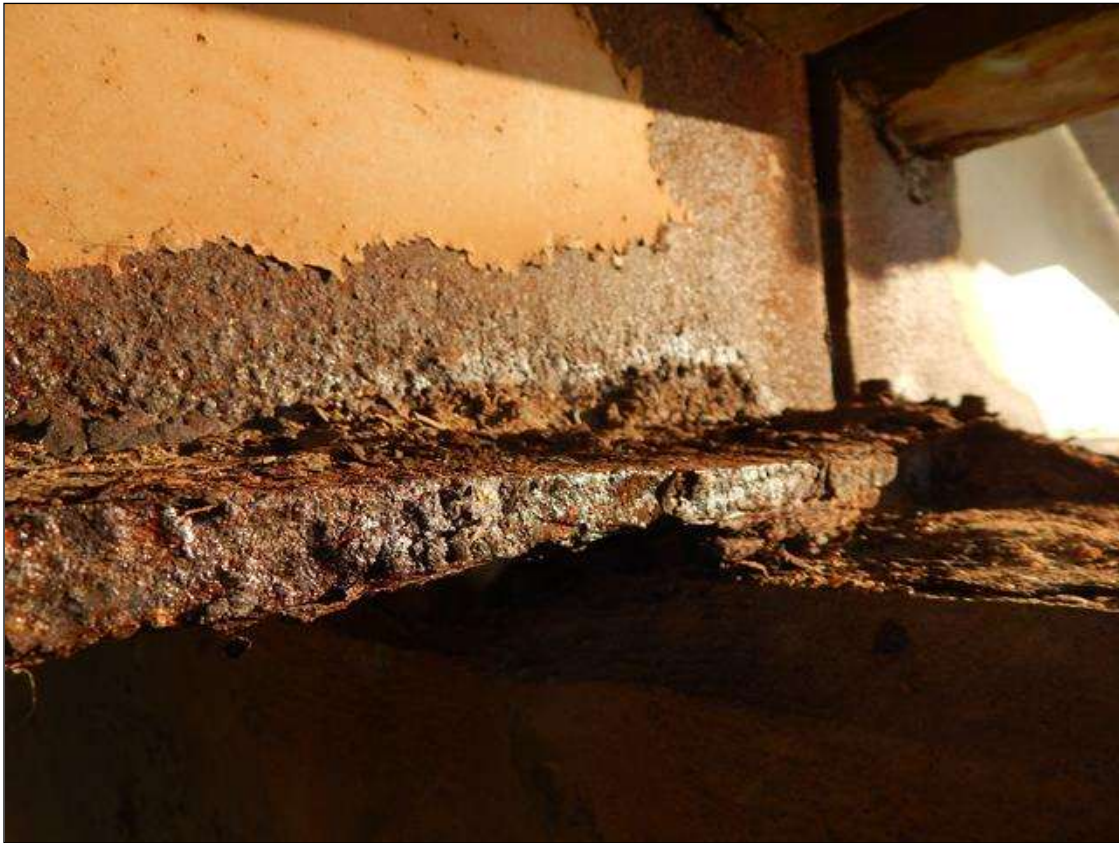
SPAN 11 BEAM 1: 11" X 4" AREA OF 1/8" SECTION LOSS (5/8" REMAINING) BOTH SIDES OF BOTTOM FLANGE  
AT BENT 10

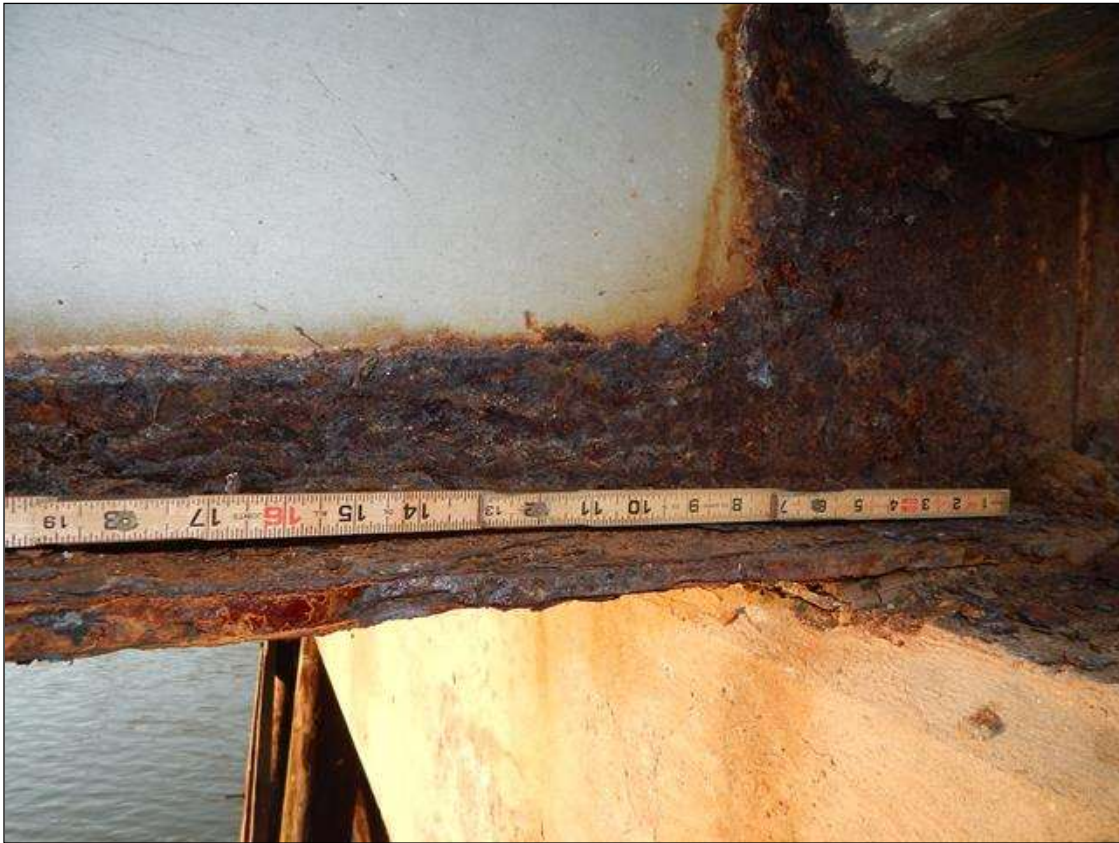
SPAN 11 BEAM 4: 20" X 4" AREA OF 5/16" SECTION LOSS (7/16 REMAINING) ON THE RIGHT SIDE OF BOTTOM FLANGE AT BENT 11

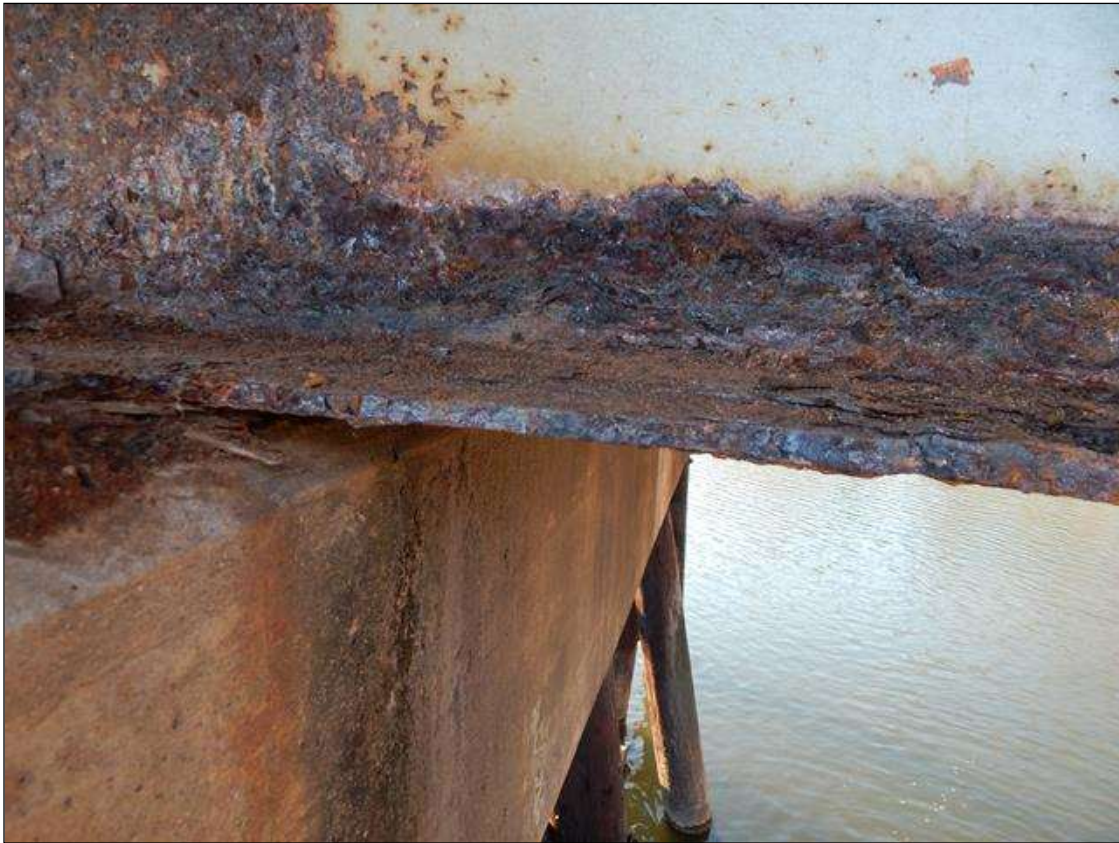
SPAN 12 BEAM 4: 6" X 3" AREA OF 1/4" SECTION LOSS (1/2" REMAINING) IN LEFT SIDE OF BOTTOM FLANGE  
AT END BENT 2

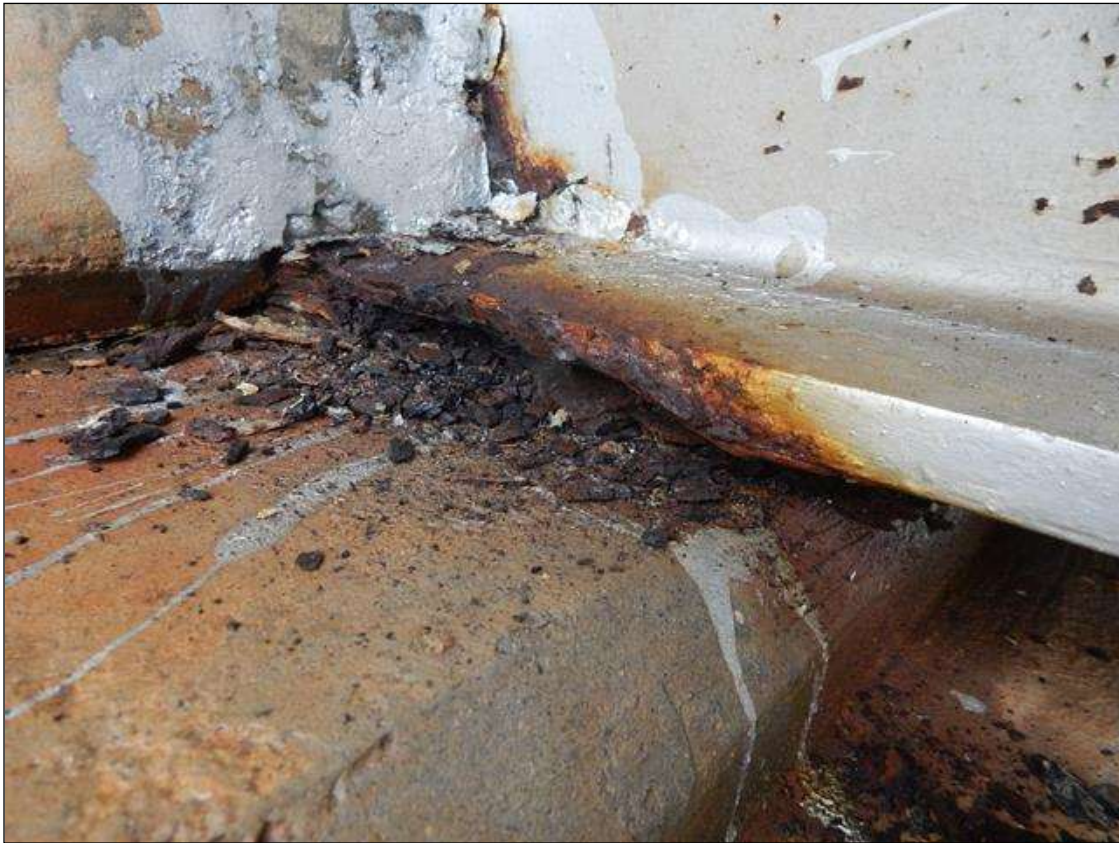
SPAN 12 BEAM 1: 7" X 3" AREA OF 1/4" SECTION LOSS (1/2" REMAINING) IN LEFT SIDE OF BOTTOM FLANGE  
AT END BENT 2
