NC DEPARTMENT OF TRANSPORTATION  
DIVISION OF HIGHWAYS  
STRUCTURE MANAGEMENT UNIT

## Structure Safety Report

### Routine Element Inspection - Contract

COUNTY: WAKE STRUCTURE NUMBER: 910091 FREQUENCY: 24 MONTHS

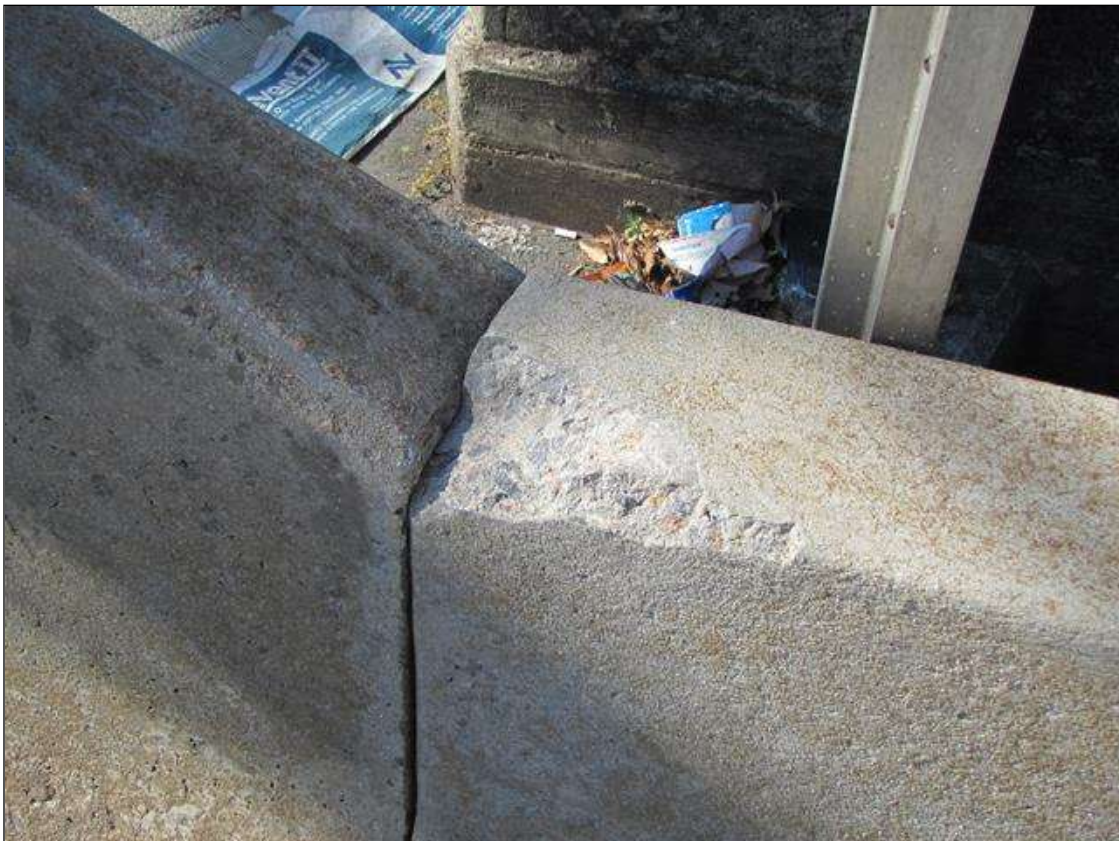
Span 4 Right Bridge Rail: 8IN X 3IN X 1IN DEEP SPALL, AT END OF RAIL, AT END BENT 2.

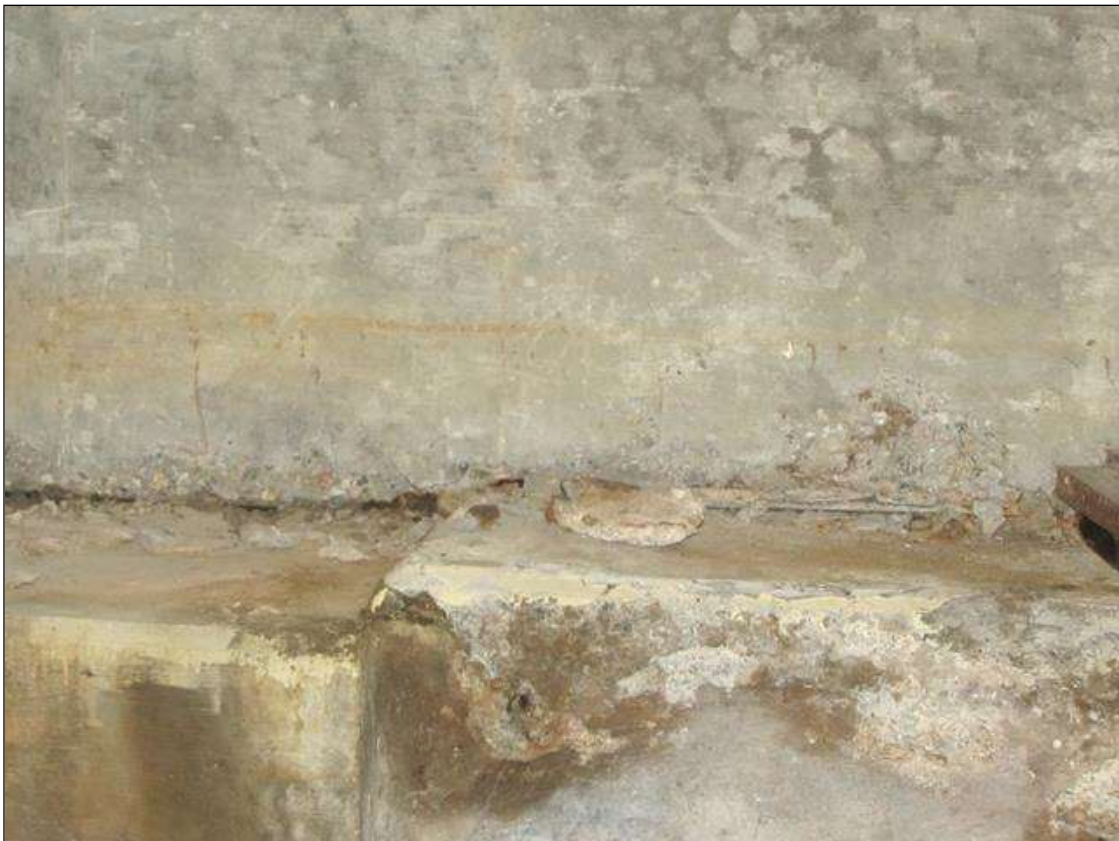
End Bent 1 Abutment/Backwall : DELAMINATION 1 FT X 8" IN BAY 13

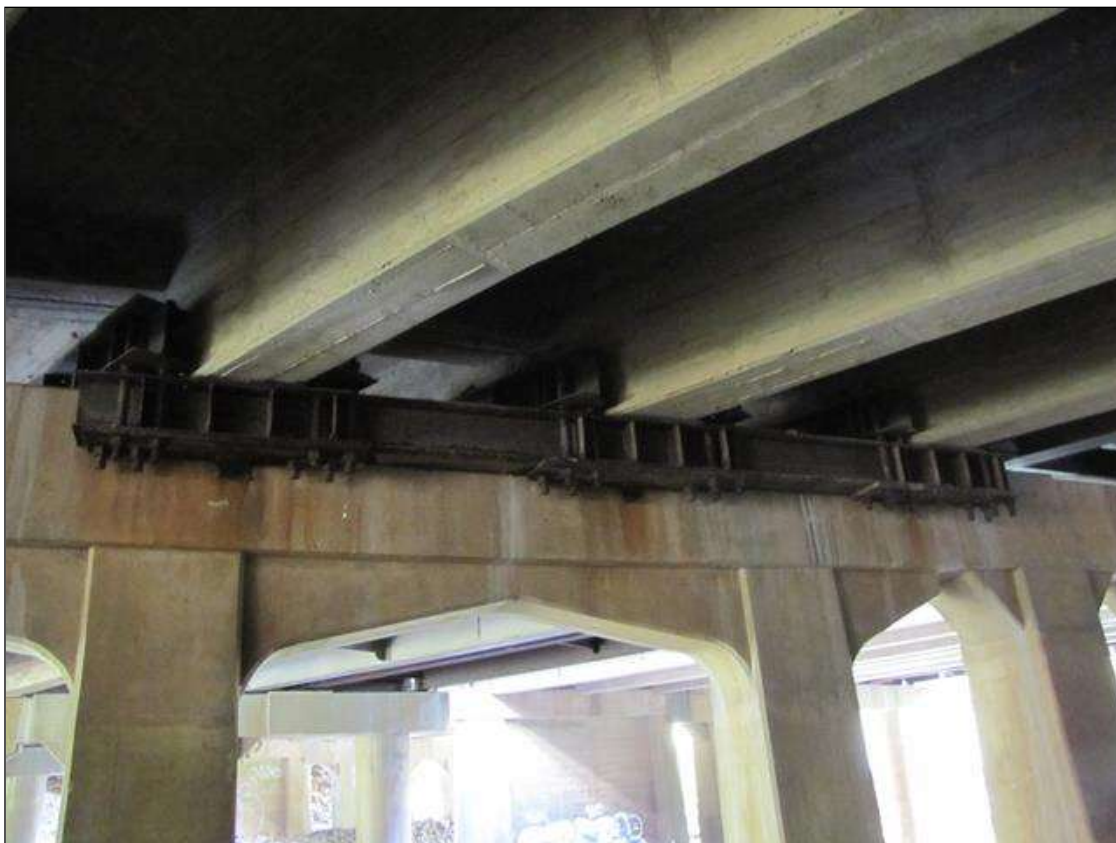
CAP REPAIR AT BENT 1 UNDER BEAMS 8, 9, 10 IN SPANS 1 AND 2 (WEST SIDE SHOWN)
