NC DEPARTMENT OF TRANSPORTATION  
DIVISION OF HIGHWAYS  
STRUCTURE MANAGEMENT UNIT

## Structure Safety Report

### Routine Element Inspection - Contract

COUNTY: WAKE STRUCTURE NUMBER: 910260 FREQUENCY: 24 MONTHS  
FACILITY CARRIED: I440 MILE POST: 6.5  
LOCATION: 1.88 MI.N.E.SR1676  
FEATURE INTERSECTED: US70  
LATITUDE: 35° 50' 7.05" LONGITUDE: 78° 40' 10.1"  
SUPERSTRUCTURE: RC FLOOR/I-BEAMS(WIDENED)  
SUBSTRUCTURE: EBTS:RC CAP/PRESTR.CONC.PILES;BTS:RCP&B/PILE FTGS.  
SPANS: 2@67';1@70'6;1@45'  
☐ FRACTURE CRITICAL ☐ TEMPORARY SHORING ☐ SCOUR CRITICAL ☐ SCOUR PLAN OF ACTION  
PRESENT CONDITION: Fair INSPECTION DATE: 07/12/2016  
POSTED SV: Not Posted POSTED TTST: Not Posted  
OTHER SIGNS PRESENT: None

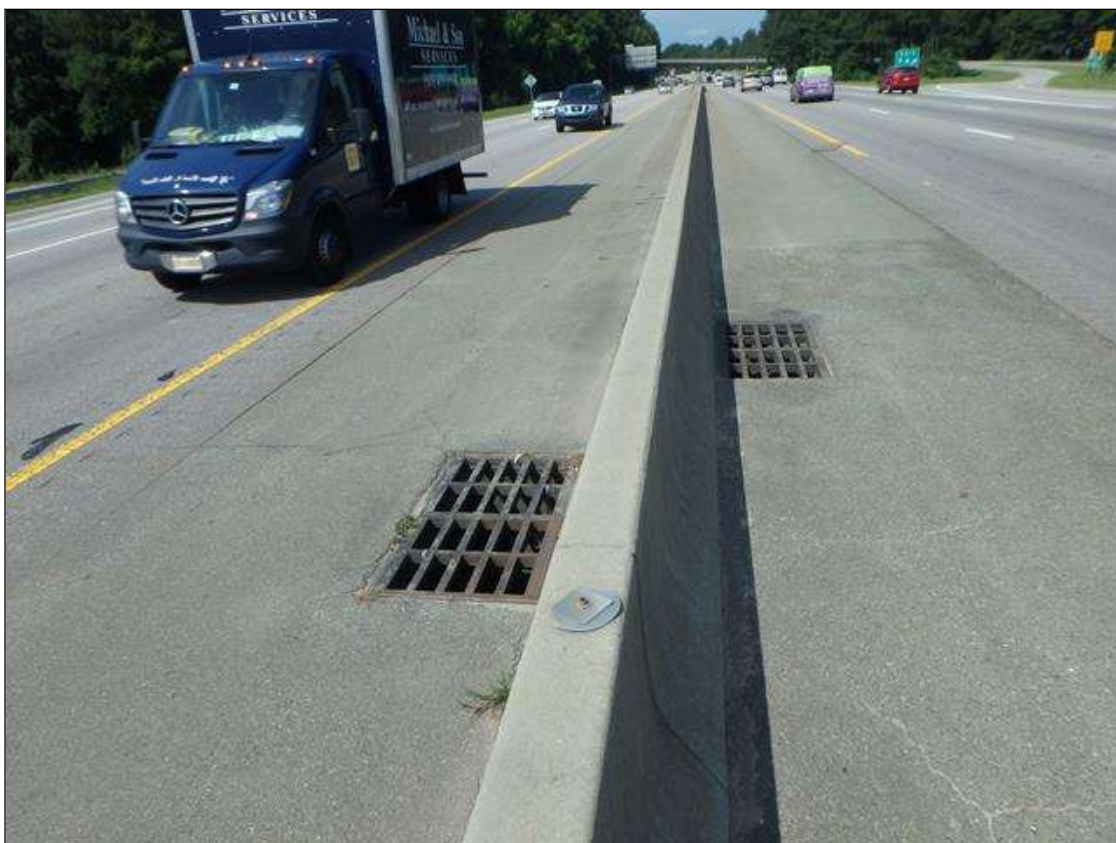
(x2) Grated Drop Inlets at the South Approach in the median

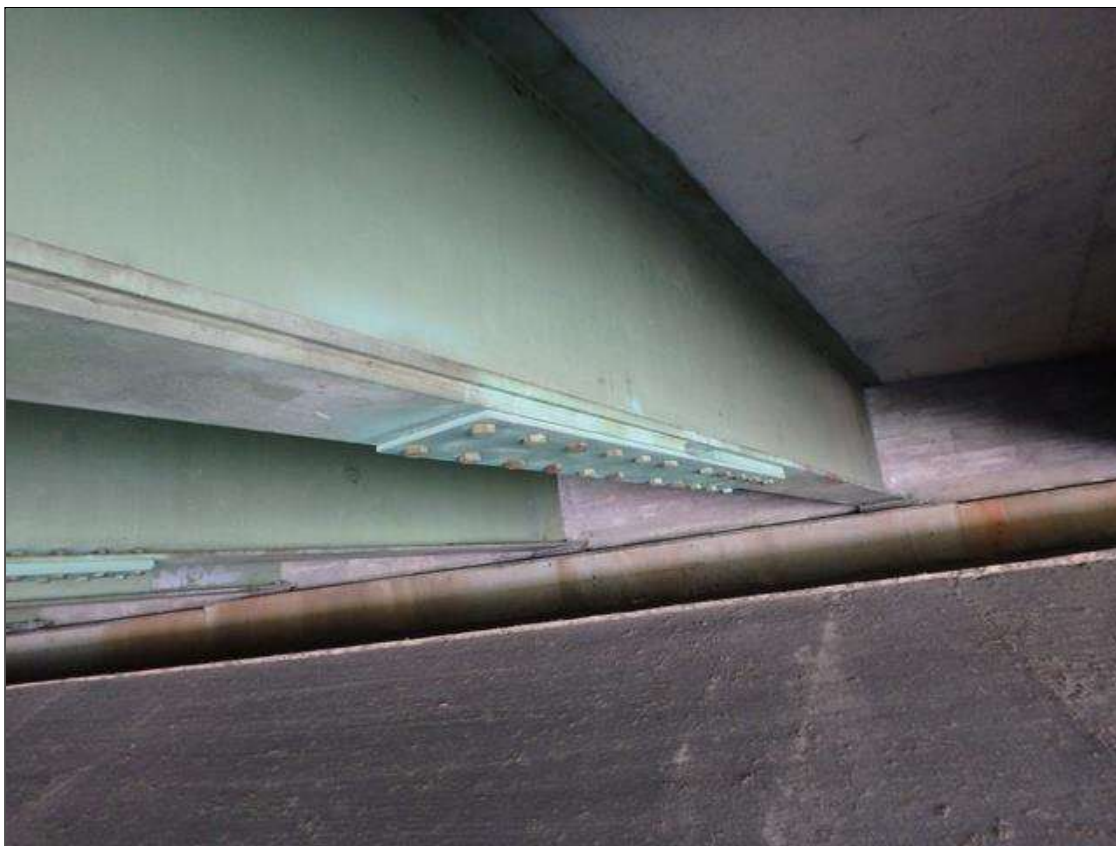
Span 1 Beam 5: connections and cover plates on the bottom flanges of the beams

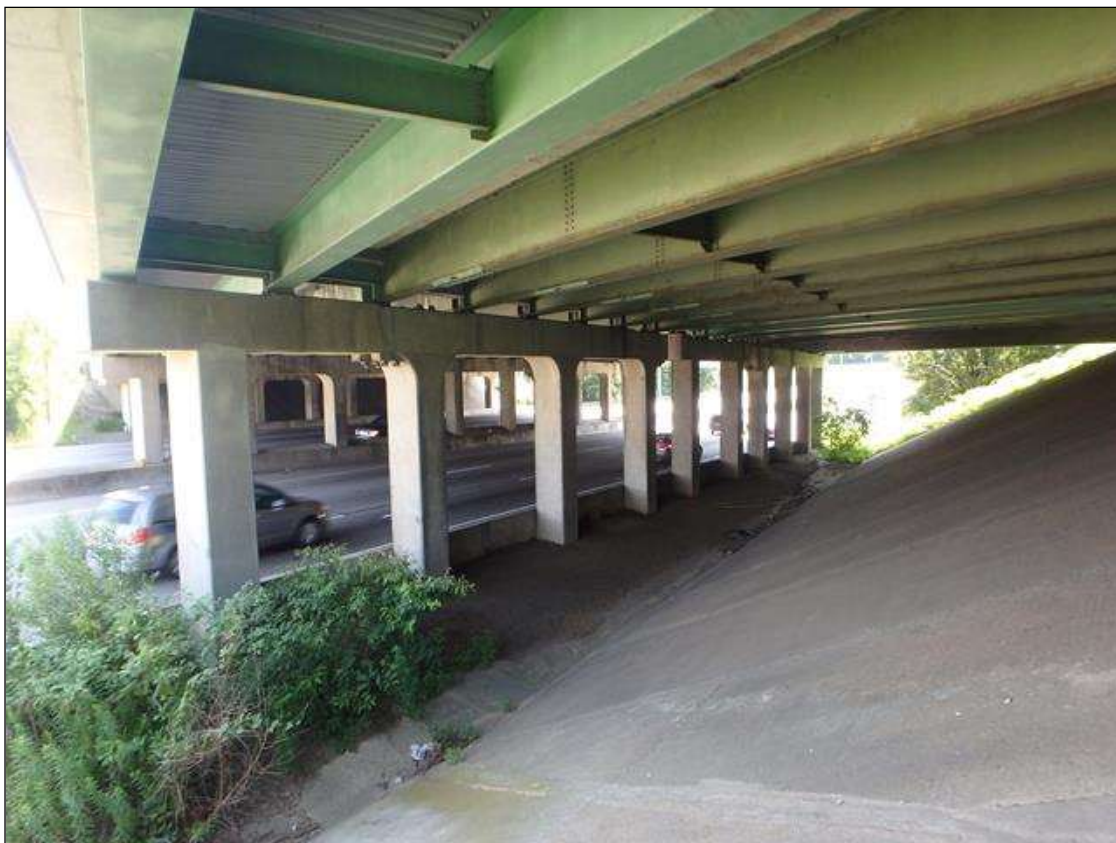
Bent 1 West Face

Column 1 at Bent 1 West Face: spall with exposed rebar (14" x 2" x 1/4")

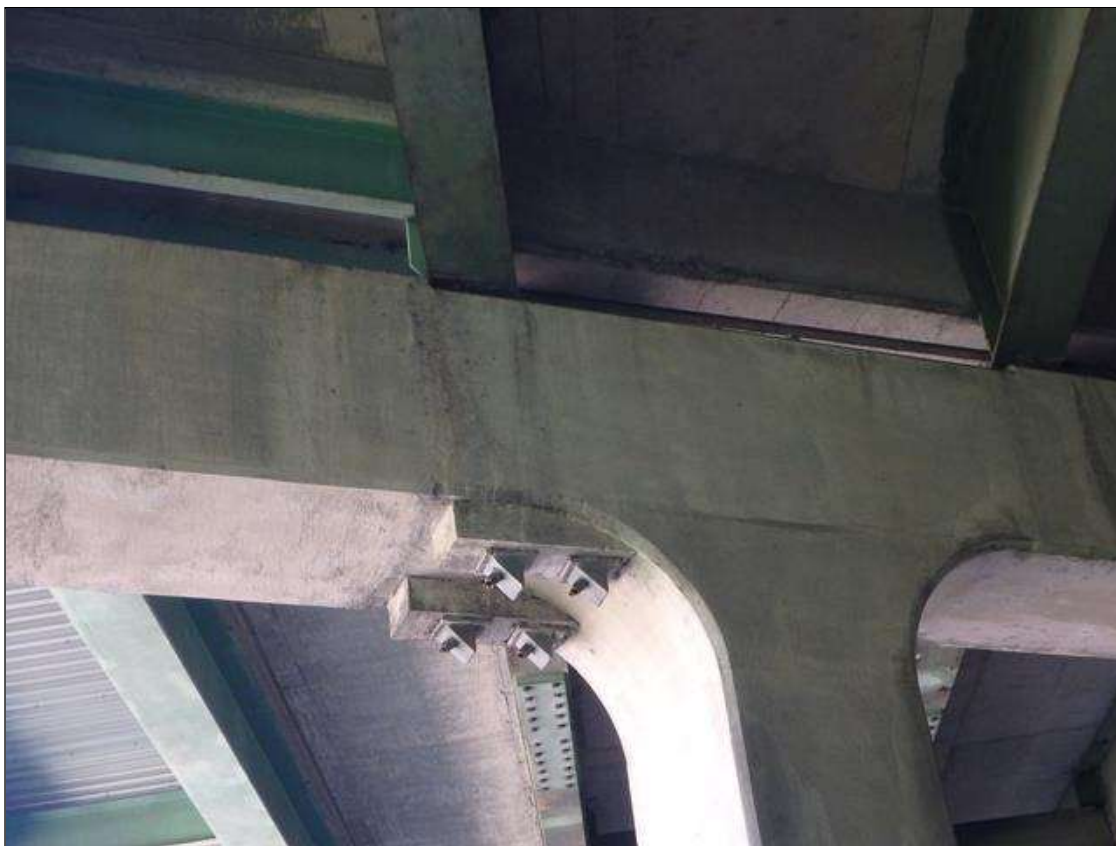
Bent 1 Cap at Column 2: posttensioning connection (similar at the original sections of each bent cap)

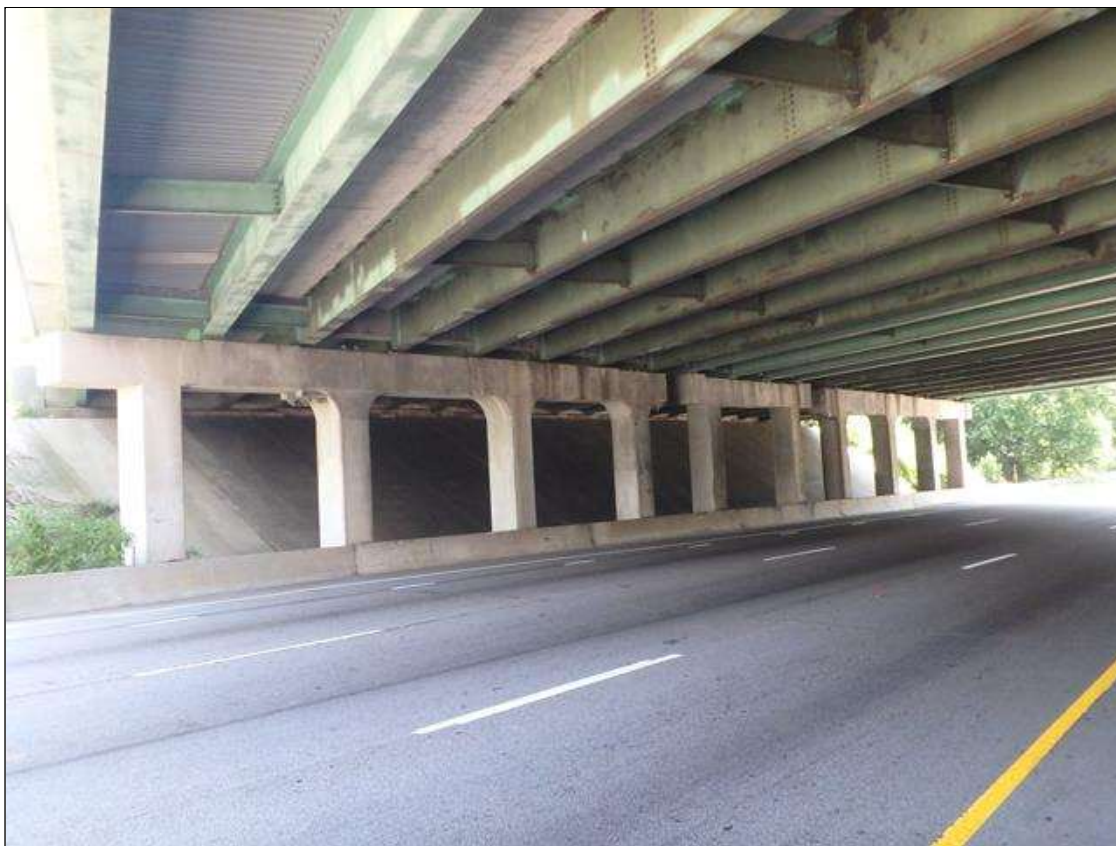
Bent 3 South Face

Bent 3 Cap East Face under Bay 8: spall with exposed rebar (19" x 19" x 1 1/4")
