NC DEPARTMENT OF TRANSPORTATION  
DIVISION OF HIGHWAYS  
STRUCTURE MANAGEMENT UNIT

## Structure Safety Report

### Routine Element Inspection - Contract

COUNTY: WAKE STRUCTURE NUMBER: 910494 FREQUENCY: 24 MONTHS

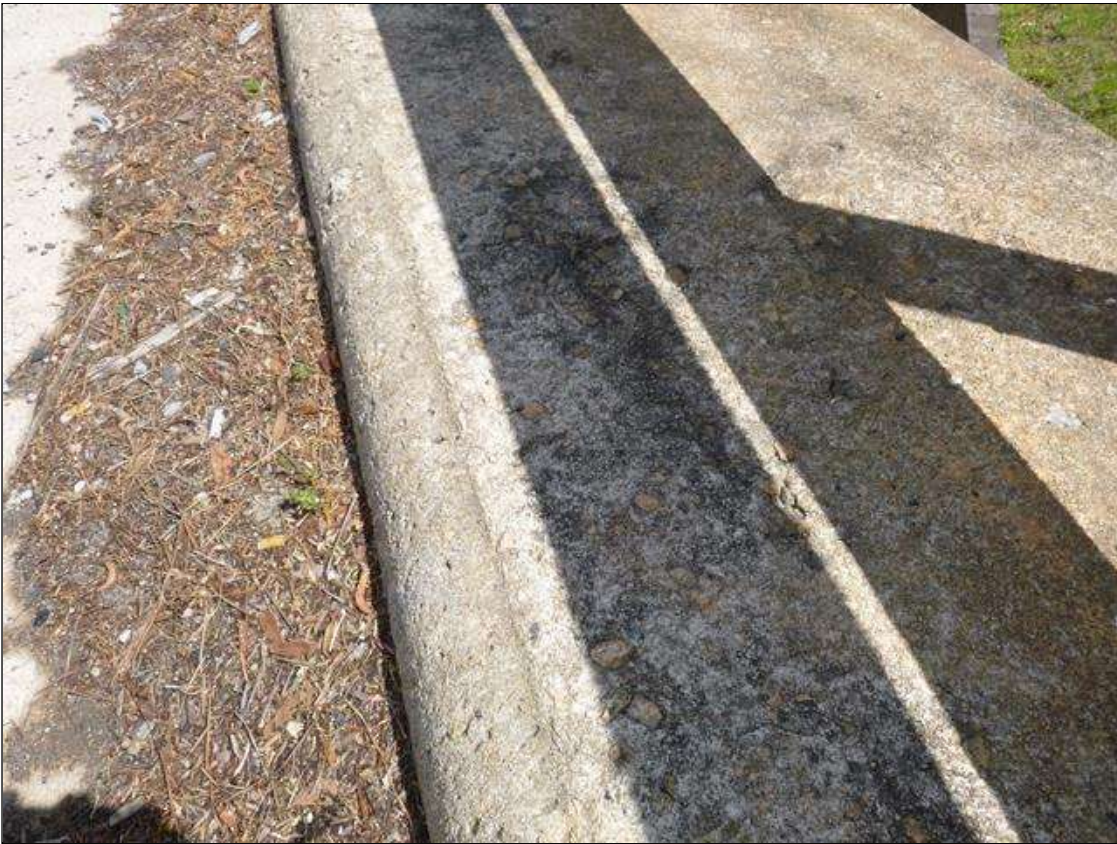
Span 1 Right Bridge Rail: 21' X 2' WIDE AREA OF EXPOSED AGGREGATE ALONG RIGHT CURB, BEGINNING AT END BENT 1.

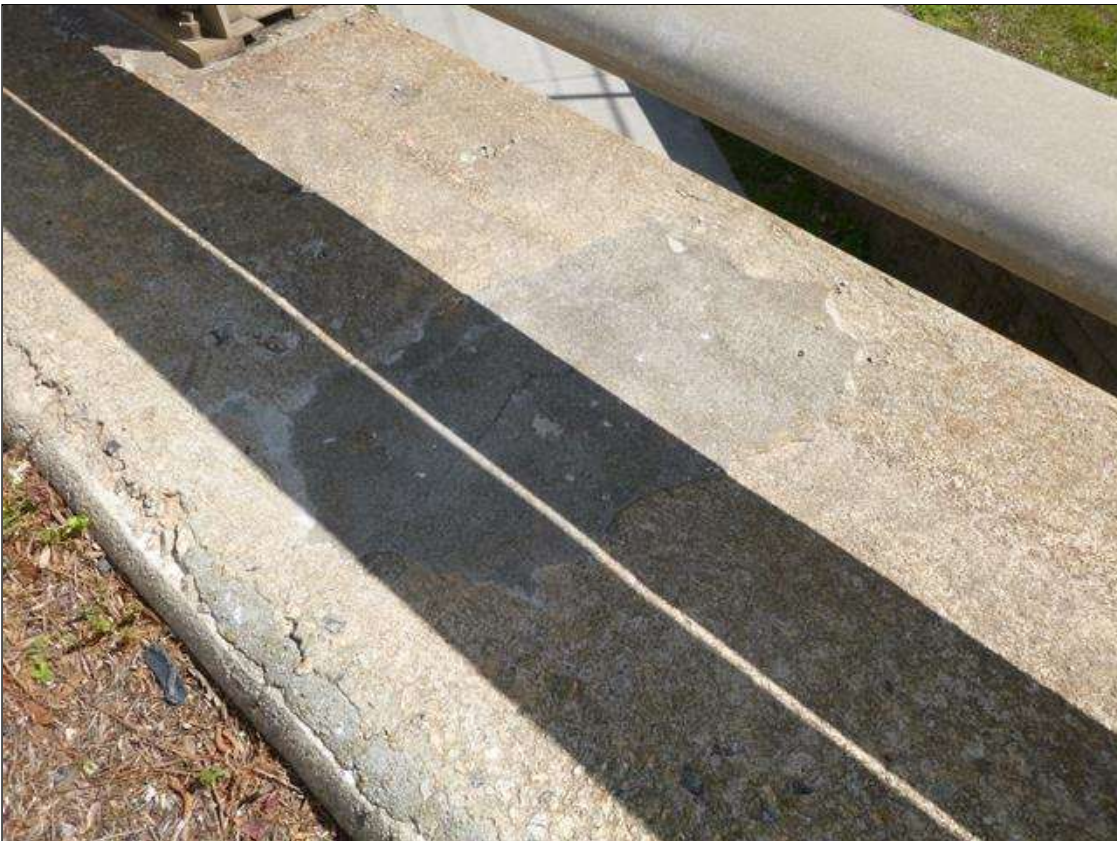
1' X 2' UNSOUND TEMPORARY REPAIR ALONG RIGHT CURB, BETWEEN RAIL POST 2 AND 3.

Span 1 Right Bridge Rail: 1' X 2' UNSOUND TEMPORARY REPAIR ALONG RIGHT CURB, BETWEEN RAIL POST 2 AND 3.

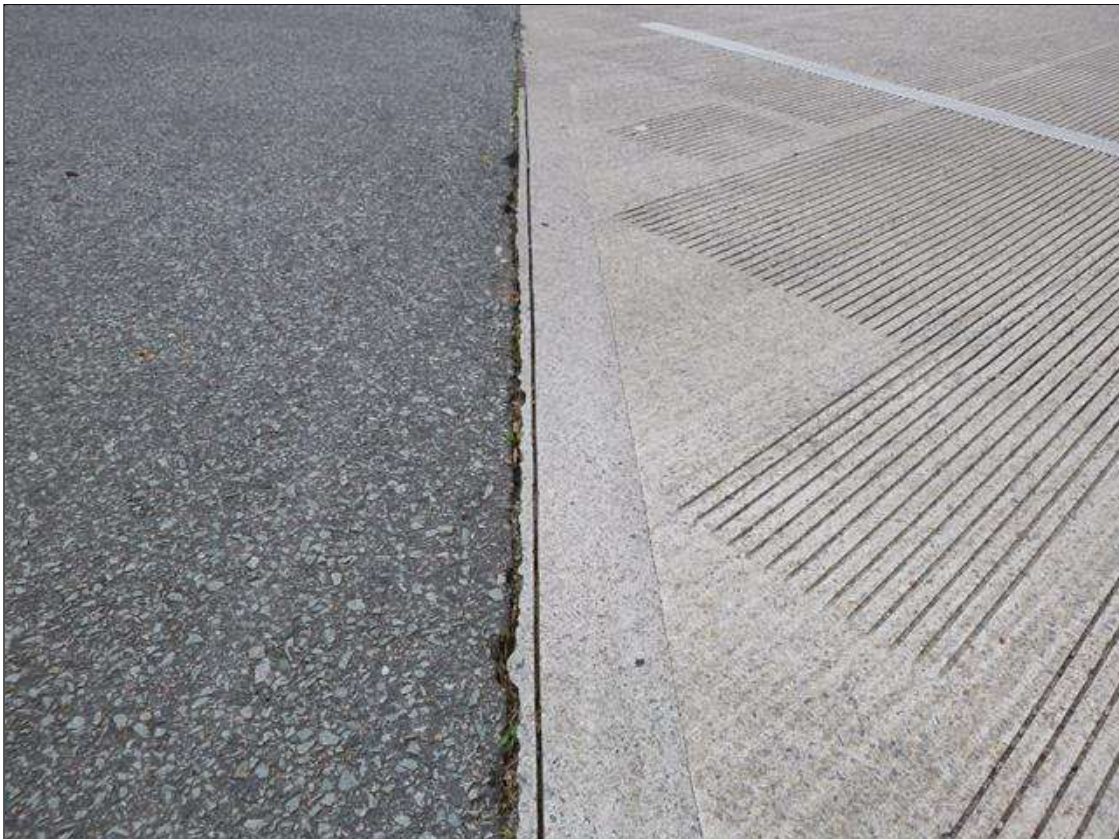
15' TOTAL FT OF TEMPORARY REPAIR, DECK SURFACE, ALONG SOUTH EDGE OF DECK, OVER END BENT 1, NORTH BOUND LANE.

Span 1 Deck: 15' TOTAL FT OF TEMPORARY REPAIR, DECK SURFACE, ALONG SOUTH EDGE OF DECK, OVER END BENT 1, NORTH BOUND LANE.

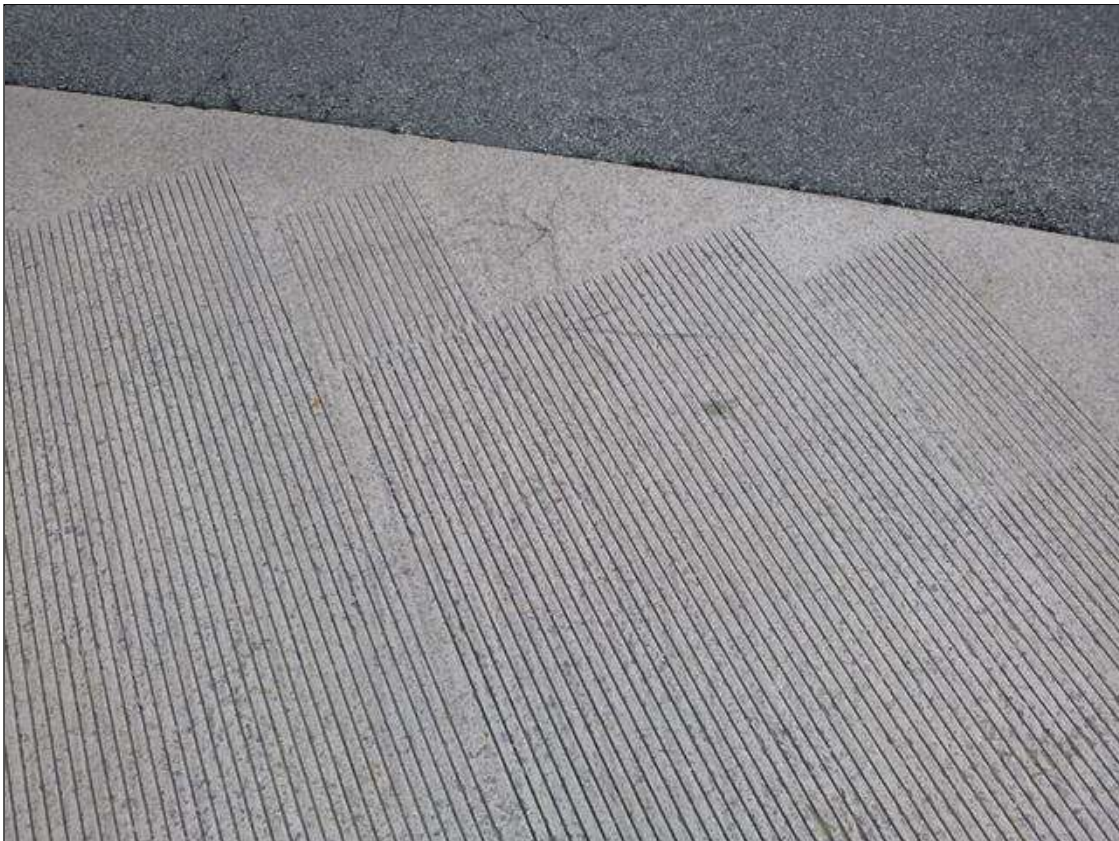
5' DIAGONAL HAIRLINE CRACK, DECK SURFACE, SOUTH END OF SOUTH BOUND LANE, 5' FROM LEFT CURB, AT END BENT 1.

Span 1 Deck: 5' DIAGONAL HAIRLINE CRACK, DECK SURFACE, SOUTH END OF SOUTH BOUND LANE, 5' FROM LEFT CURB, AT END BENT 1.

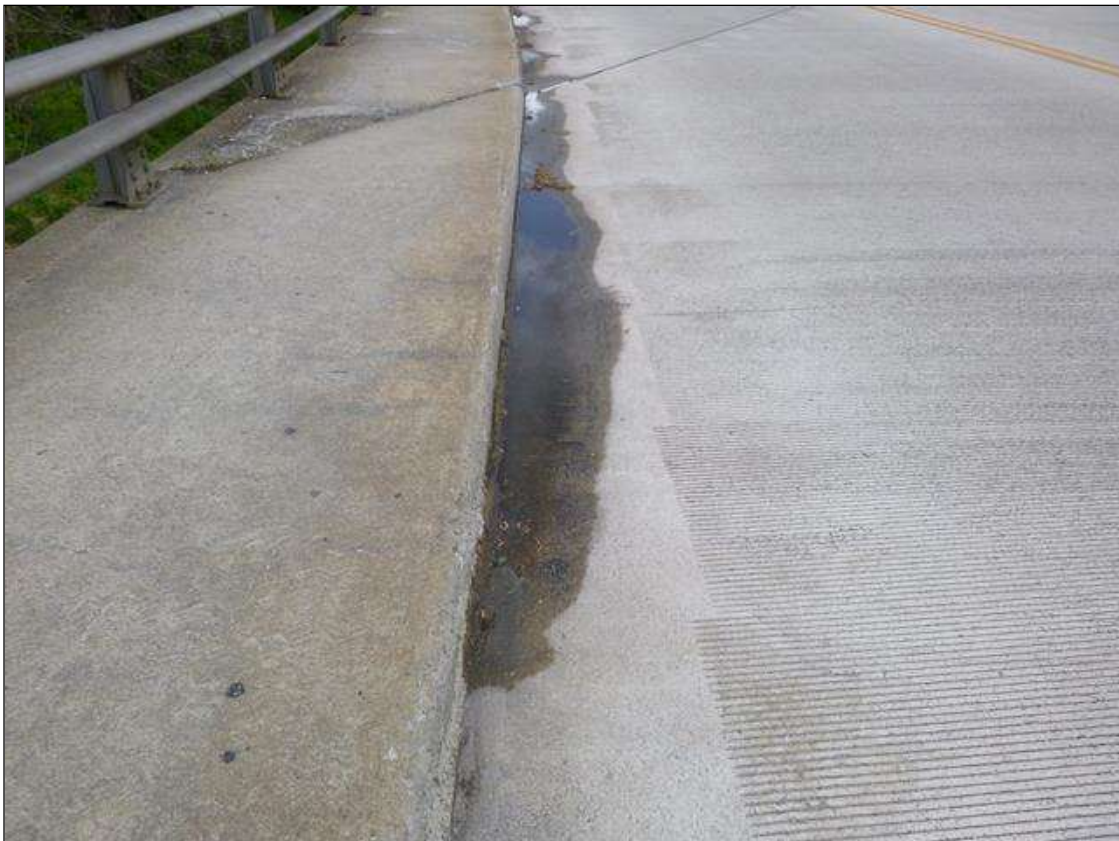
Drainage : 18' X 1' AREA OF WATER PONDING, AT LEFT CURB, BEGINNING AT BENT 1, DECK IS SLOPED TOWARD LEFT SIDE OF BRIDGE WITH NO DRAINS ON LEFT SIDE.

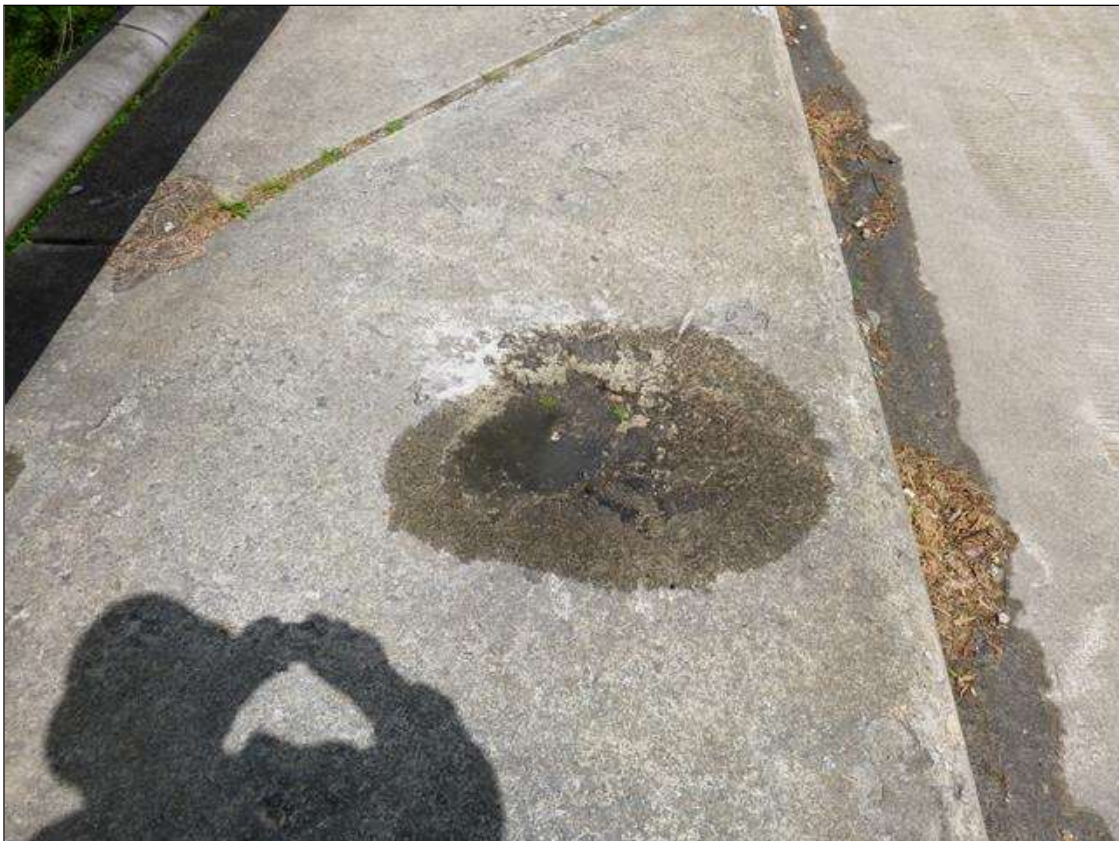
19" X 12" X 1" SPALL, TOP OF LEFT SIDE WALK, 5' FROM BENT 2.

Span 2 Left Bridge Rail: 19" X 12" X 1" SPALL, TOP OF LEFT SIDE WALK, 5' FROM BENT 2.

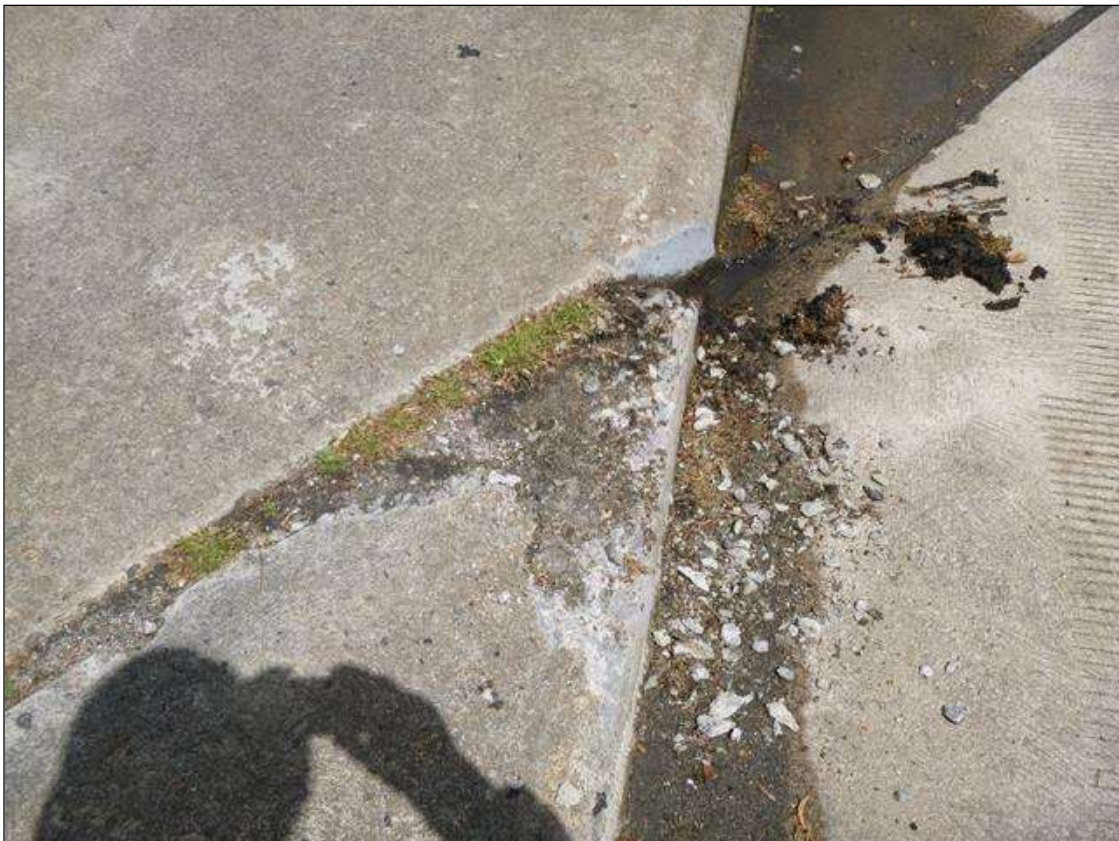
1' X 1' X 1/2" AREA OF SPALL, TOP EDGE OF LEFT SIDE WALK, AT BENT 2.

Span 2 Left Bridge Rail: 1' X 1' X 1/2" AREA OF SPALL, TOP EDGE OF LEFT SIDE WALK, AT BENT 2.

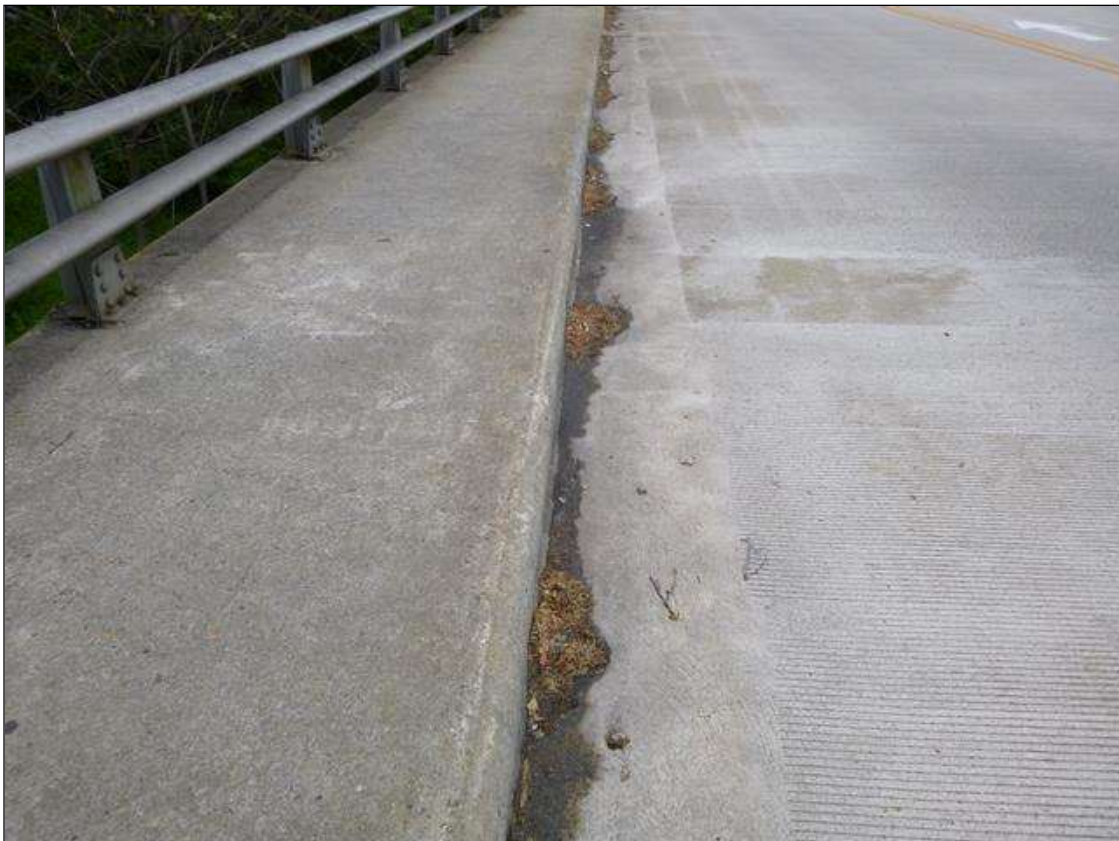
Deck Debris : 1' WIDE X UP TO 2" DEEP OF DECK DEBRIS ALONG BOTH CURBS, ALL SPANS.

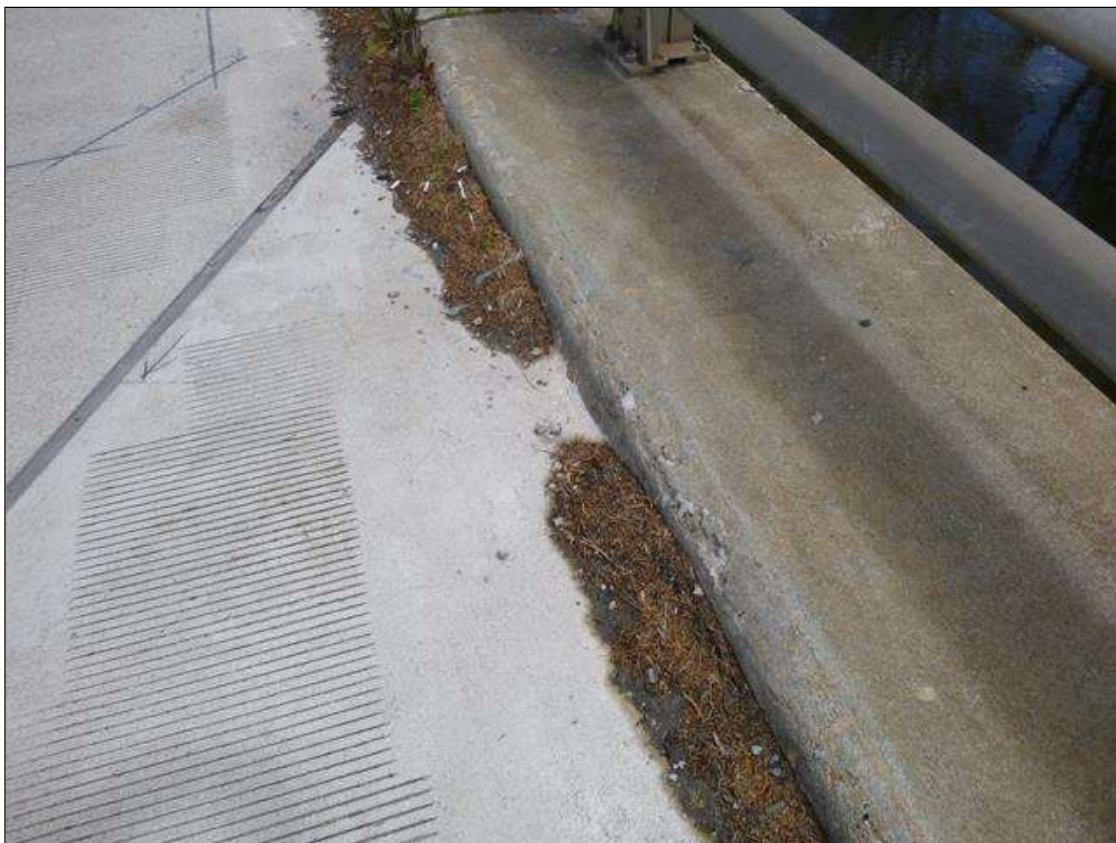
Span 2 Right Bridge Rail: 7' OF EXPOSED AGGREGATE ALONG RIGHT CURB AT BENT 2.

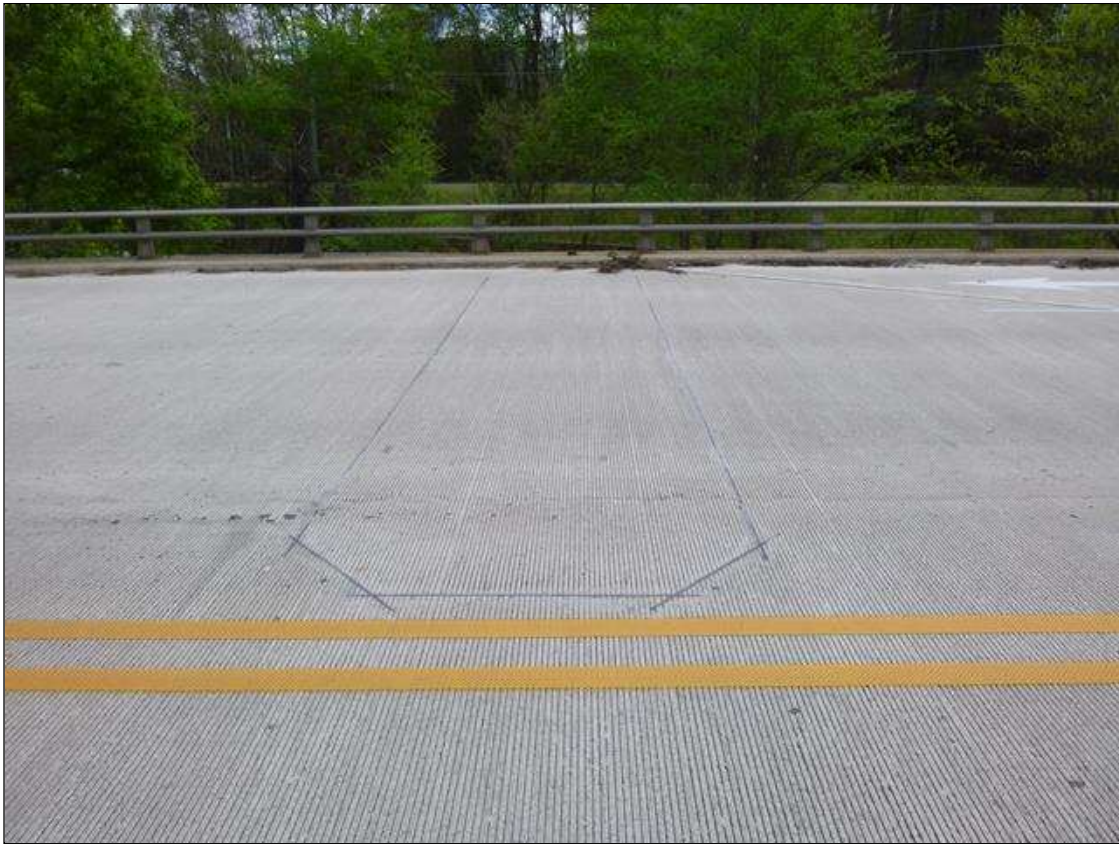
Span 3 Deck: TRAFFIC LIGHT INDUCTANCE LOOP IS CUT INTO NORTH BOUND LANE, MIDDLE OF SPAN.

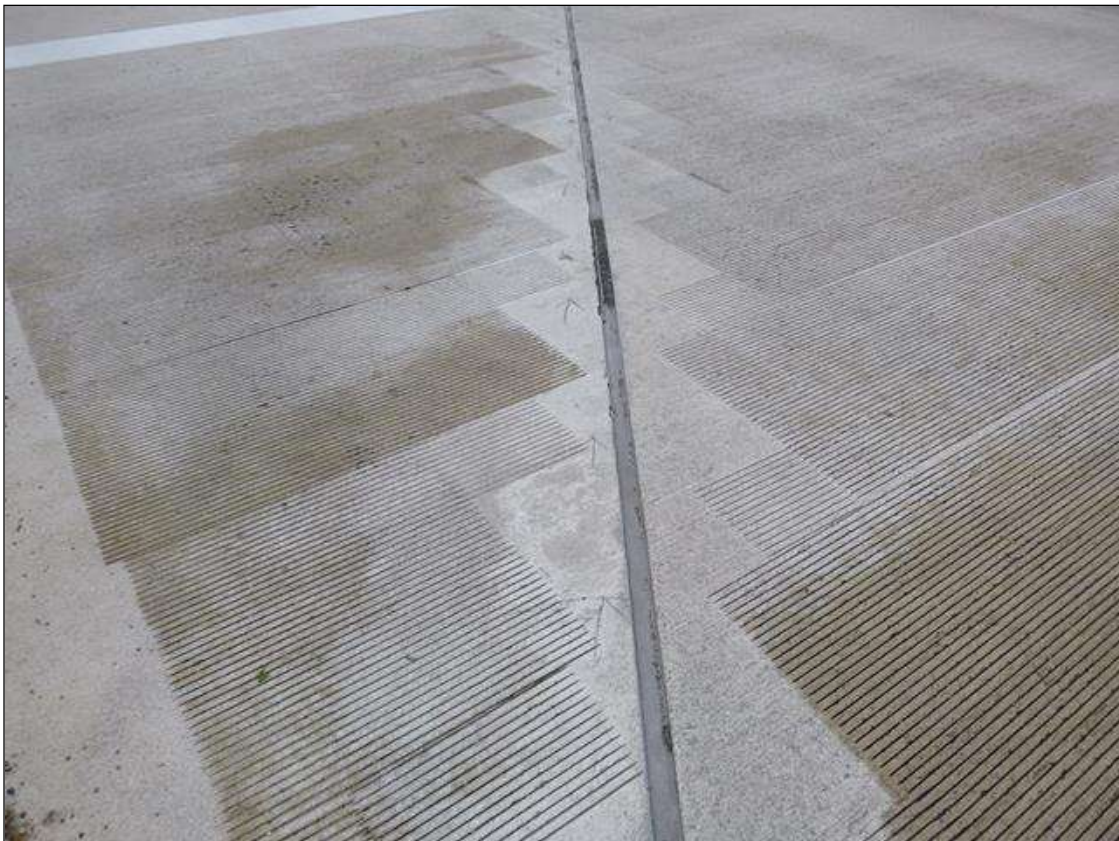
Span 3 Deck: (10) 3' DIAGONAL HAIRLINE CRACKS AT 3' CENTERS, DECK SURFACE, AT BENT 3, BEGINNING AT RIGHT CURB.

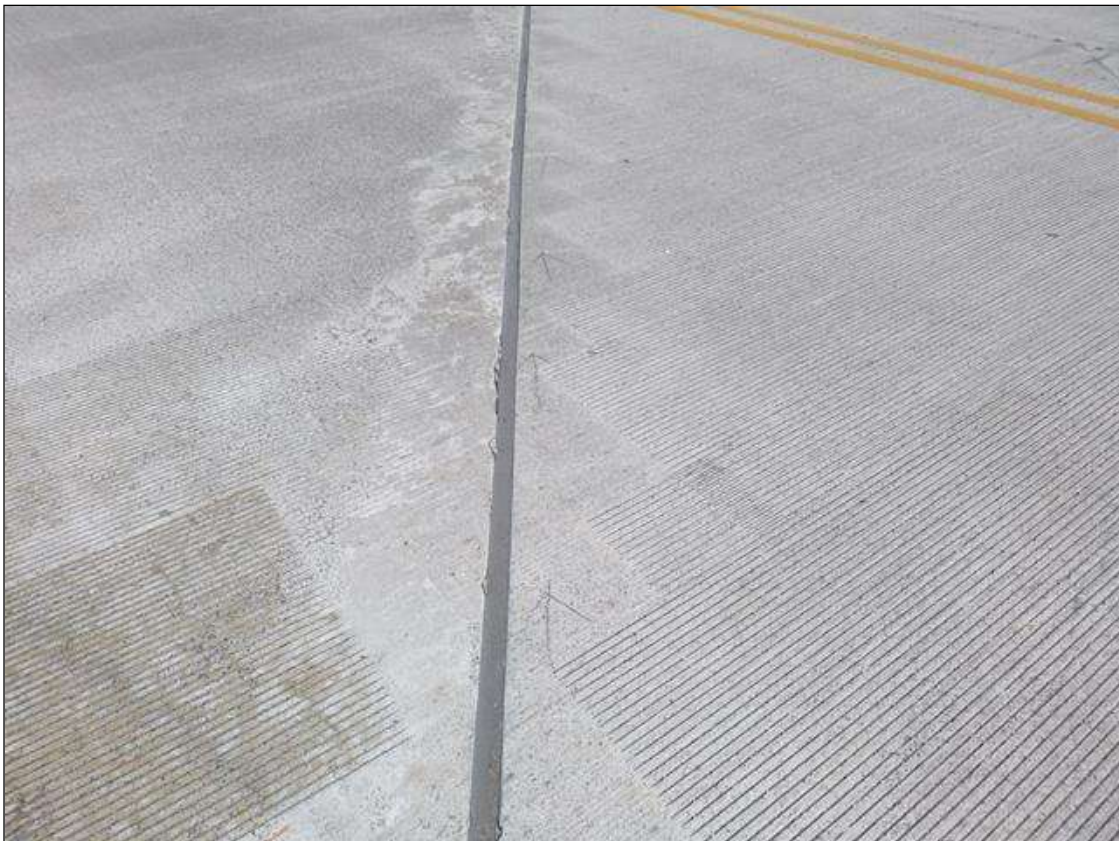
Span 3 Deck: (5) 2' DIAGONAL HAIRLINE CRACK AT 3' CENTERS, AT BENT 3, BEGINNING 5' FROM LEFT CURB.

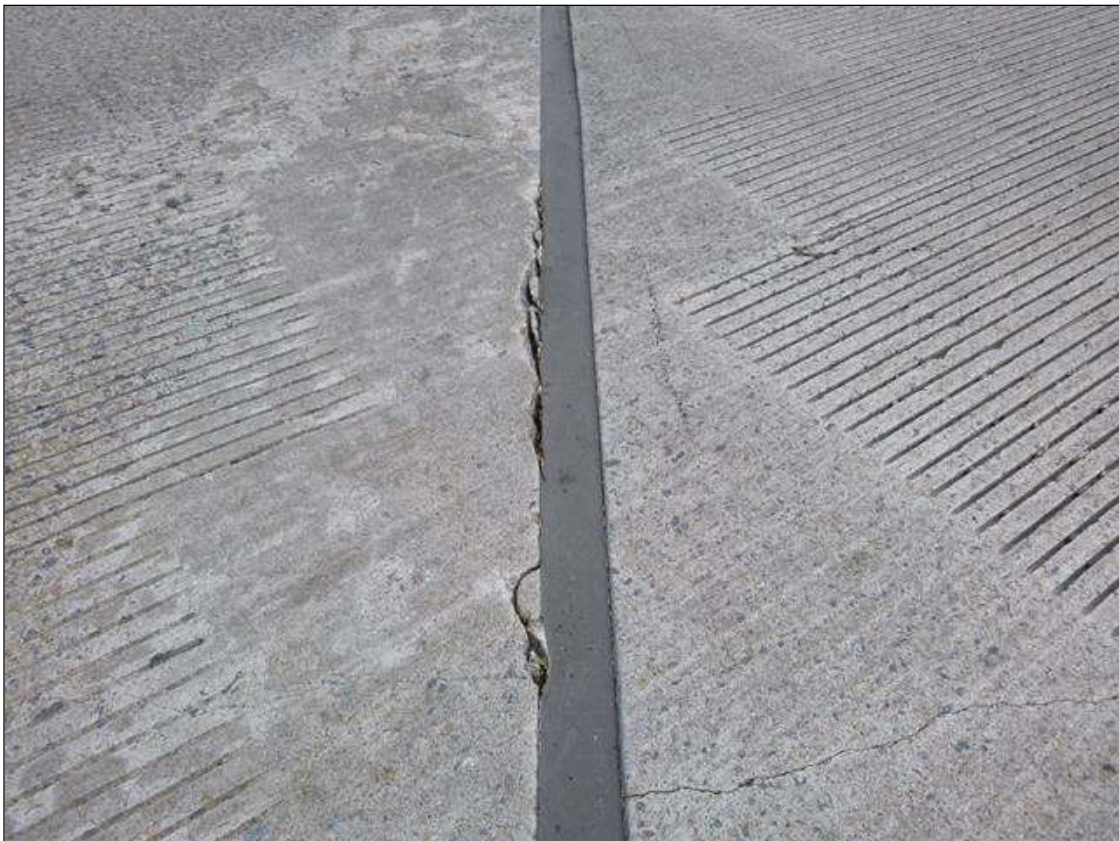
Expansion Joint 4 : 7' LOSS OF ADHESION, SOUTH BOUND LANE, BEGINNING 2' FROM LEFT CURB.

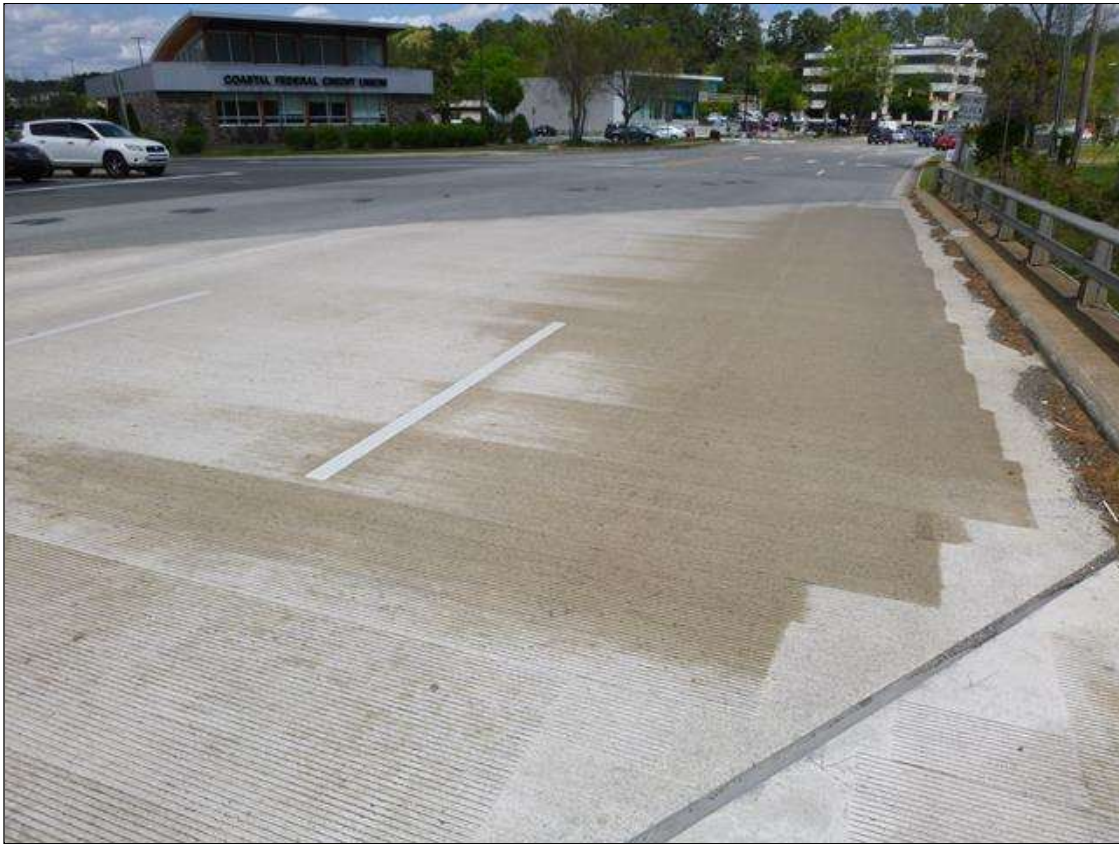
Drainage : WATER PONDING IN RIGHT TRAVEL LANE, SPAN 4.

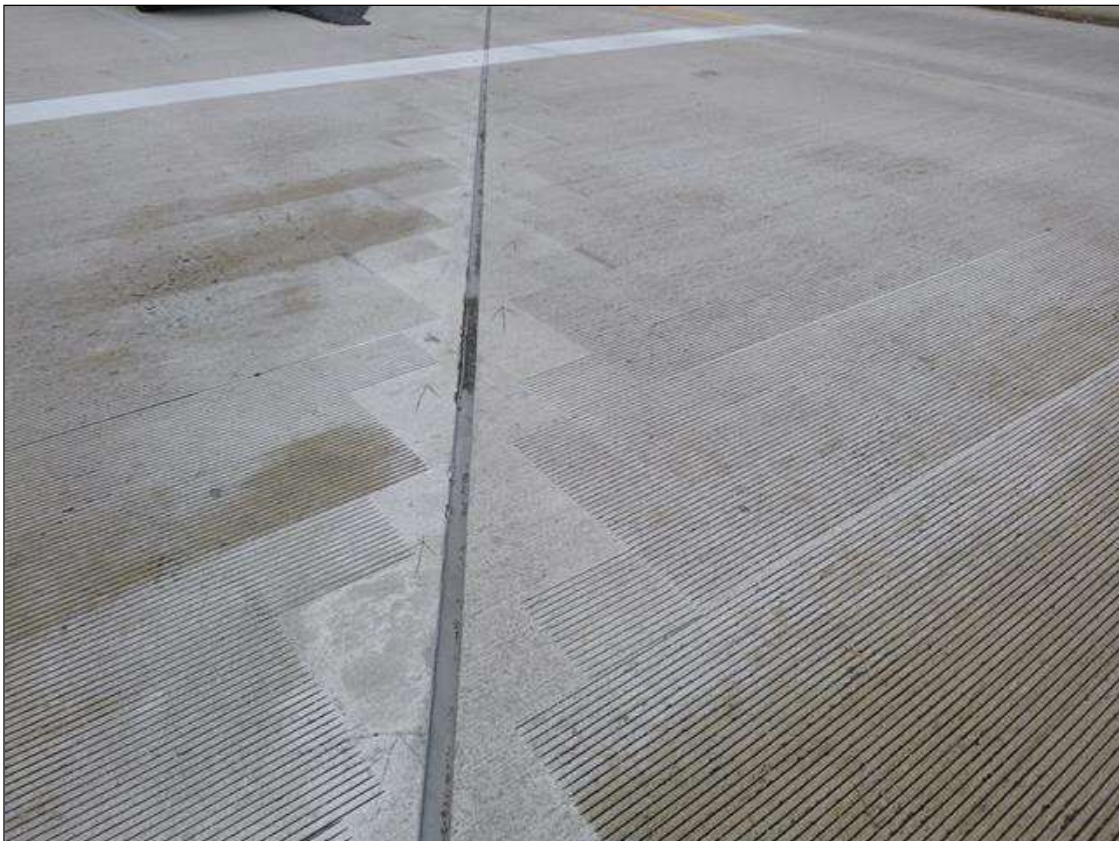
Span 4 Deck: (10) 3' DIAGONAL HAIRLINE CRACKS AT 3' CENTERS, DECK SURFACE, AT BENT 3, BEGINNING AT RIGHT CURB.

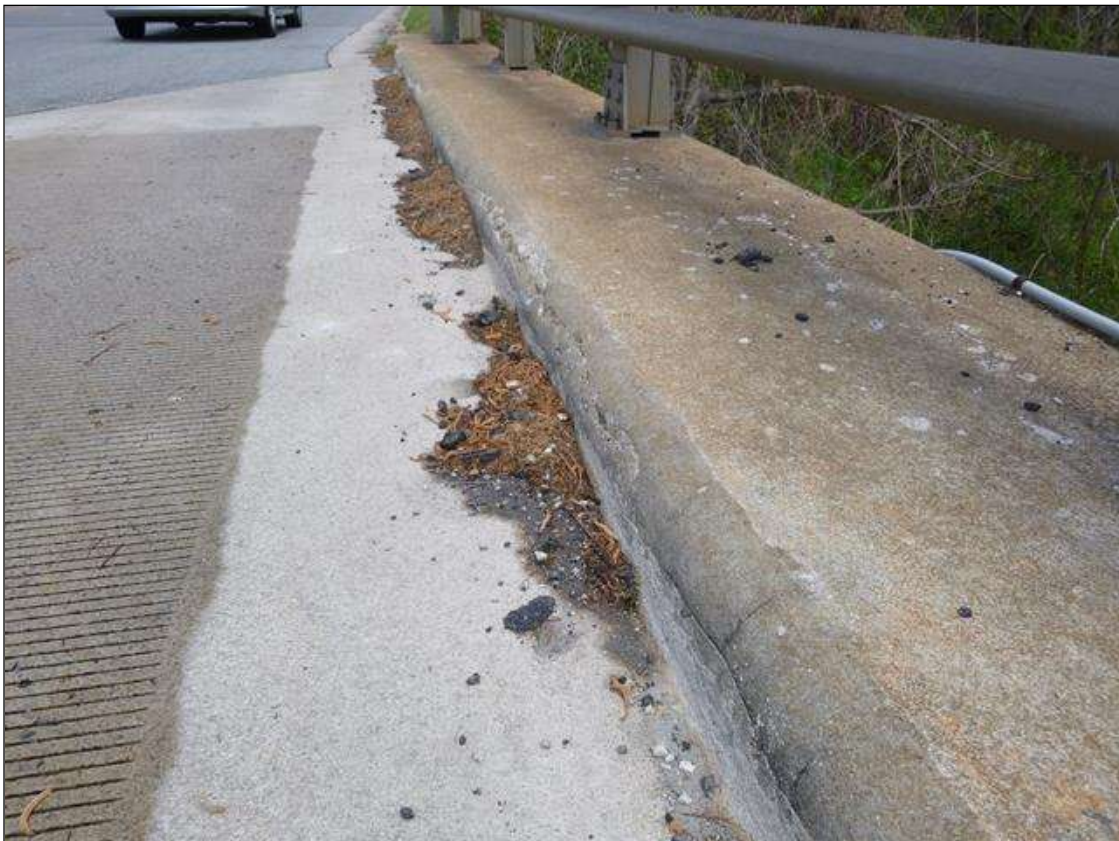
Span 4 Right Bridge Rail: 30' OF TEMPORARY REPAIR ALONG EDGE OF RIGHT CURB WITH CHIPPING AT RANDOM THROUGHOUT, AT END BENT 2.

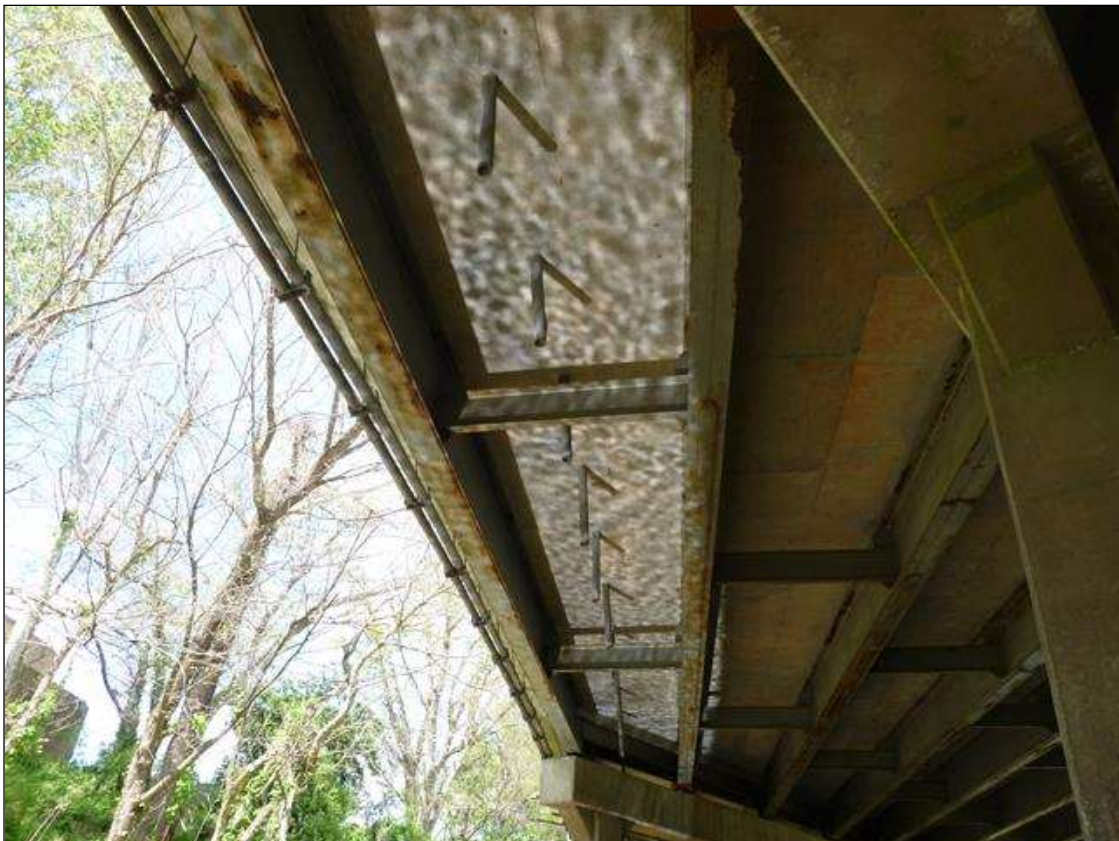
Drainage System : DECK DRAINS ARE PRESENT UNDERSIDE OF DECK, ALONG LEFT CURB BUT HAVE BEEN COVERED BY DECK PRESERVATION EFFORTS ON TOPSIDE.

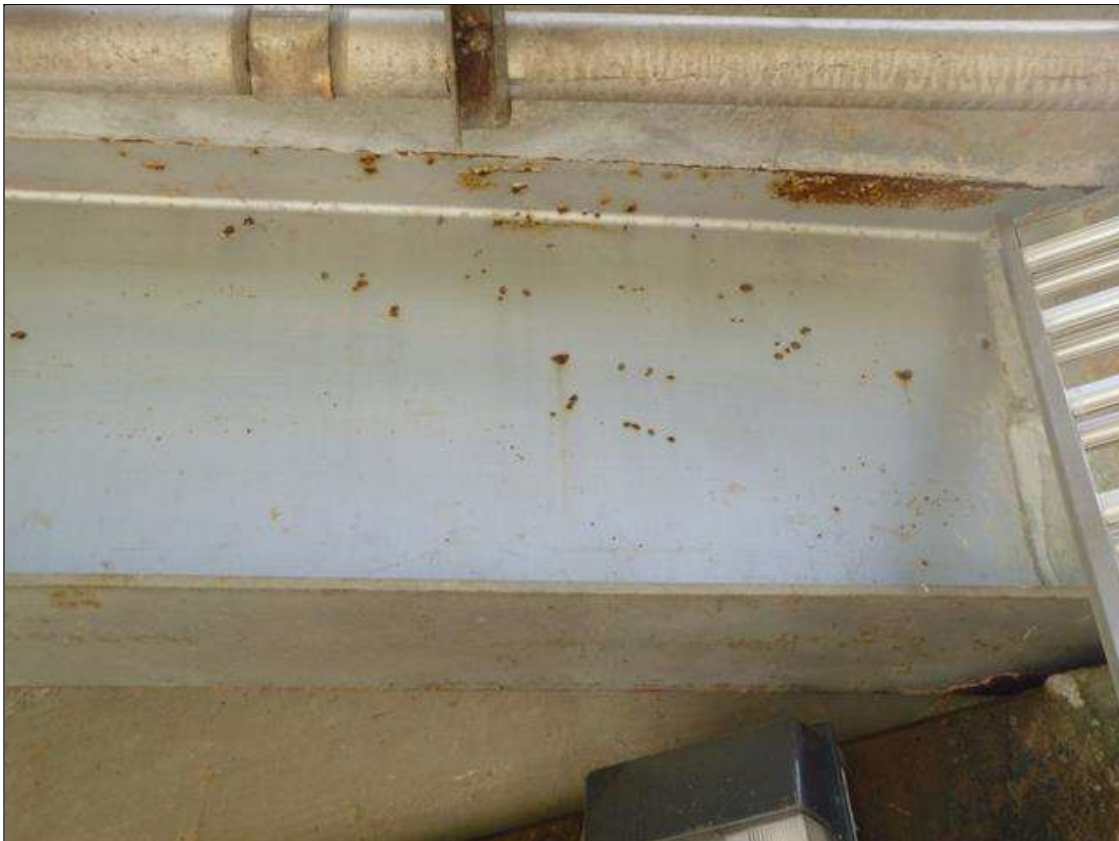
FRECKLED RUST AT RANDOM THROUGHOUT BEAM WEB.

Span 1 Beam 1: FRECKLED RUST AT RANDOM THROUGHOUT BEAM WEB.

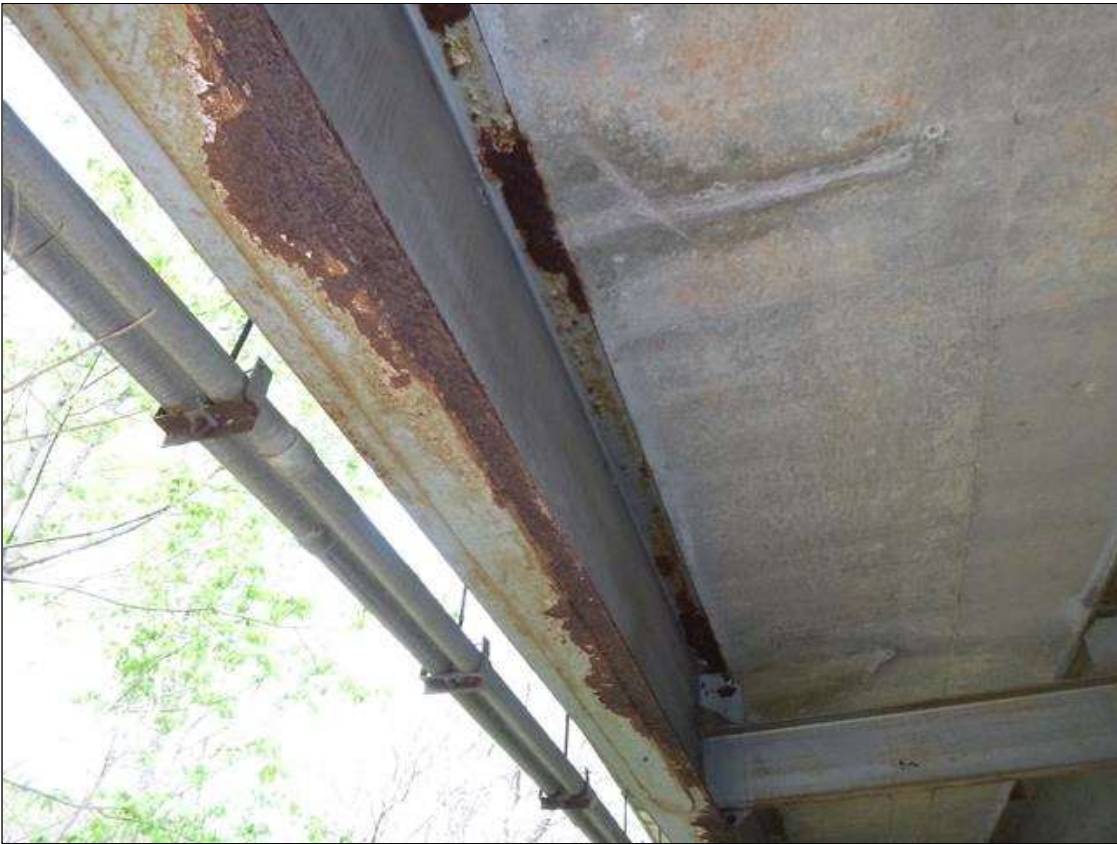
35' OF CORROSION WITH RUST SCALE AT UNDERSIDE OF TOP FLANGE AND THROUGHOUT BOTTOM FLANGE EXTENDING UP TO 10" INTO WEB, BEGINNING AT BENT 1.

Span 1 Beam 1: 35' OF CORROSION WITH RUST SCALE AT UNDERSIDE OF TOP FLANGE AND THROUGHOUT BOTTOM FLANGE EXTENDING UP TO 10" INTO WEB, BEGINNING AT BENT 1.

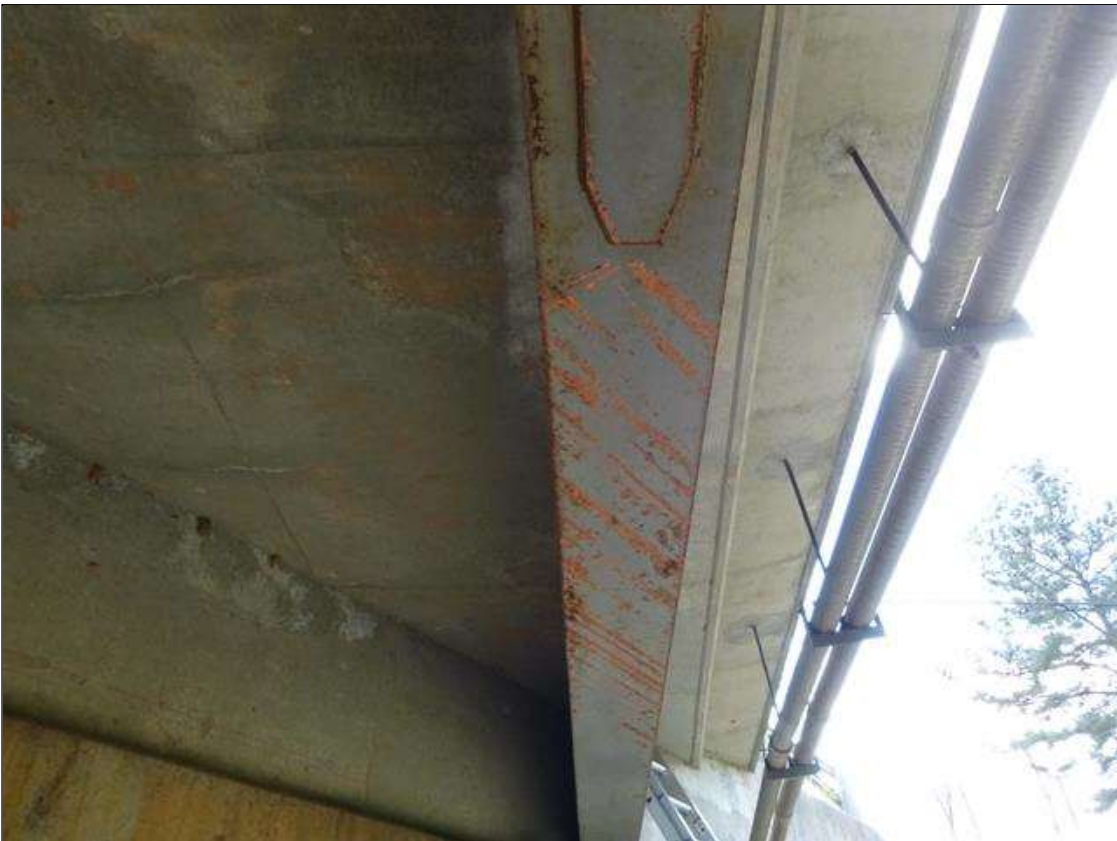
Span 1 Beam 1: 10' OF SURFACE PROTECTION HAS BEEN SCRAPED OFF UNDERSIDE OF BOTTOM FLANGE DIRECTLY ABOVE TRAIL.

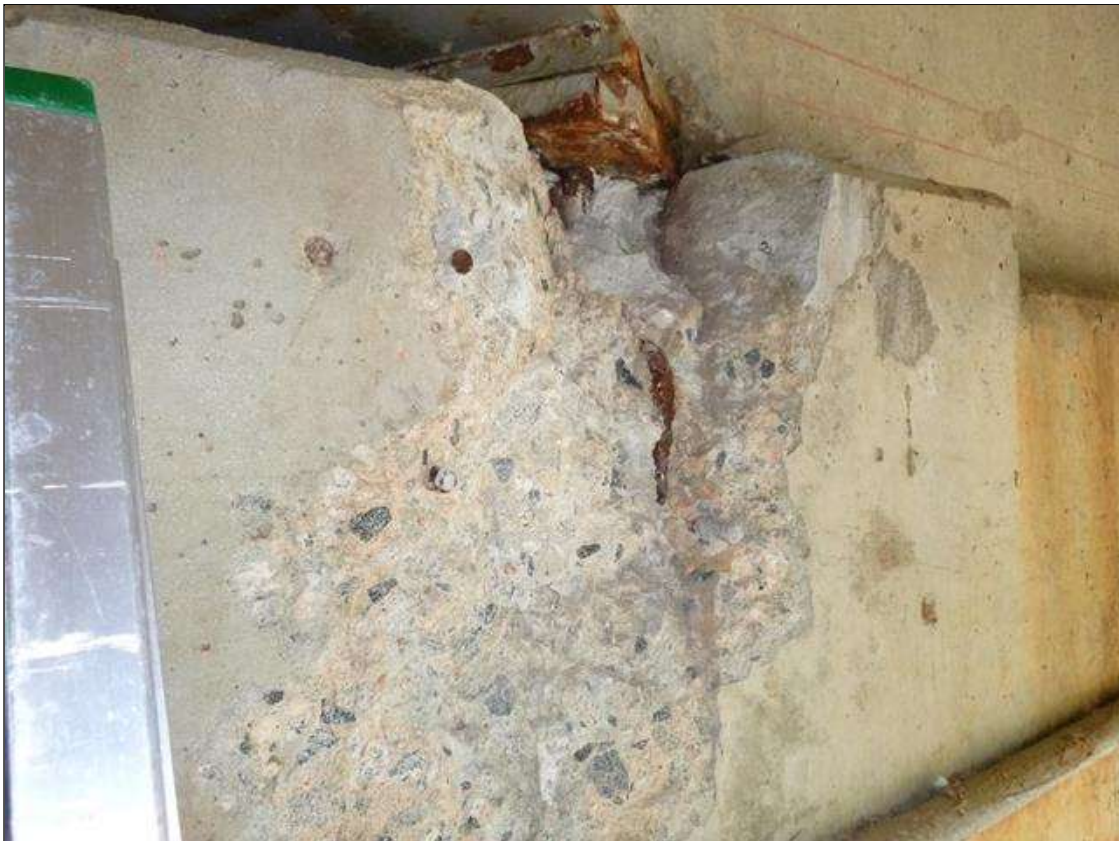
End Bent 1 Cap : 16" X 19" X 5.25" DEEP SPALL WITH EXPOSED REINFORCING, NORTH FACE, EXTENDING 3.75" UNDER BEAM 2 BEARING PLATE. (PM)

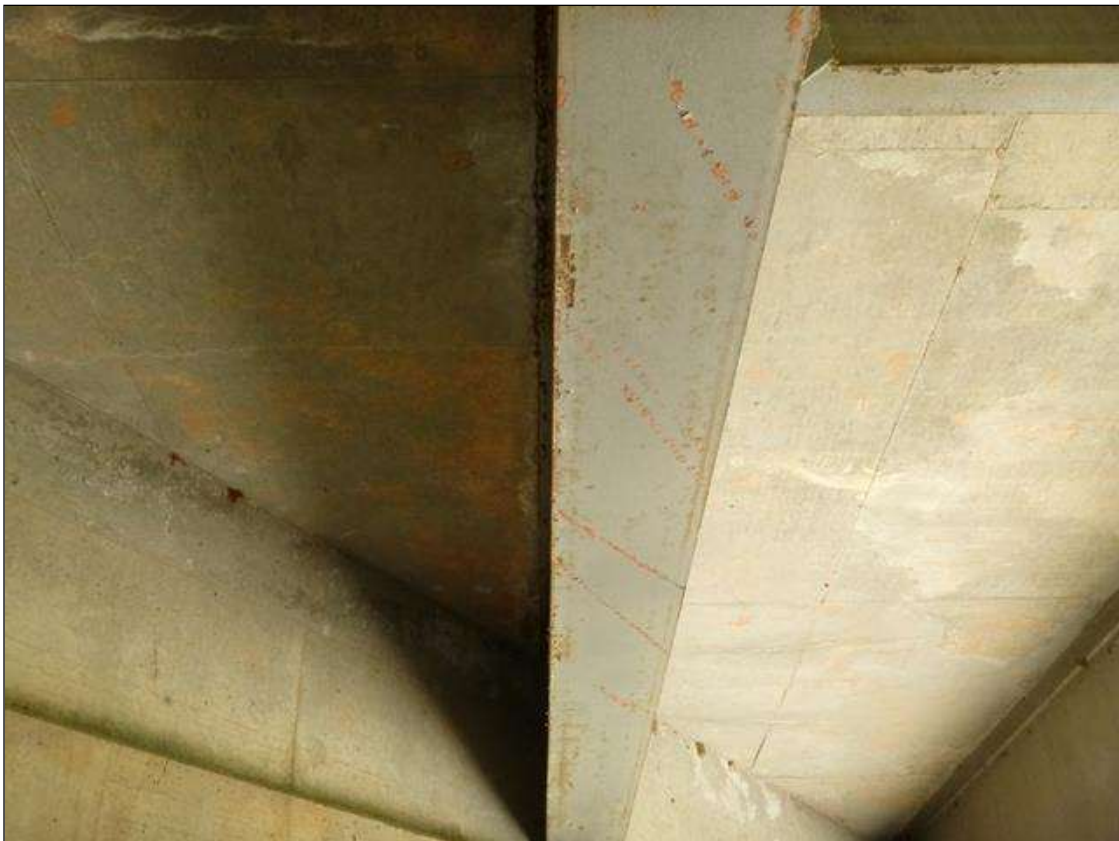
Span 1 Beam 2: 10' OF SURFACE PROTECTION HAS BEEN SCRAPED OFF UNDERSIDE OF BOTTOM FLANGE DIRECTLY ABOVE TRAIL.

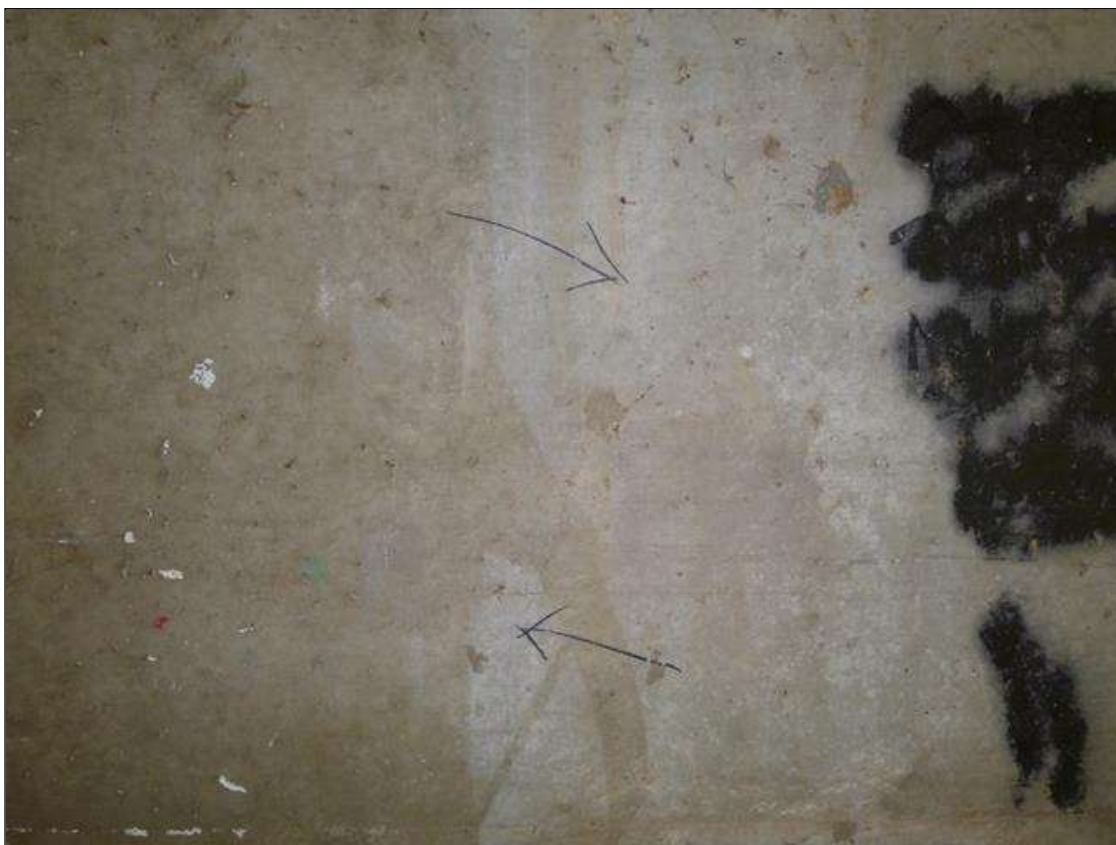
End Bent 1 Abutment/Backwall : (11) 9' VERTICAL CRACKS UP TO 1/32", AT AVERAGE 8' CENTERS, NORTH FACE OF ABUTMENT.
