NC DEPARTMENT OF TRANSPORTATION  
DIVISION OF HIGHWAYS  
STRUCTURE MANAGEMENT UNIT

## Structure Safety Report

### Routine Element Inspection - Contract

COUNTY: WAKE STRUCTURE NUMBER: 910494 FREQUENCY: 24 MONTHS

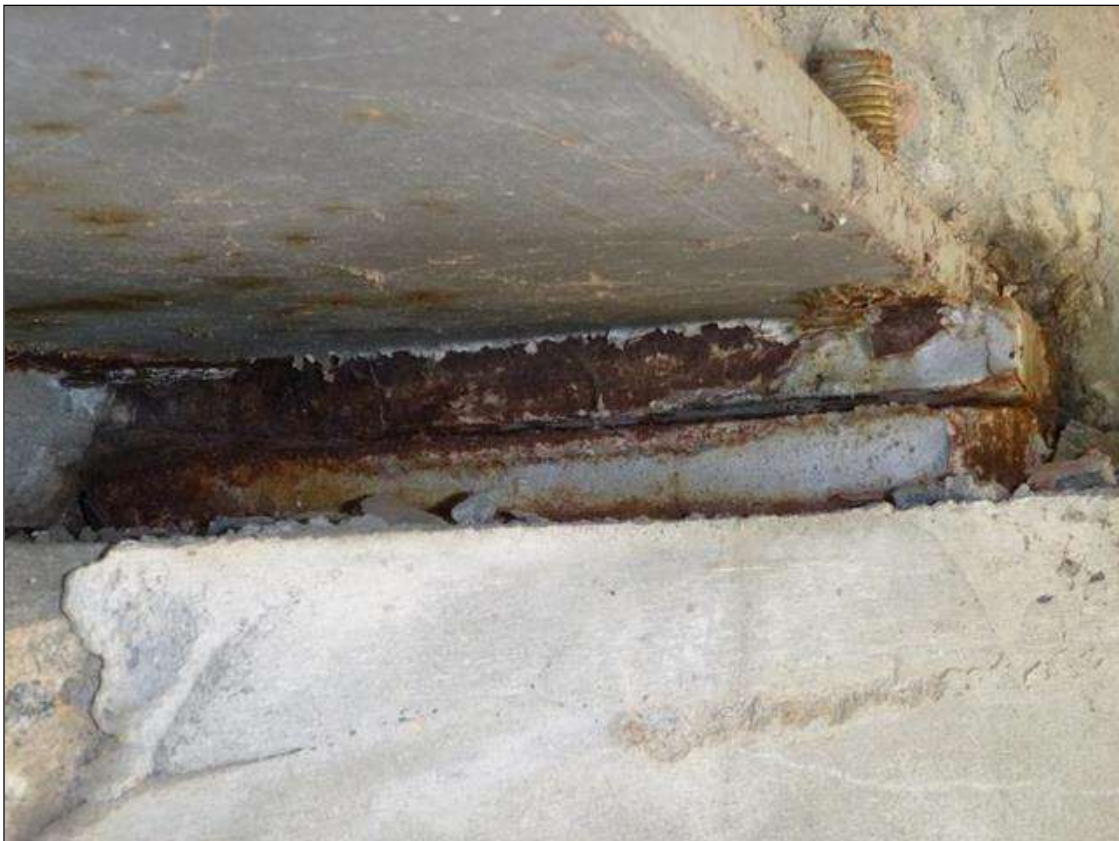
Span 1 Beam 3 Near Bearing : CORROSION WITH FRECKLED RUST THROUGHOUT.

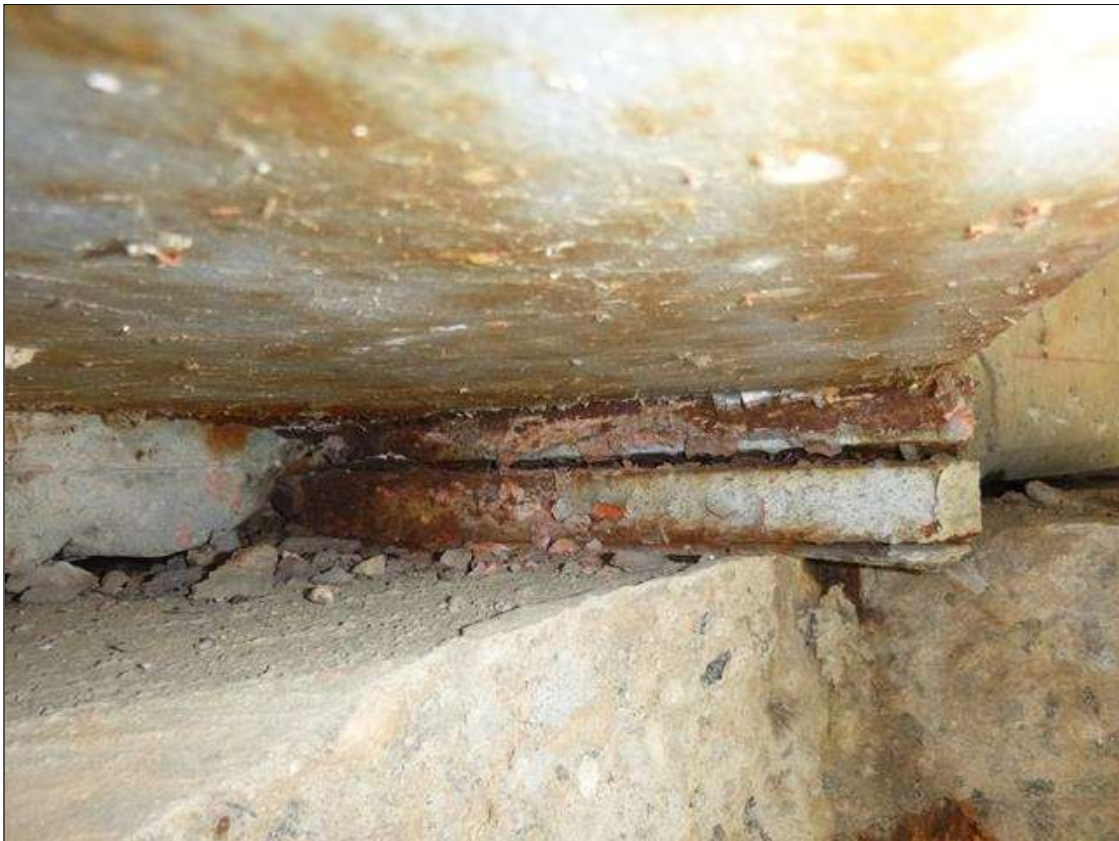
Span 1 Beam 4 Near Bearing : CORROSION WITH SURFACE RUST THROUGHOUT.

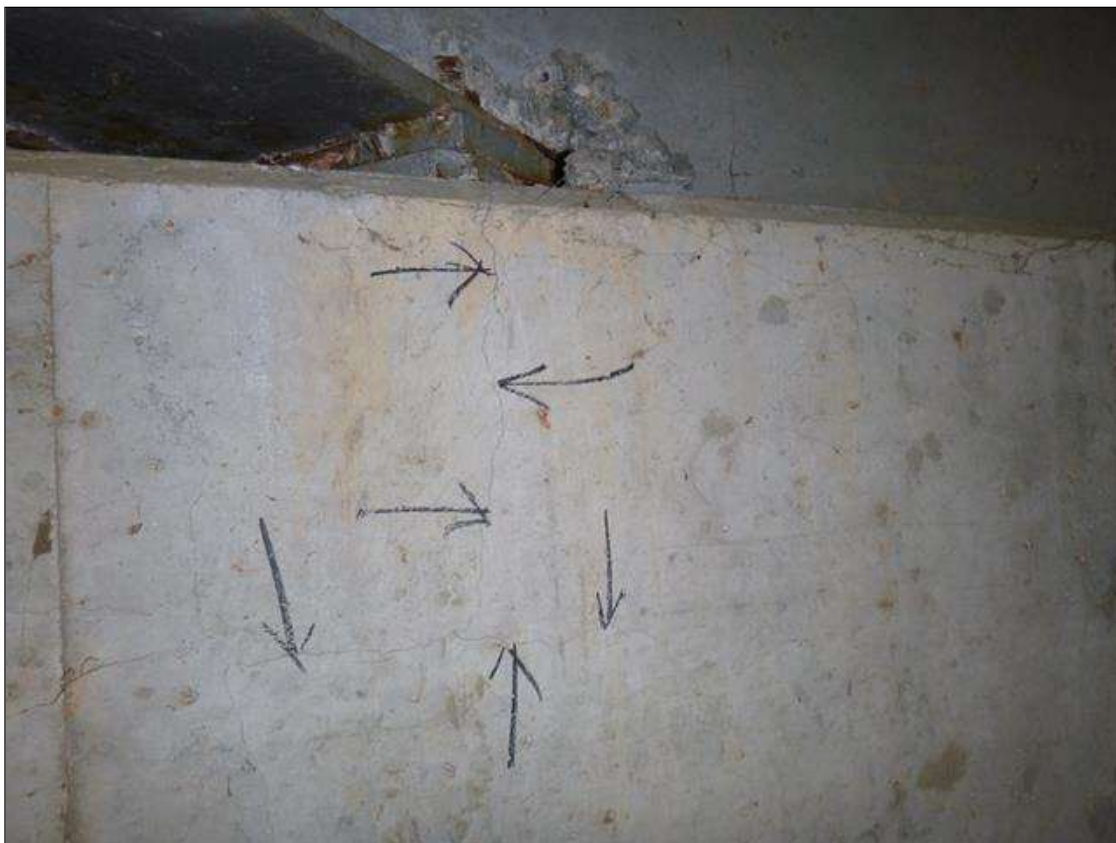
End Bent 1 Cap : 1' VERTICAL HAIRLINE CRACK BEGINNING AT TOP OF CAP, BELOW BEAM 6.

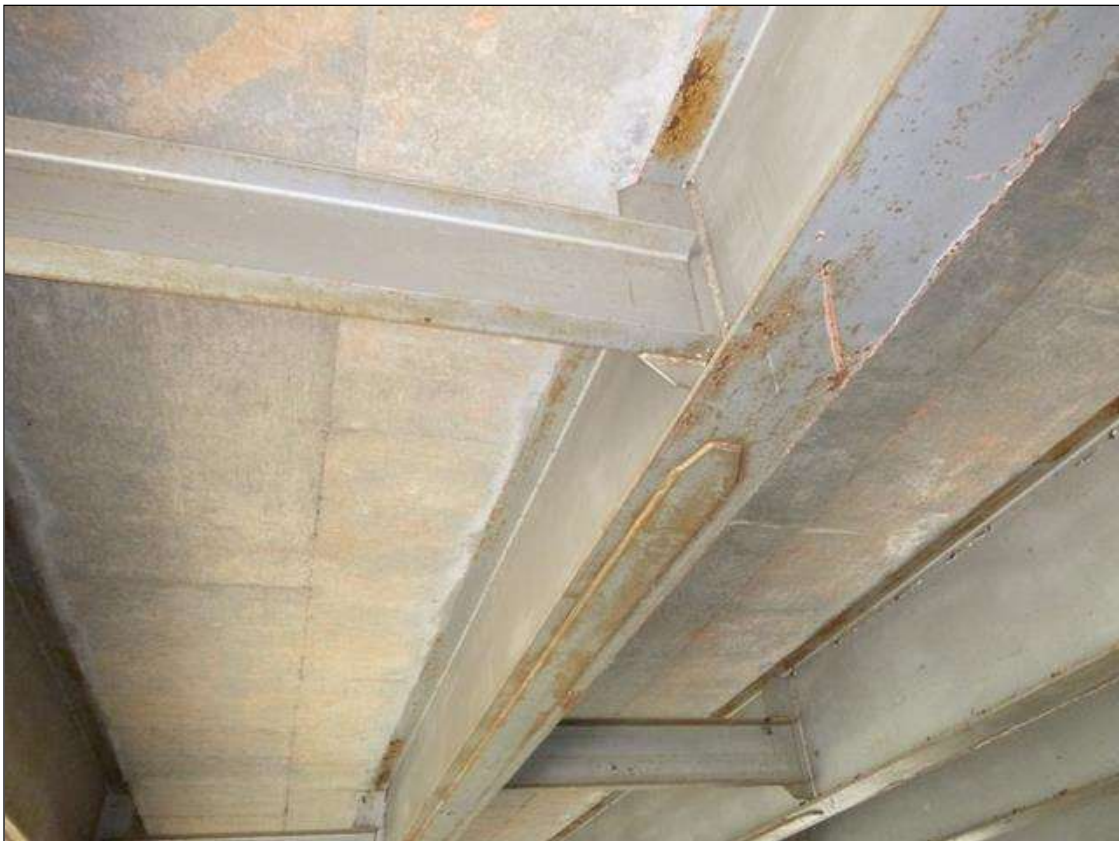
Span 1 Beam 3: FRECKLED RUST AT RANDOM THROUGHOUT UNDERSIDE OF BOTTOM AND TOP FLANGE AND WEB.

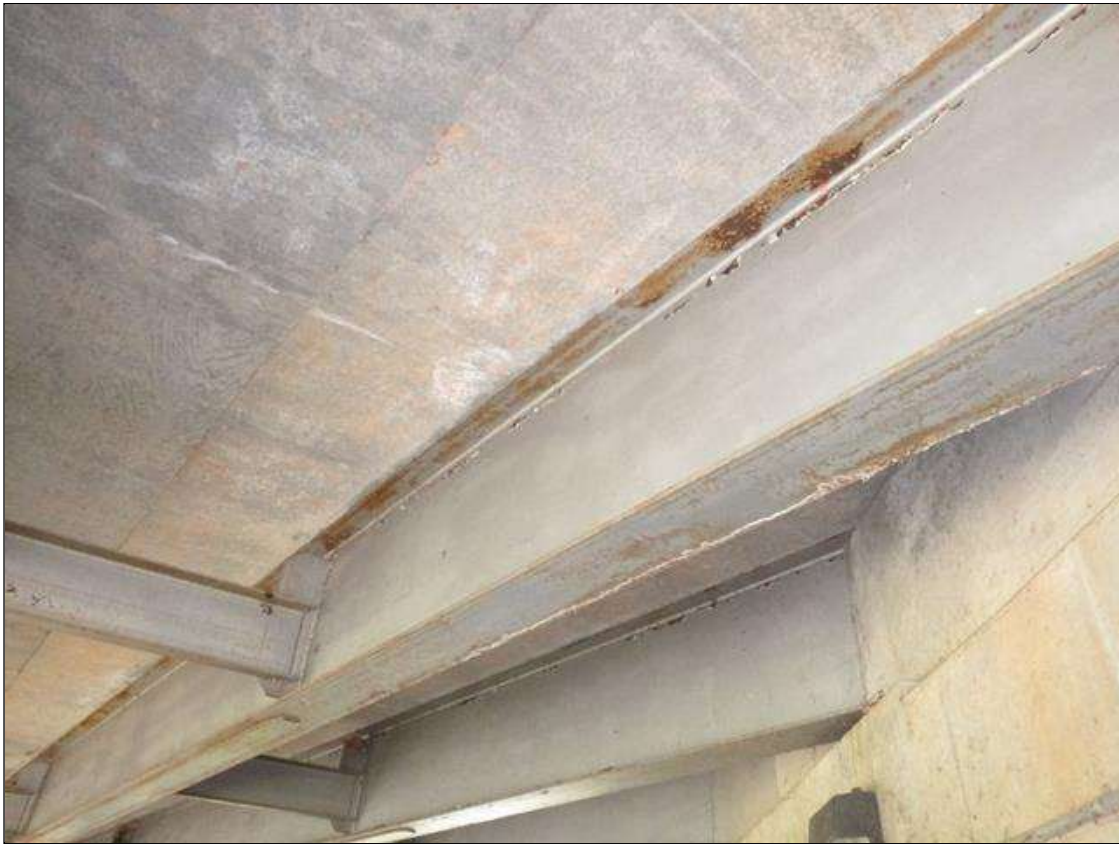
Span 1 Beam 4: FRECKLED RUST AT RANDOM THROUGHOUT UNDERSIDE OF BOTTOM AND TOP FLANGE AND WEB.

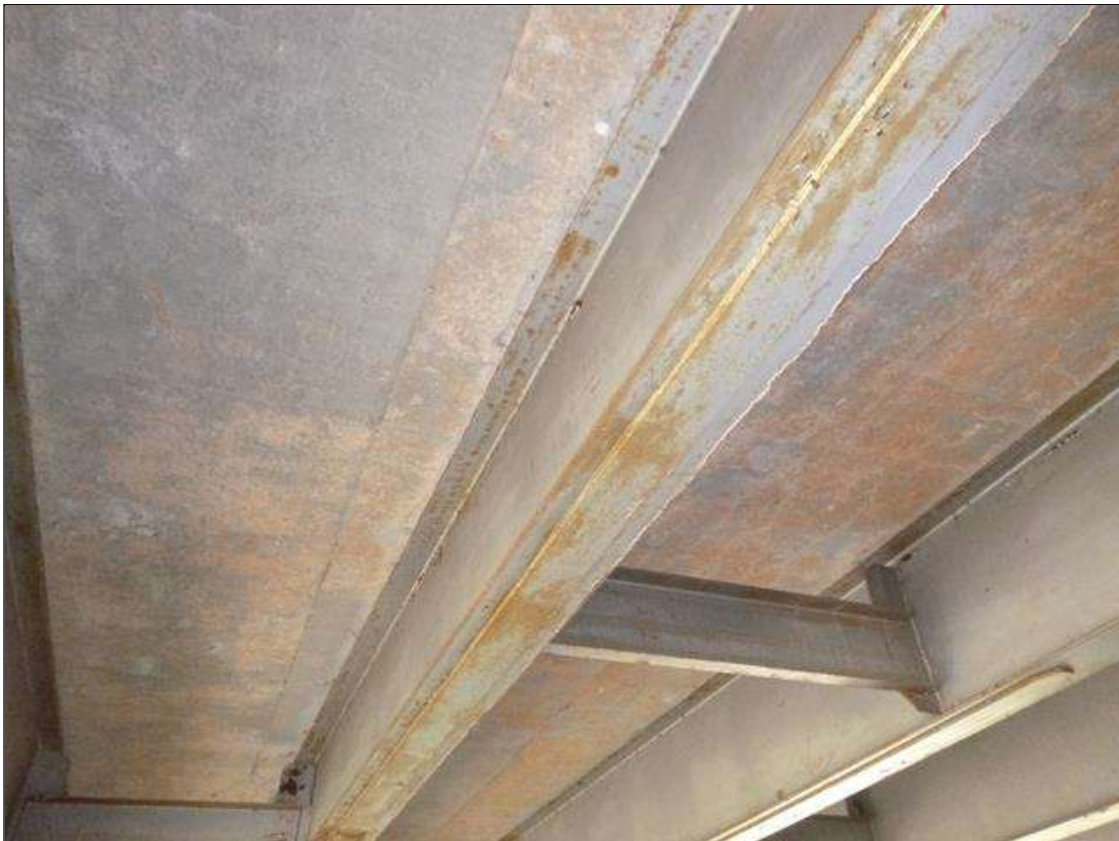
Span 1 Beam 5: FRECKLED RUST AT RANDOM THROUGHOUT UNDERSIDE OF BOTTOM AND TOP FLANGE AND WEB.

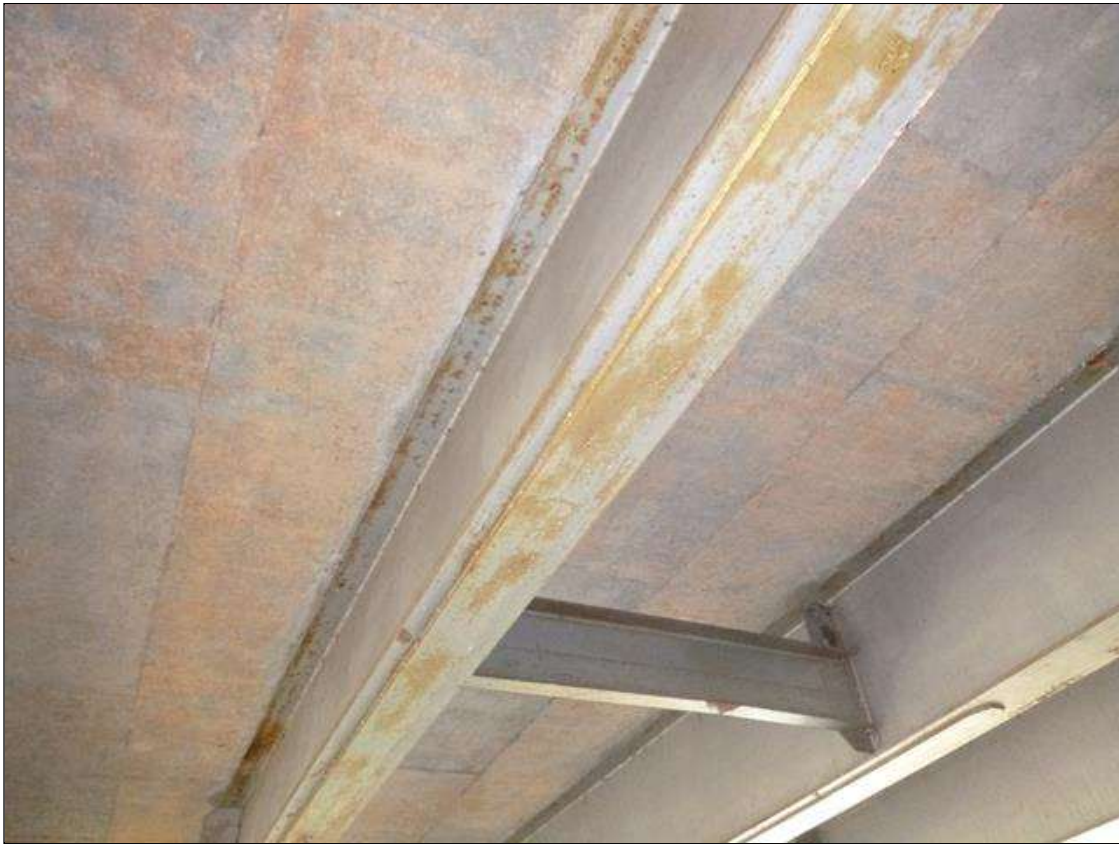
Span 1 Beam 6: FRECKLED RUST AT RANDOM THROUGHOUT UNDERSIDE OF BOTTOM AND TOP FLANGE AND WEB.

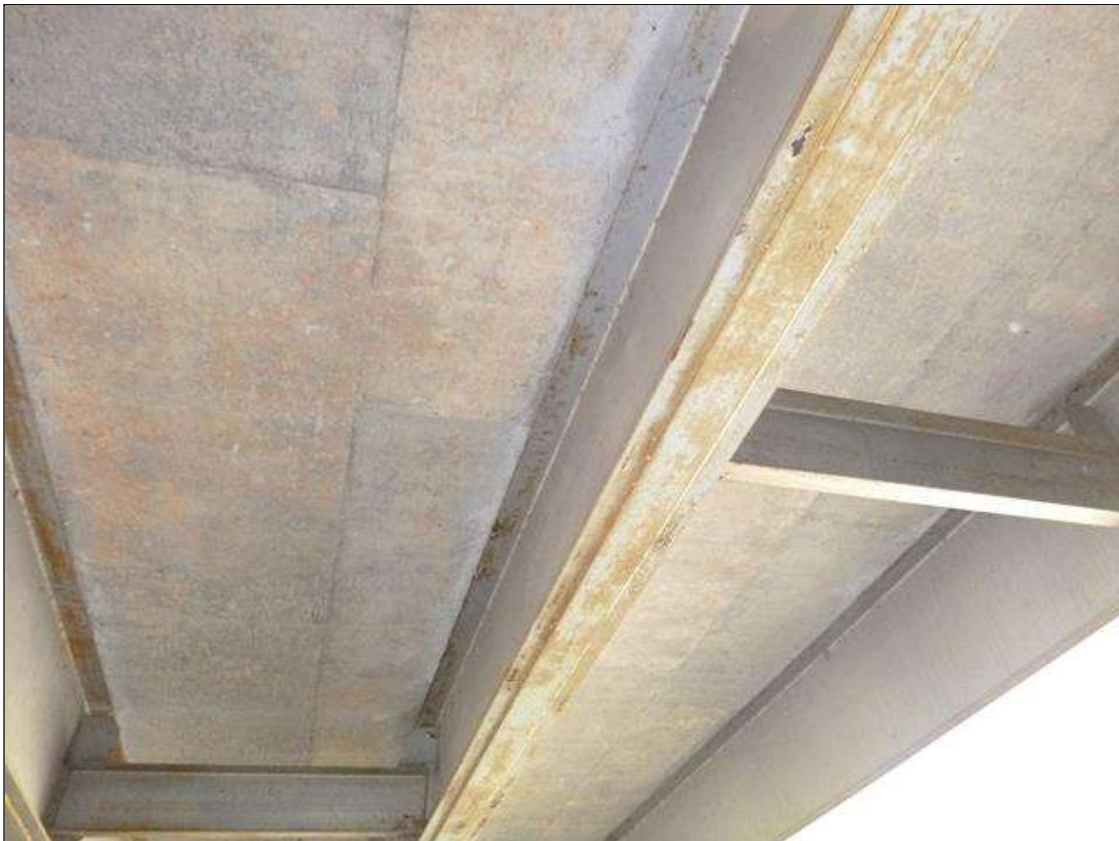
Span 1 Beam 7: FRECKLED RUST AT RANDOM THROUGHOUT UNDERSIDE OF BOTTOM AND TOP FLANGE AND WEB.

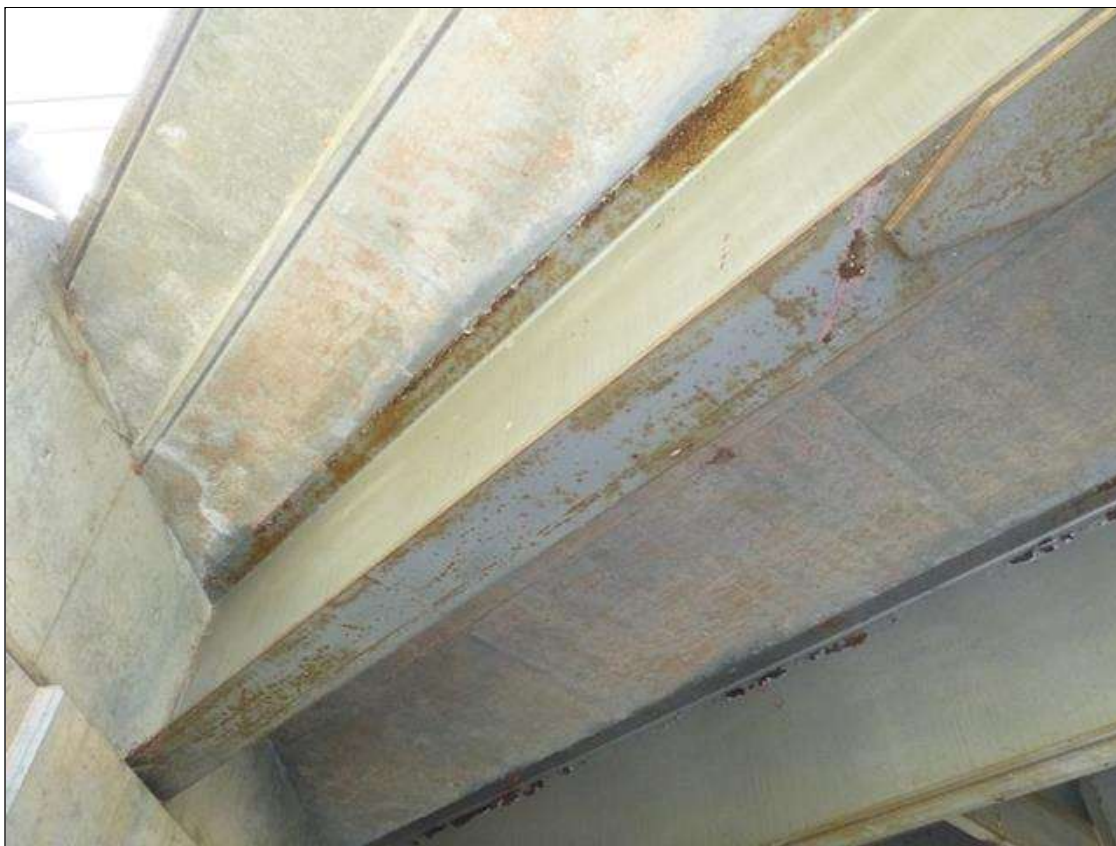
Span 1 Beam 8: FRECKLED RUST AT RANDOM THROUGHOUT UNDERSIDE OF BOTTOM AND TOP FLANGE AND WEB.

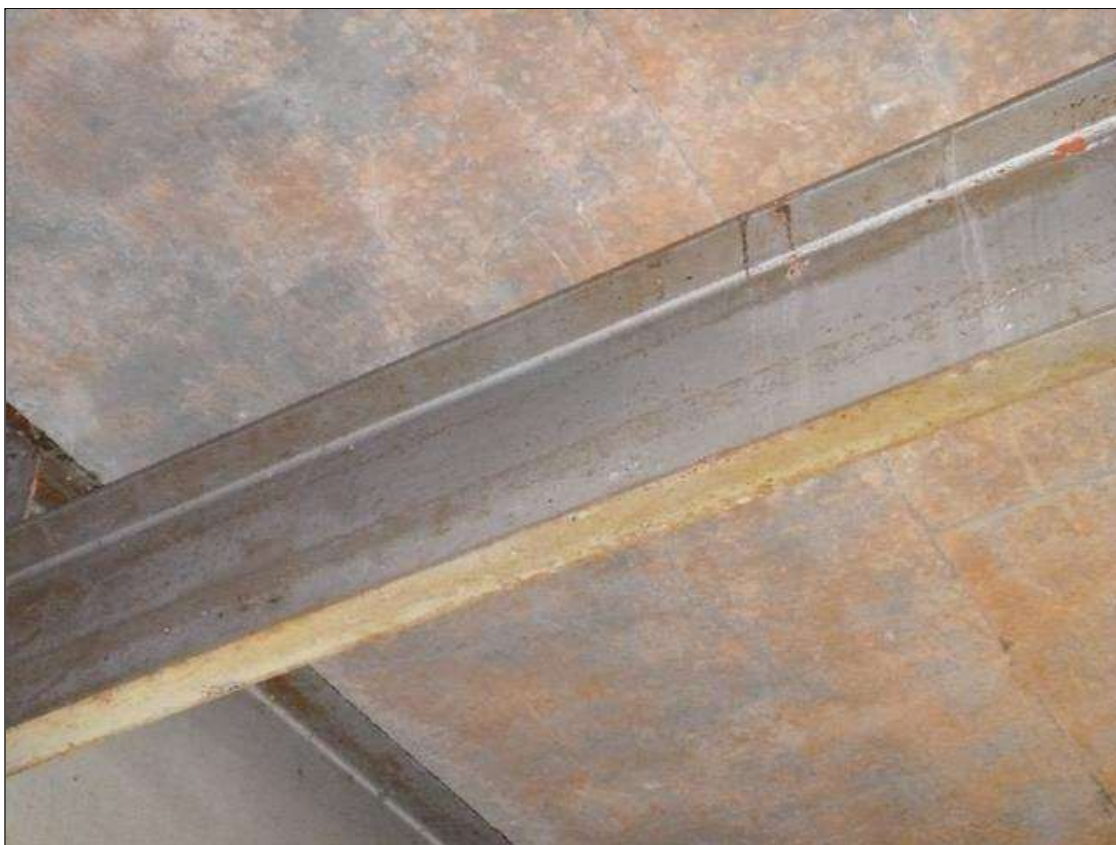
Superstructure : SPAN 1 INTERMEDIATE DIAPHRAGMS HAVE SURFACE RUST AT RANDOM THROUGHOUT.

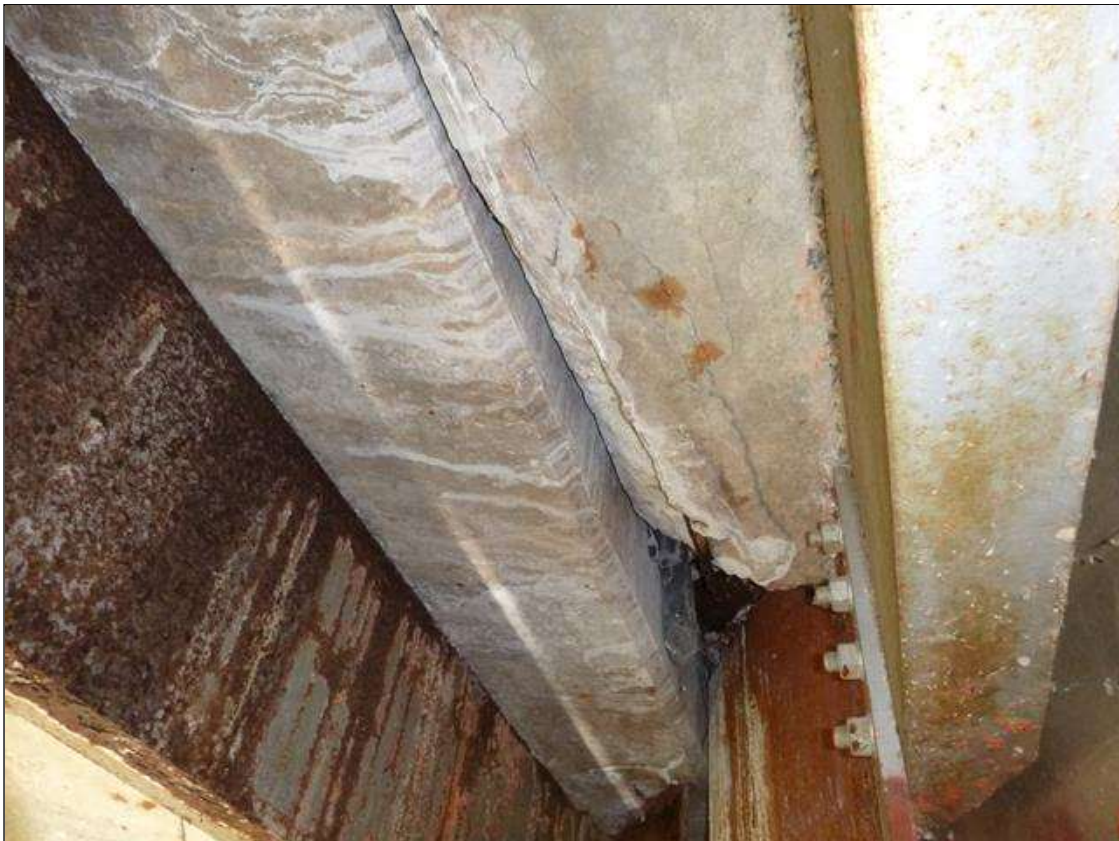
Superstructure : 4' X 10" X UP TO 8" SPALL WITH EXPOSED REINFORCING UNDERSIDE OF BENT 1 END DIAPHRAGM, SPAN 1, BETWEEN BEAMS 1 AND 2, NEXT TO BEAM 2.

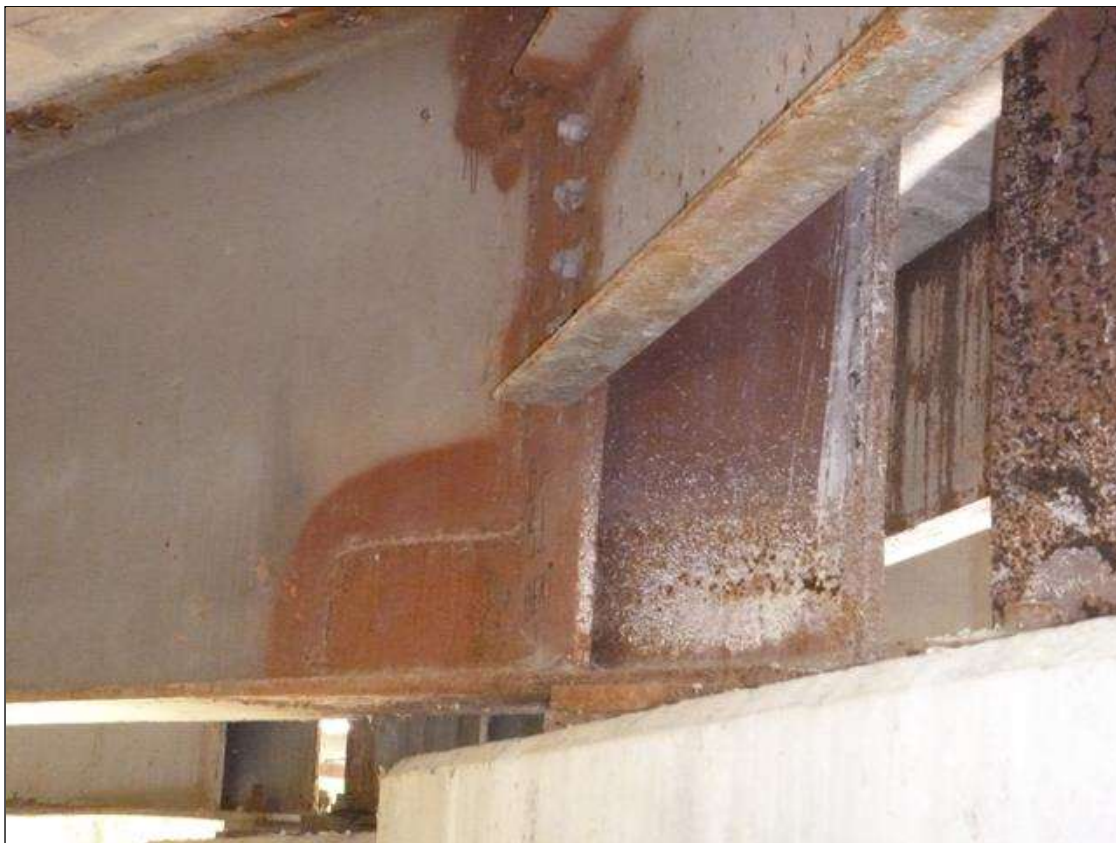
Span 1 Beam 2: TEMPORARY REPAIR TO BOTTOM FLANGE, WEB AND STIFFENER, AT BENT 1.

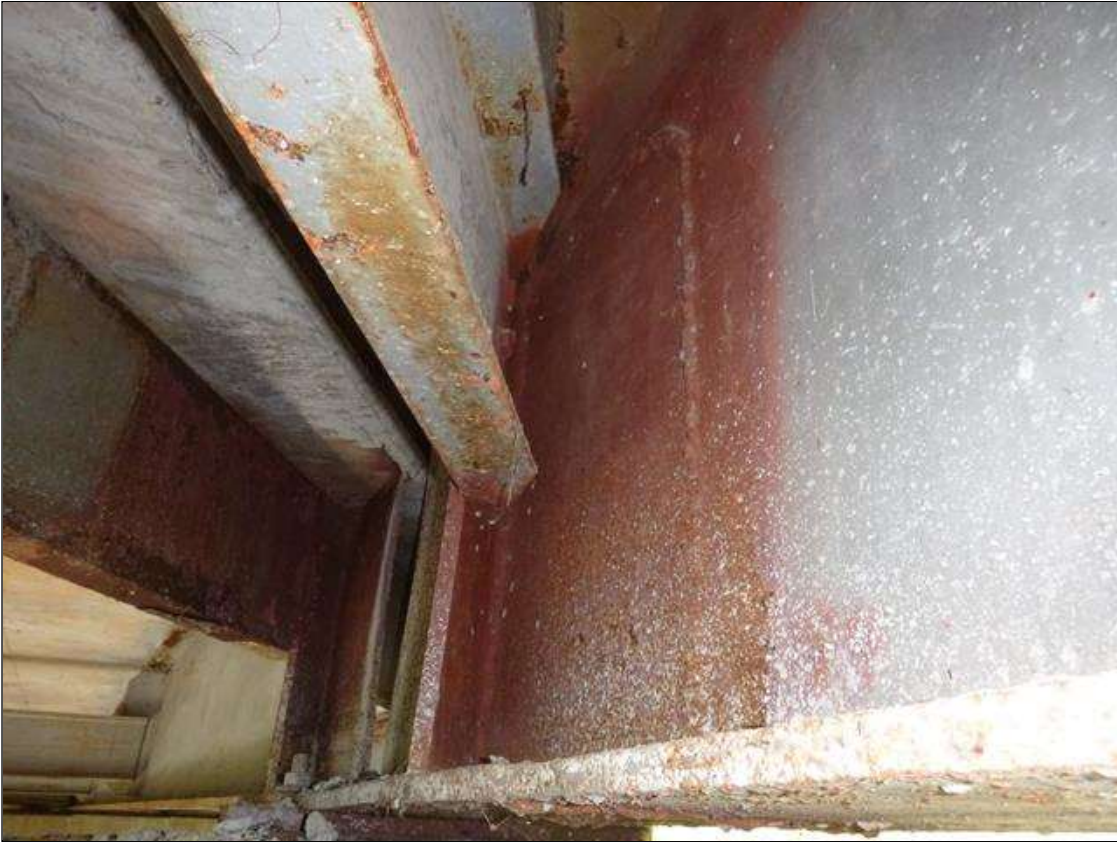
Span 1 Beam 3: TEMPORARY REPAIR TO BOTTOM FLANGE, WEB AND STIFFENER, AT BENT 1.

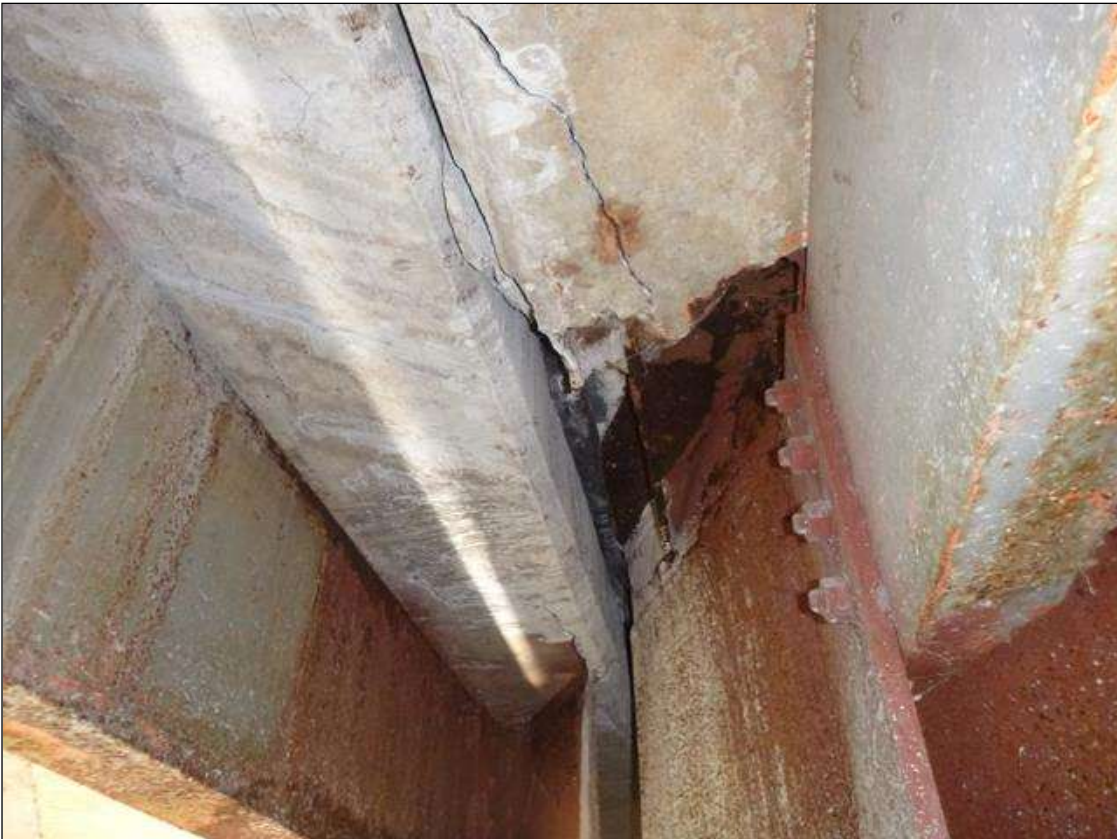
Superstructure : 3' X 10" X UP TO 10" SPALL WITH EXPOSED REINFORCING UNDERSIDE OF BENT 1 END DIAPHRAGM, SPAN 1, BETWEEN BEAMS 2 AND 3, NEXT TO BEAM 3.

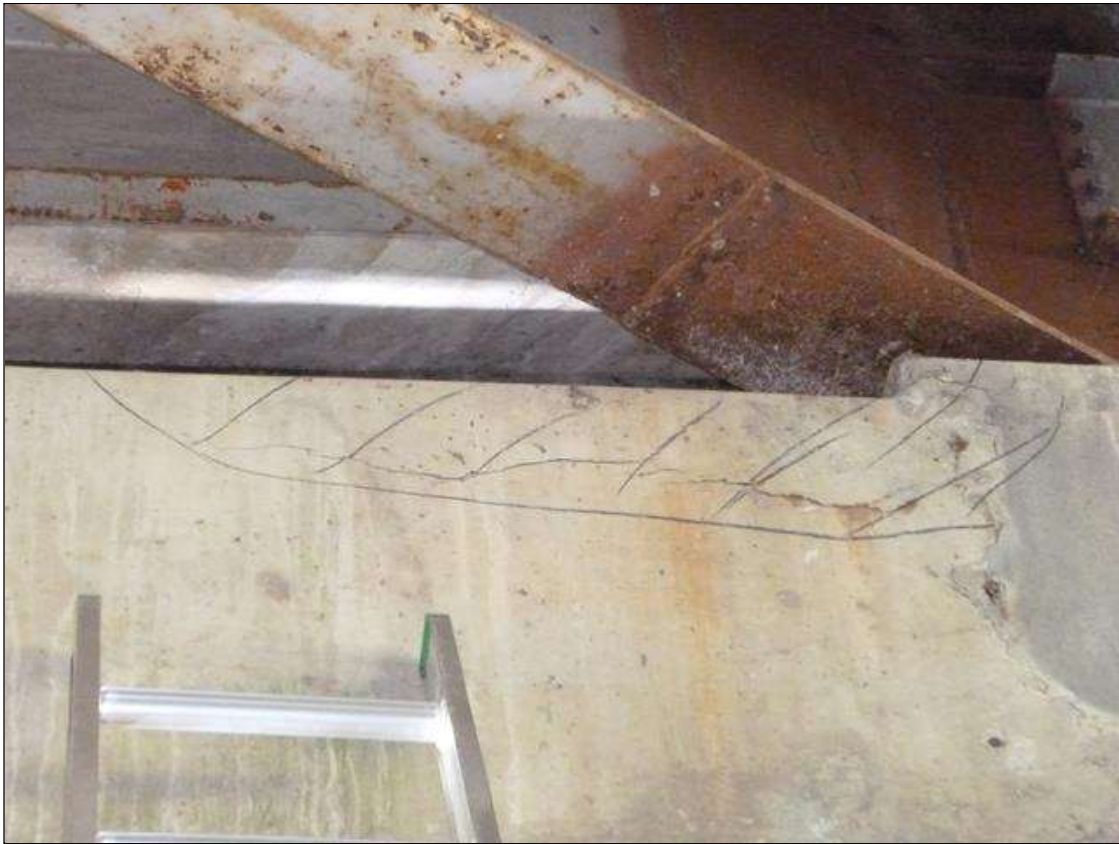
Bent 1 Cap : 4' X 10" X 5" DELAMINATION, TOP CORNER OF SOUTH FACE OF CAP, BELOW BEAM 3.

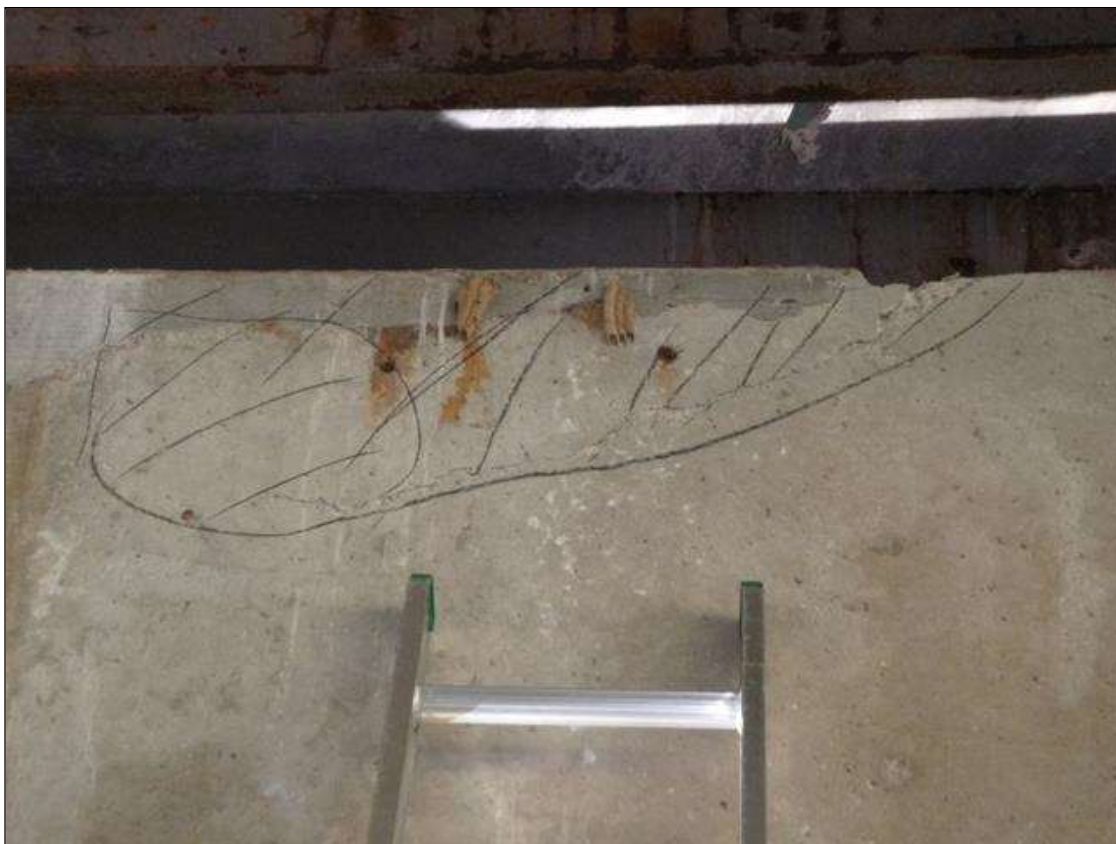
Bent 1 Cap : 9' X UP TO 2' TEMPORARY REPAIR, TOP OF SOUTH FACE, BELOW BAY 3, BEGINNING AT BEAM 3.

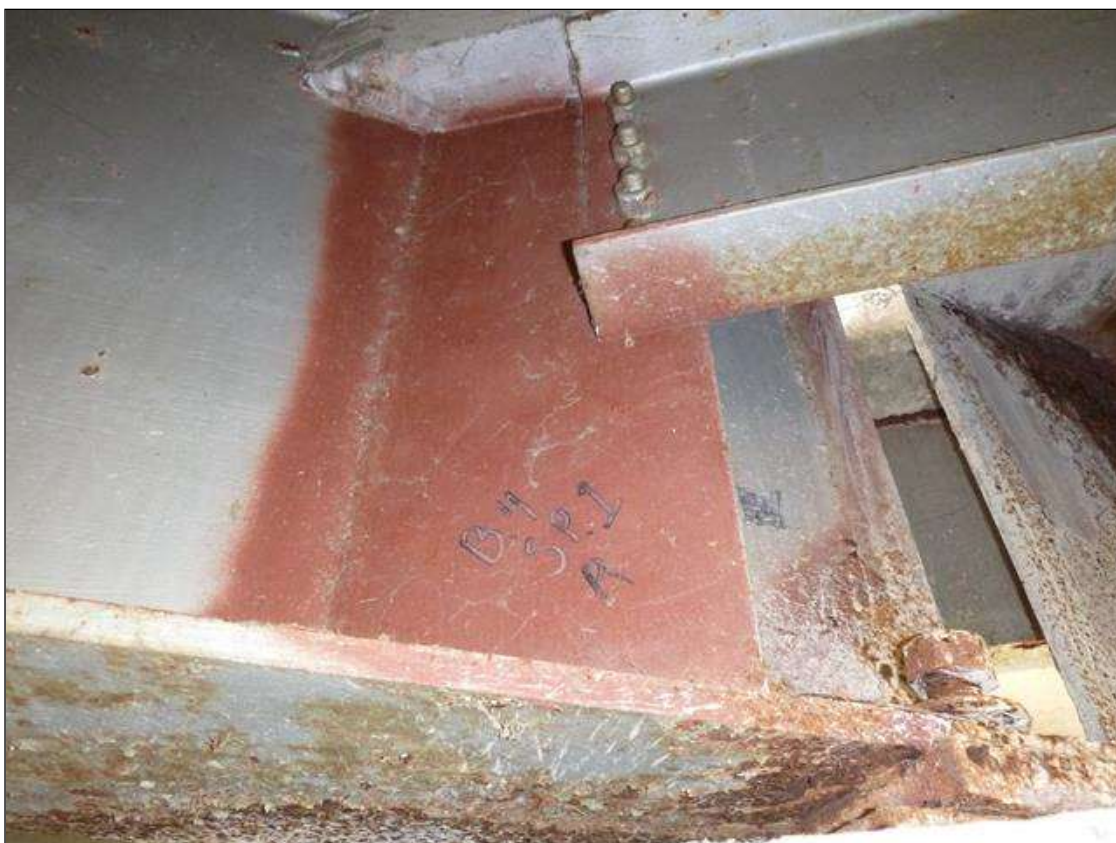
Bent 1 Cap : 3' X 16" X 5" CORNER DELAMINATION/SPALL, TOP OF SOUTH FACE, BELOW MIDDLE OF BAY 3.

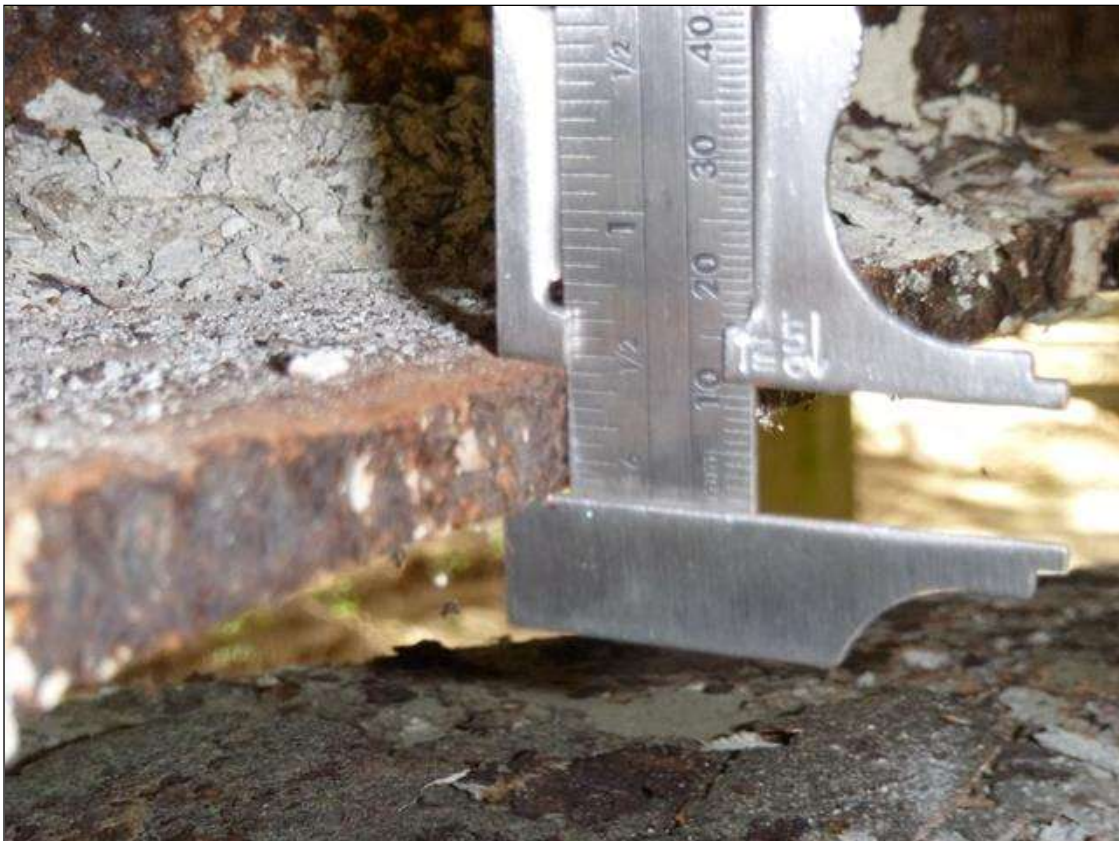
Span 1 Beam 5: TEMPORARY REPAIR TO TOP OF BOTTOM FLANGE AND BEARING STIFFENER.

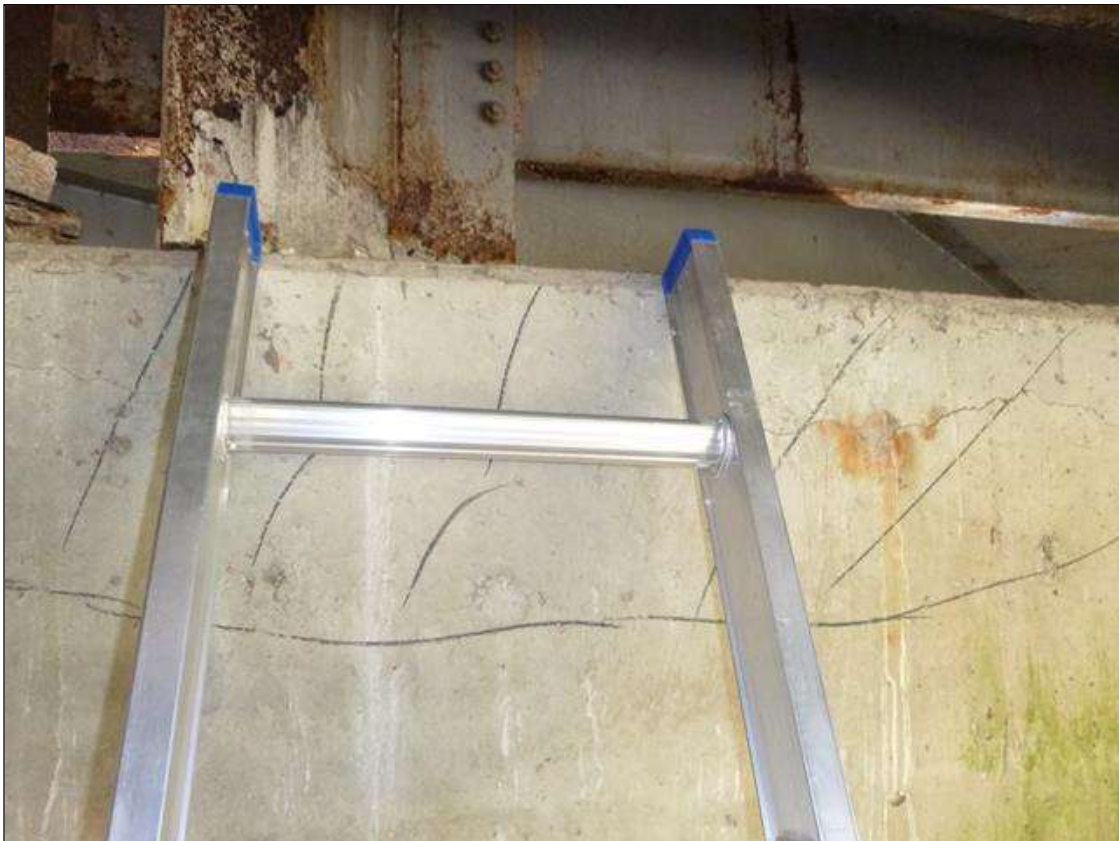
Span 2 Beam 5: 30" OF CORROSION WITH SECTION LOSS, 7/16" REMAINING ALONG BOTTOM FLANGE, AT BENT 1. (PM)

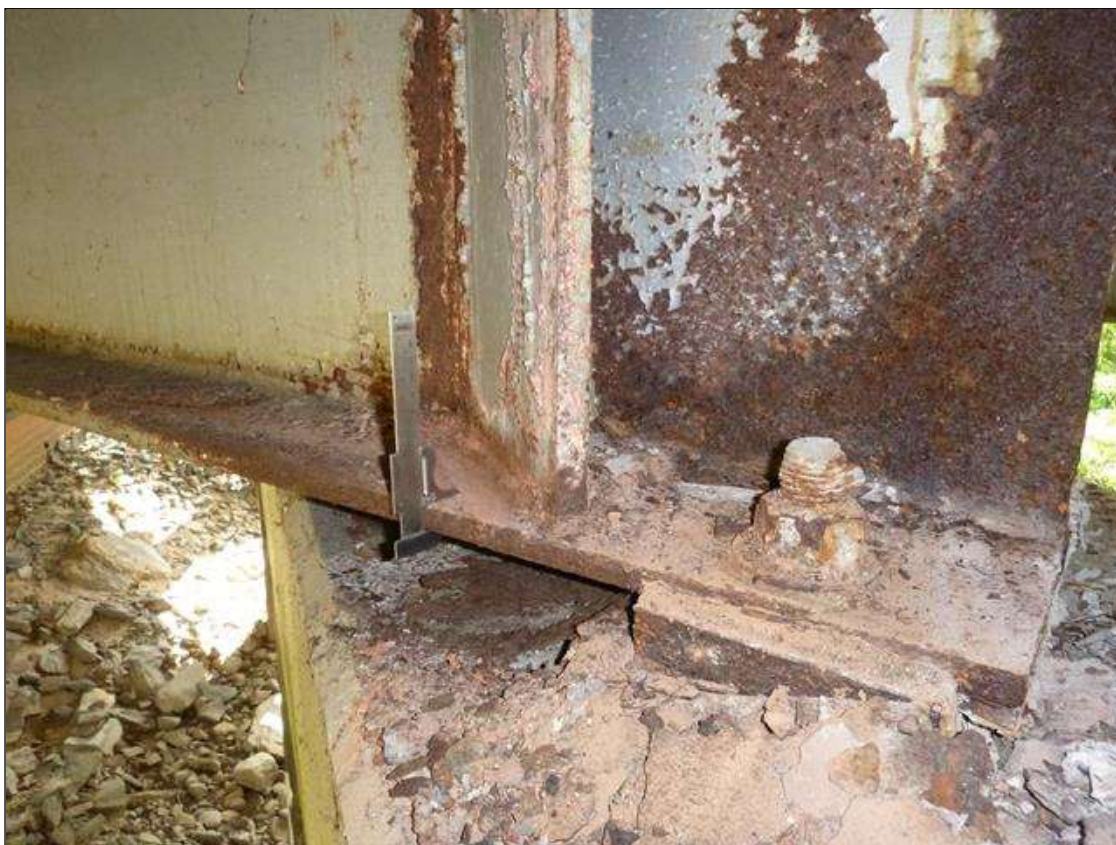
Span 1 Beam 6: 2' OF CORROSION WITH SECTION LOSS, 11/16" REMAINING ALONG BOTTOM FLANGE, AT BENT 1. (PM)

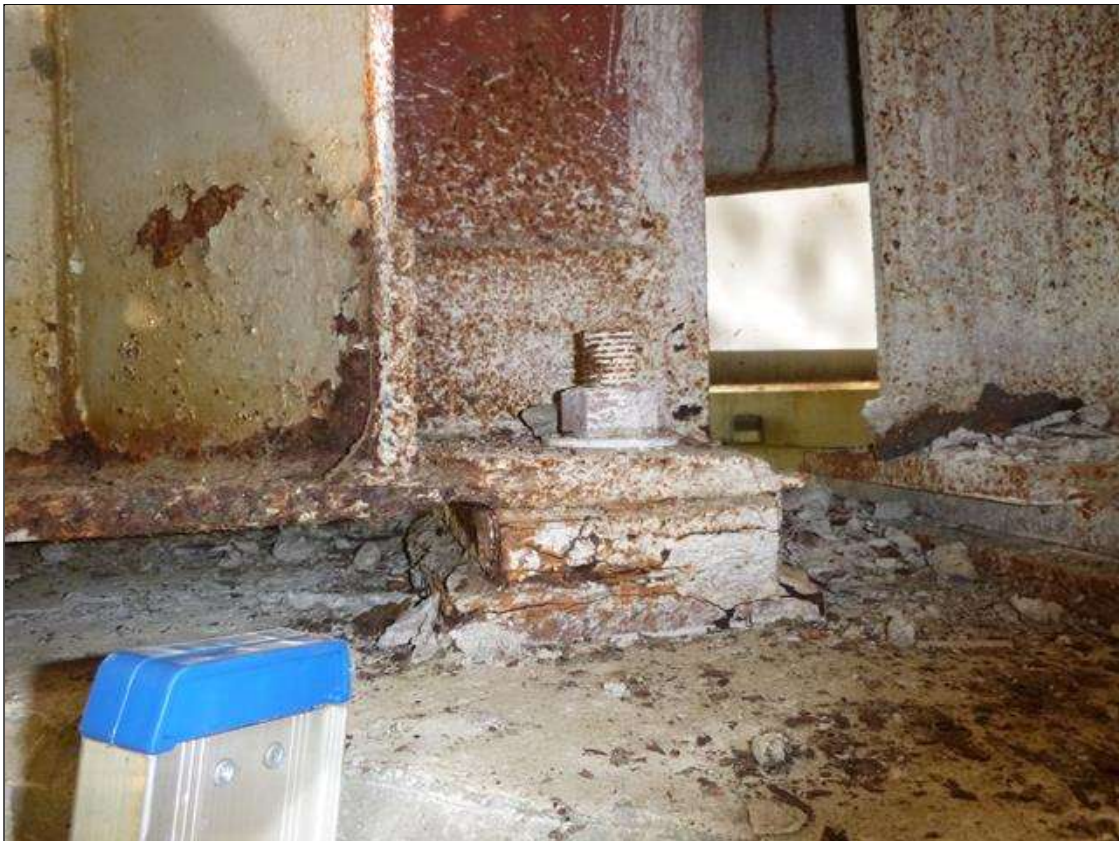
Span 2 Beam 6: 7.5' OF CORROSION WITH SECTION LOSS, 3/8" REMAINING ALONG BOTTOM FLANGE, EXTENDING UP TO 12" INTO WEB, AT BENT 1. (PM)

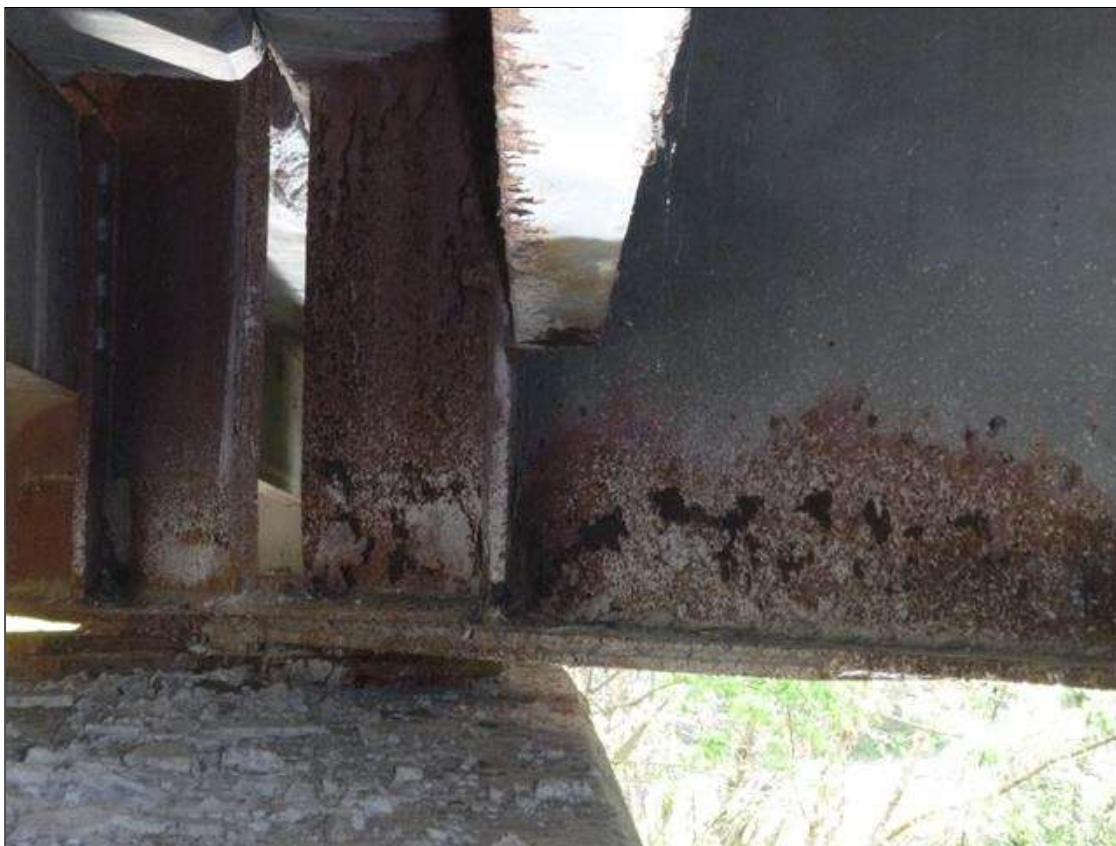
Span 2 Beam 3: 1' OF CORROSION THROUGHOUT TEMPORARY REPAIR TO BOTTOM FLANGE AND WEB, AT BENT 1.

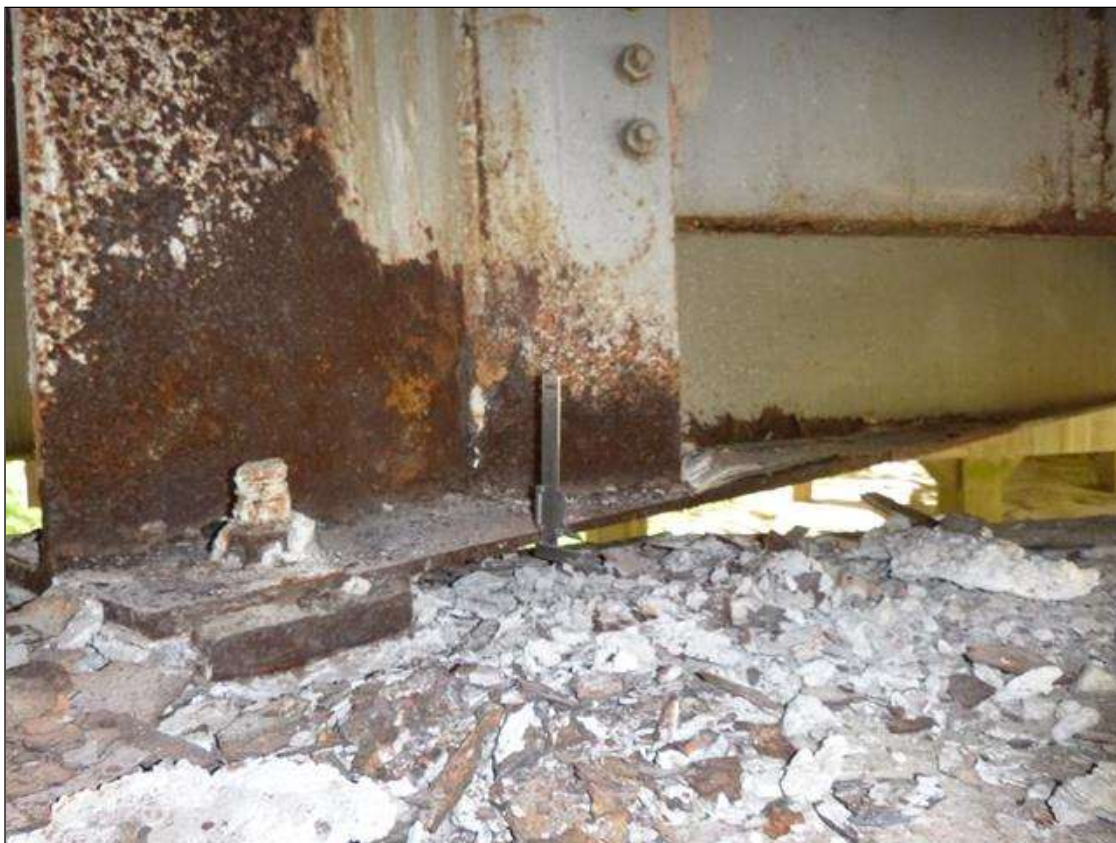
Span 2 Beam 2: TEMPORARY REPAIR TO BOTTOM FLANGE, WEB AND STIFFENER, AT BENT 1.

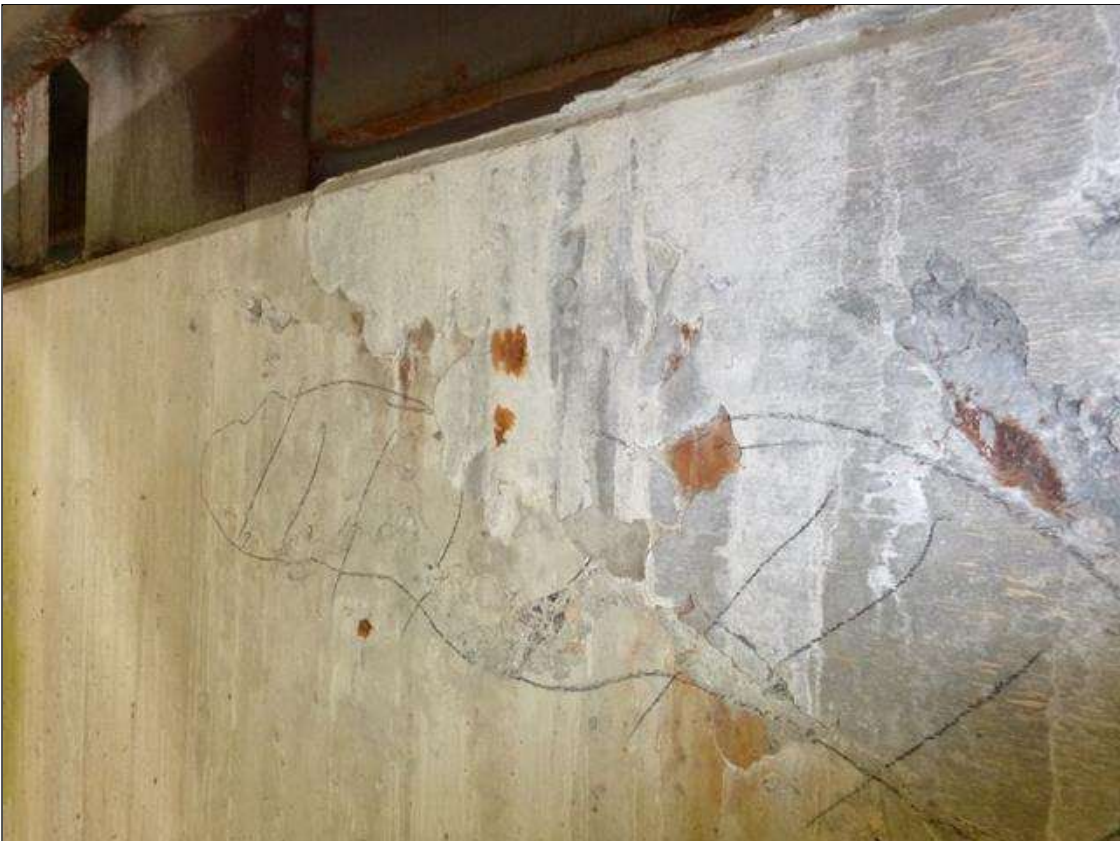
Superstructure : 4' X 10" X UP TO 8" SPALL WITH EXPOSED REINFORCING UNDERSIDE OF BENT 1 END DIAPHRAGM, SPAN 1, BETWEEN BEAMS 1 AND 2, NEXT TO BEAM 2.
