NC DEPARTMENT OF TRANSPORTATION  
DIVISION OF HIGHWAYS  
STRUCTURE MANAGEMENT UNIT

## Structure Safety Report

### Routine Element Inspection - Contract

COUNTY: WAKE STRUCTURE NUMBER: 910494 FREQUENCY: 24 MONTHS

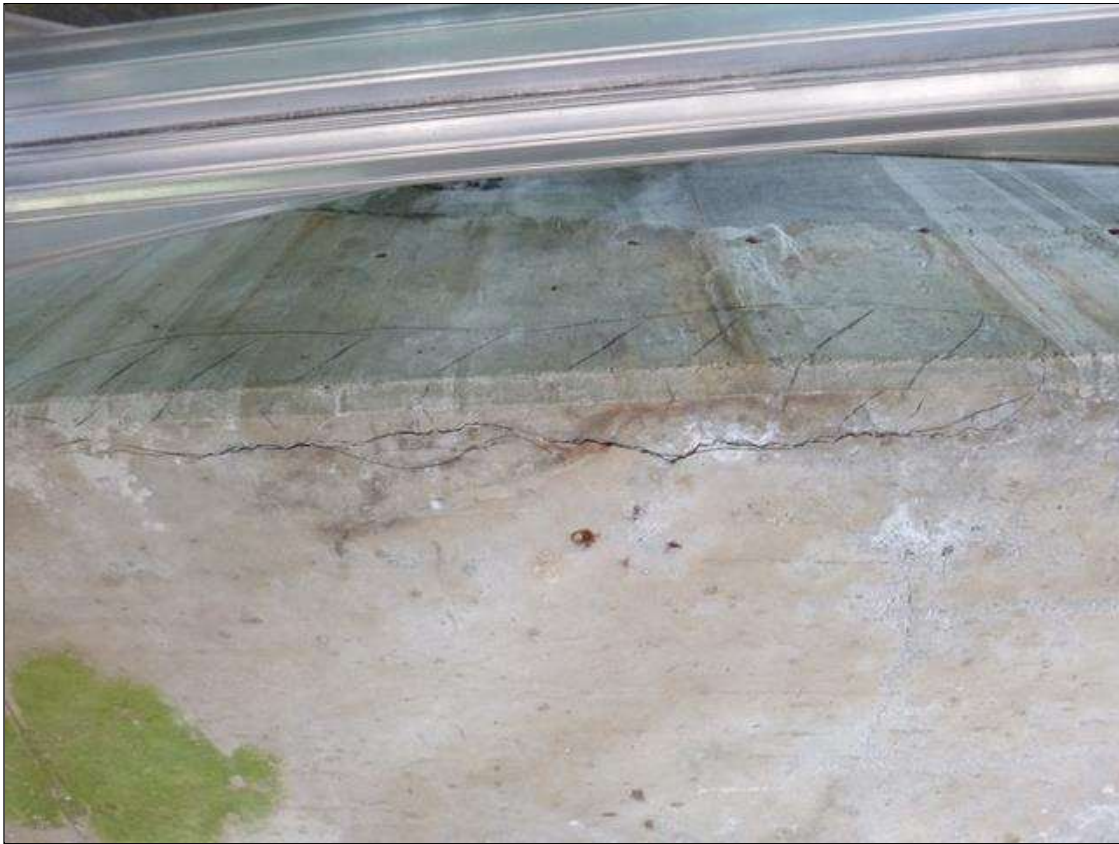
Bent 1 Cap : 33" X 8" DELAMINATION, MIDDLE OF NORTH FACE BELOW BAY 3.

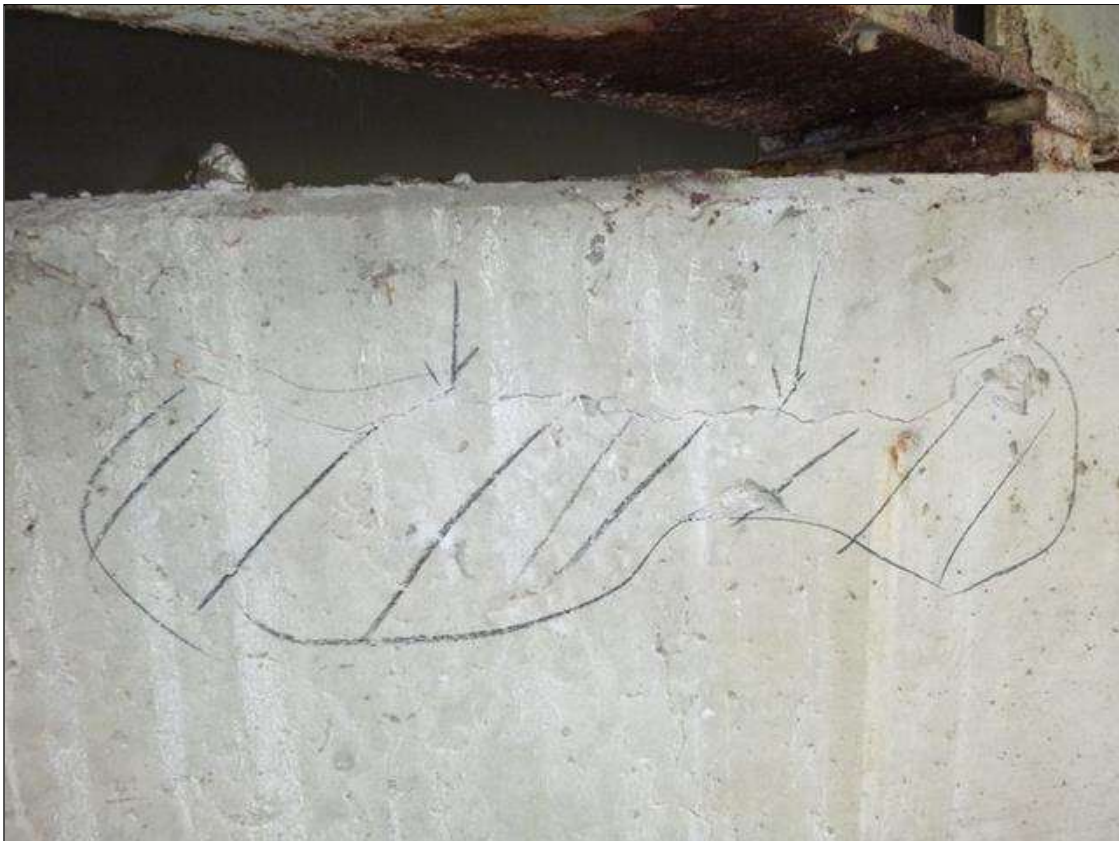
Bent 1 Cap : 3'-4" X 6" X 3" DELAMINATION WITH A 3' HORIZONTAL CRACK UP TO 1/8", BOTTOM CORNER OF NORTH FACE, BELOW BAY 3 BEGINNING AT BEAM 3.

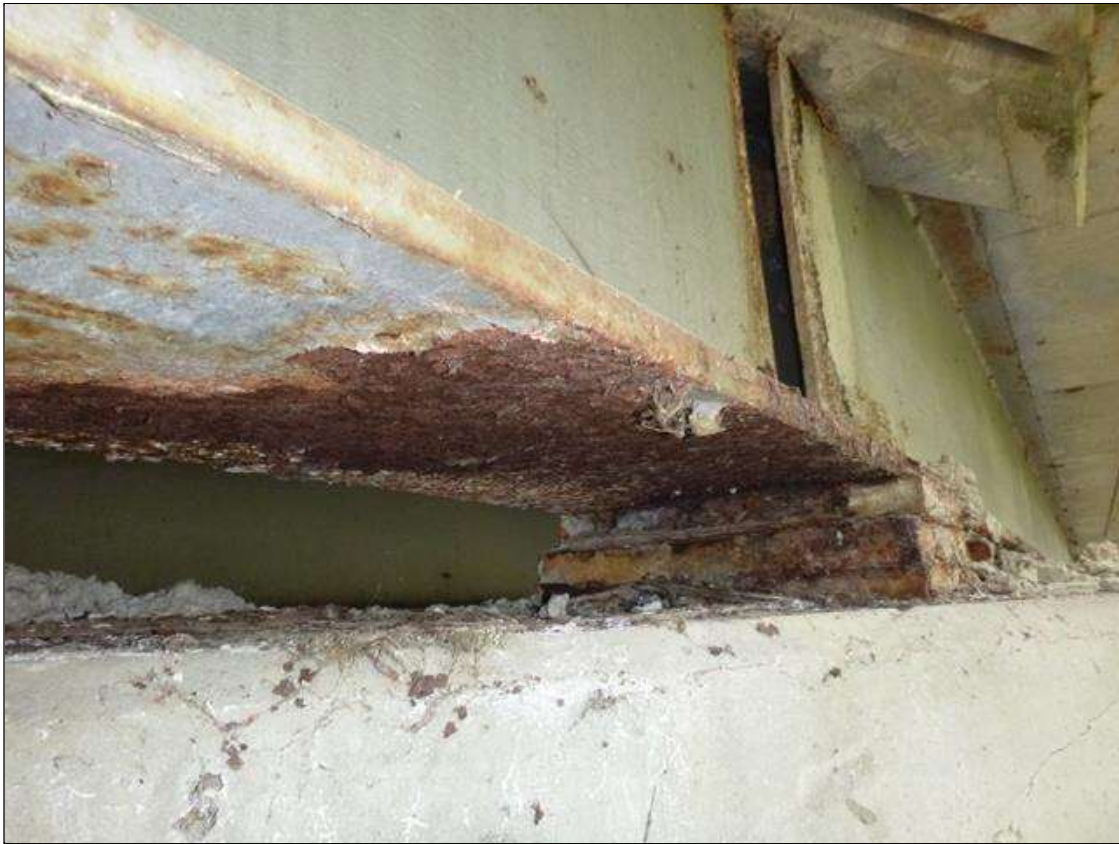
Bent 1 Cap : 2'-8" X 9" DELAMINATION WITH A 3'-8" HORIZONTAL CRACK UP TO 1/8", TOP SOUTH FACE, BELOW BEAM 8.

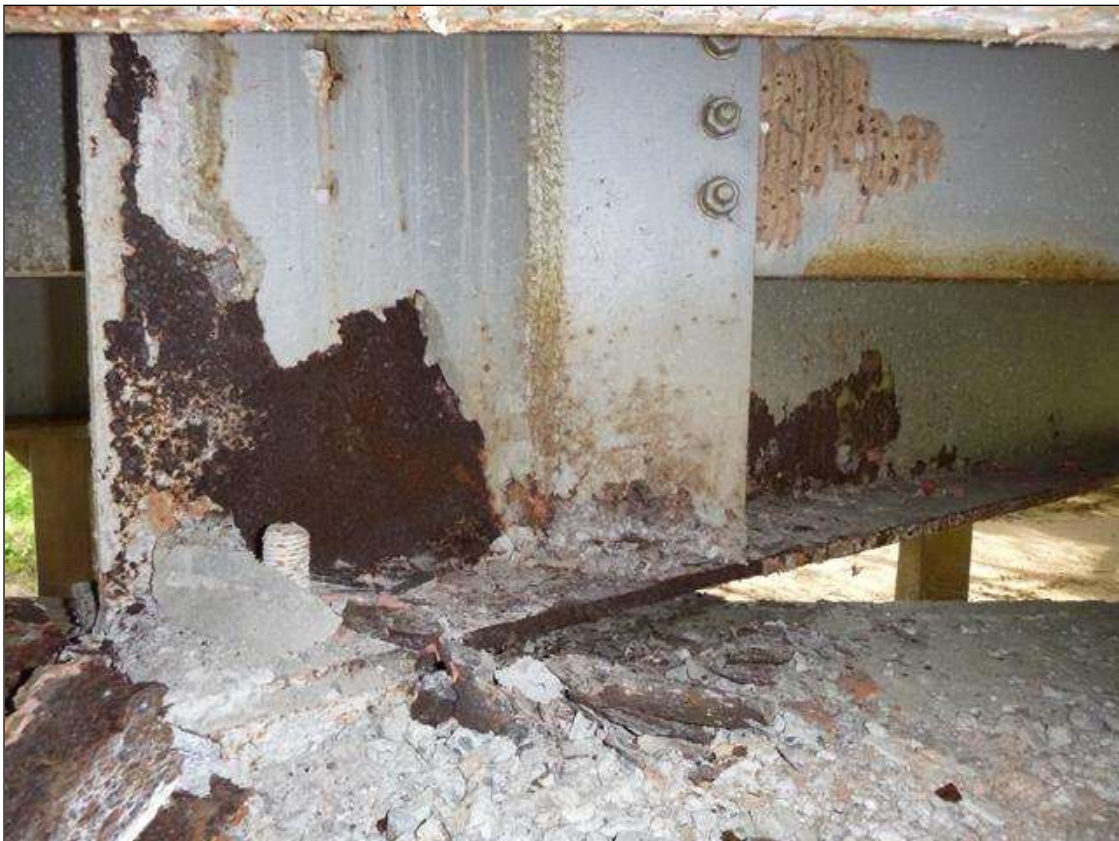
Span 1 Beam 8: 1' OF CORROSION WITH RUST SCALE ALONG BOTTOM FLANGE AT BENT 1.

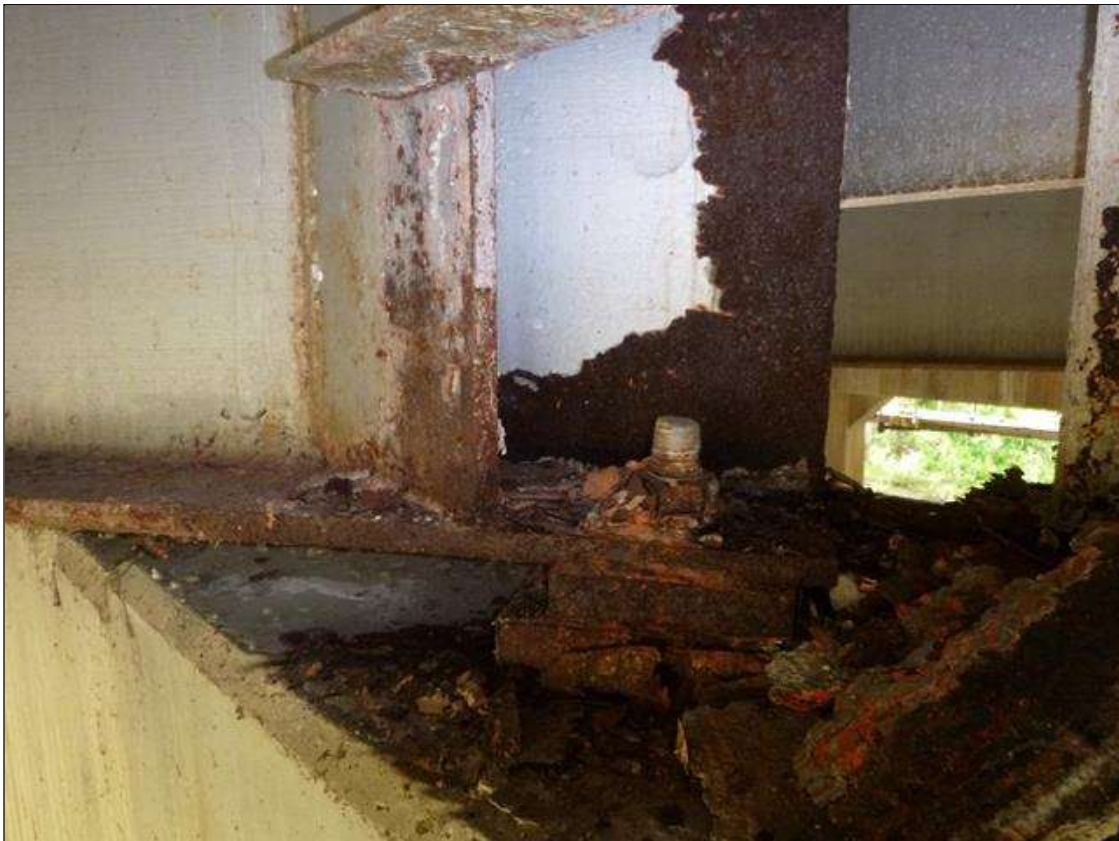
Span 2 Beam 7: 5' OF CORROSION WITH SECTION LOSS, 5/8" REMAINING, ALONG BOTTOM FLANGE EXTENDING 6" INTO WEB, AT BENT 1. (PM)

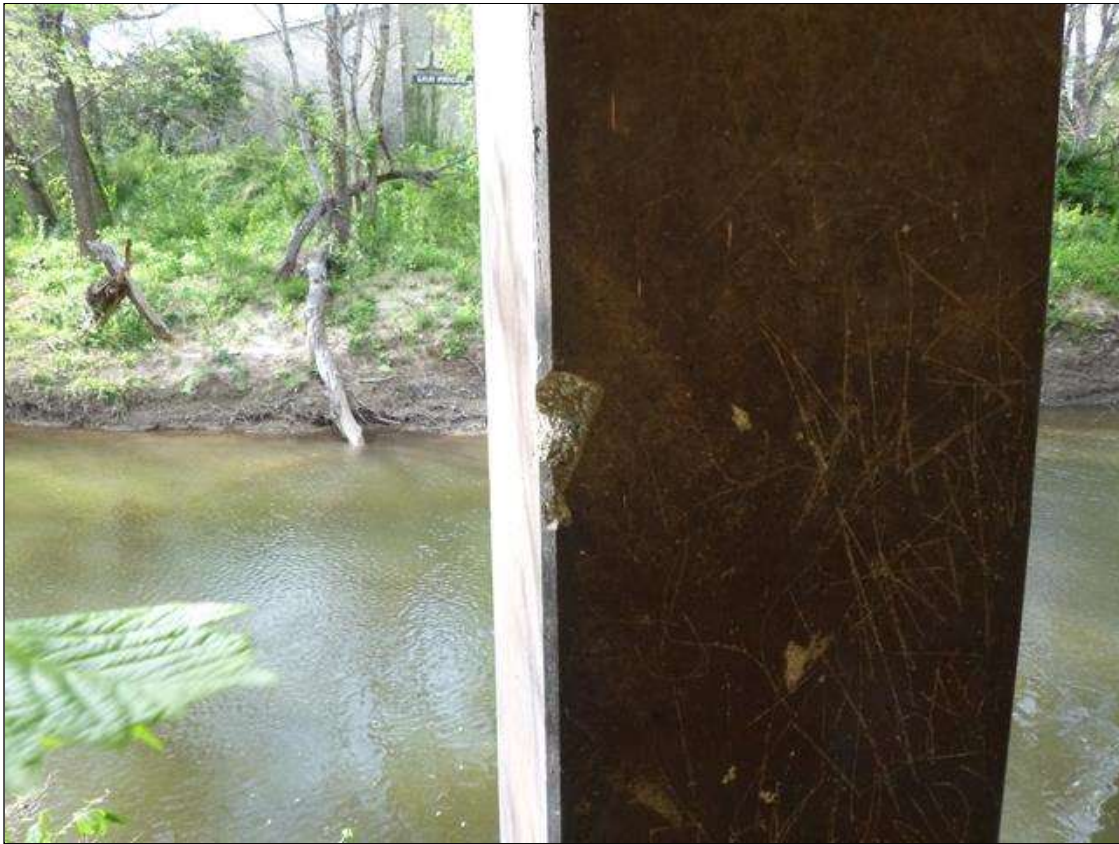
Span 1 Beam 7: 20" CORROSION WITH RUST SCALE ALONG BOTTOM FLANGE, AT BENT 1.

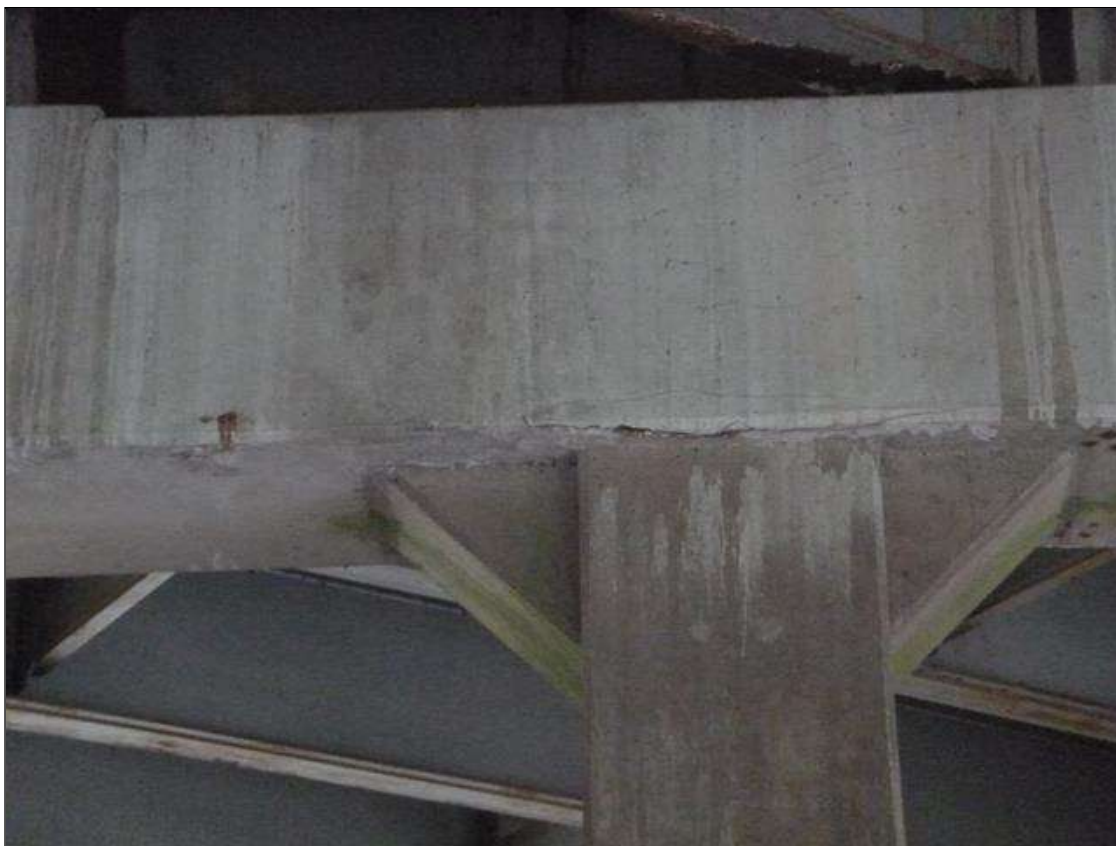
Bent 1 Cap : 3' X 6" X 6" DELAMINATION WITH A 3' HORIZONTAL CRACK UP TO 1/8", BOTTOM CORNER OF NORTH FACE, UNDER BAY 1.

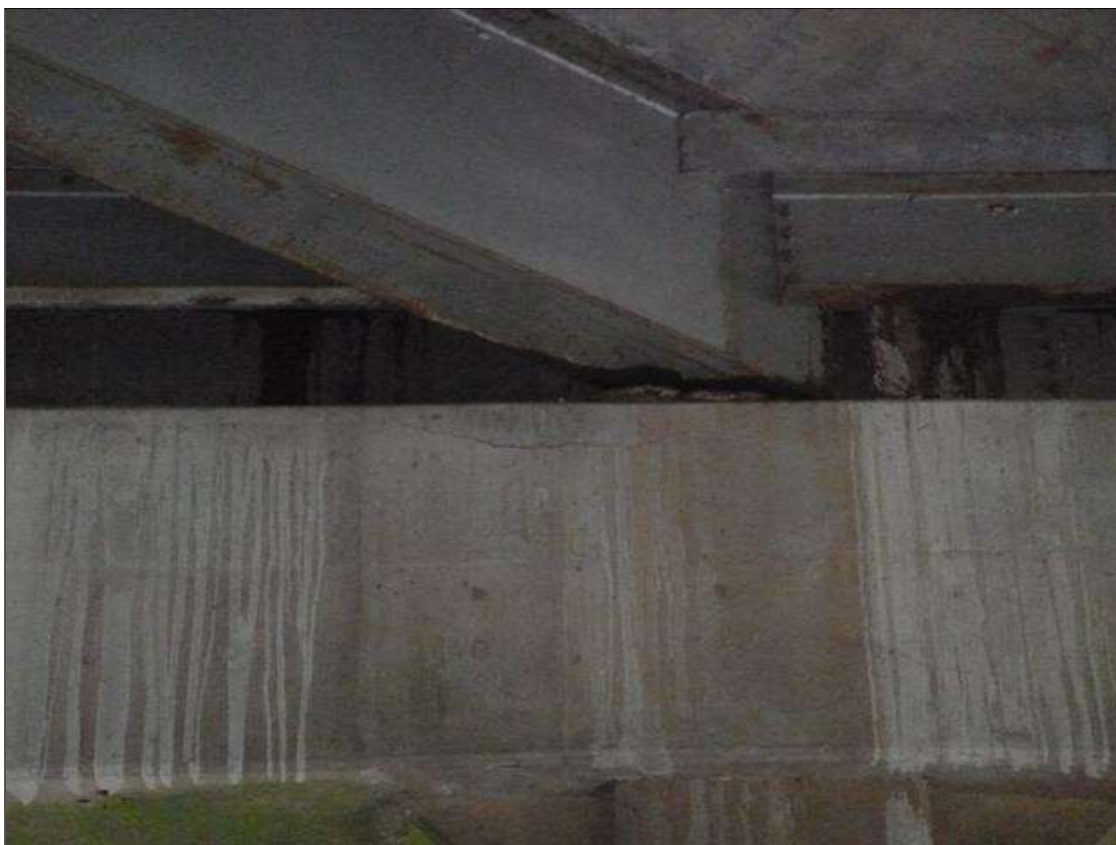
Bent 1 Cap : 6' X 6" X 3" DELAMINATION WITH A 6' HORIZONTAL CRACK UP TO 1/16", NORTH FACE, ABOVE PILE 3.

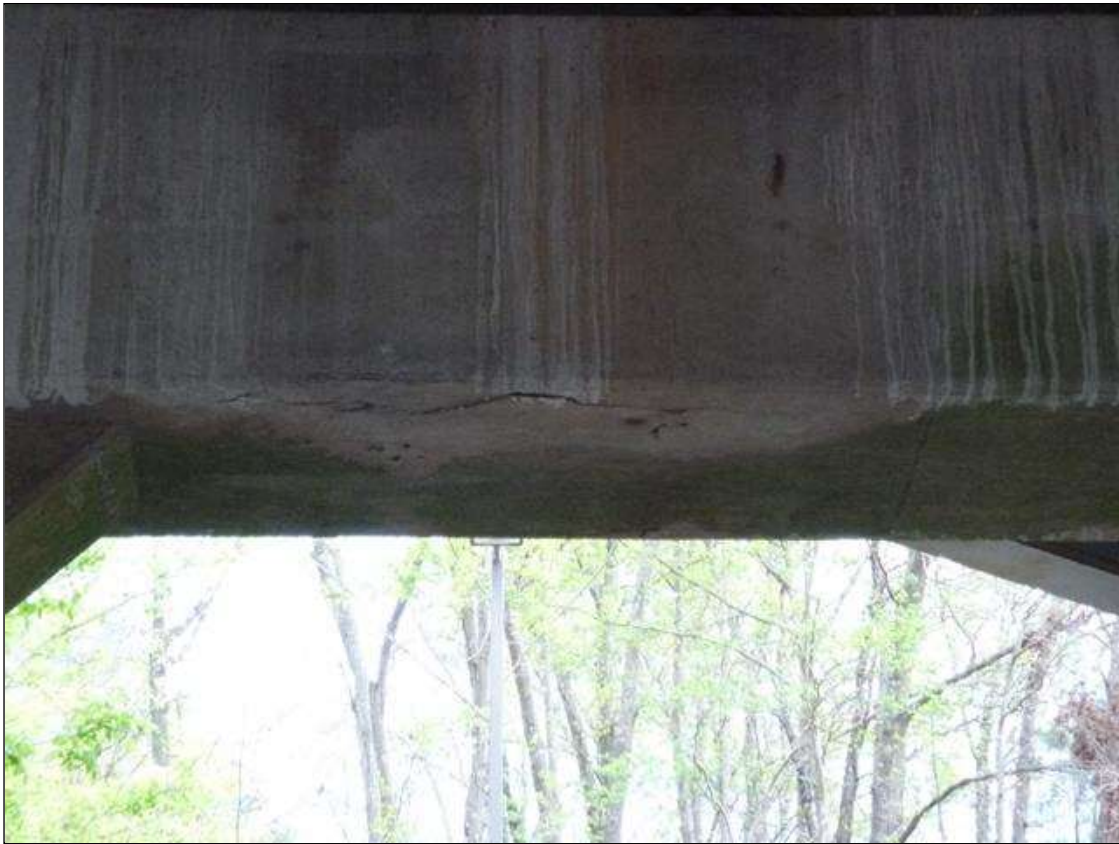
Bent 1 Cap : 30" HORIZONTAL CRACK UP TO 1/8", 4" BELOW TOP OF CAP, BELOW BEAM 6, NORTH FACE.

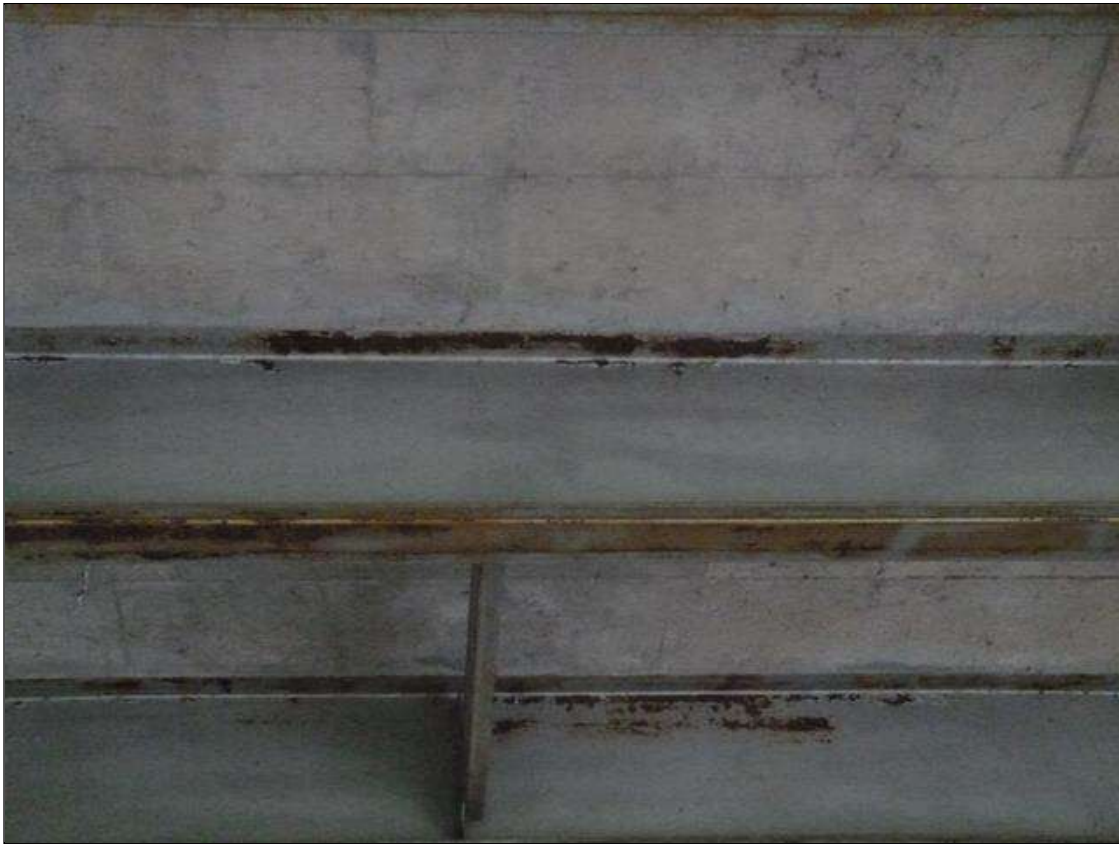
Span 2 Beam 1: 10% FRECKLED RUST AT RANDOM THROUGHOUT BEAM WEB.

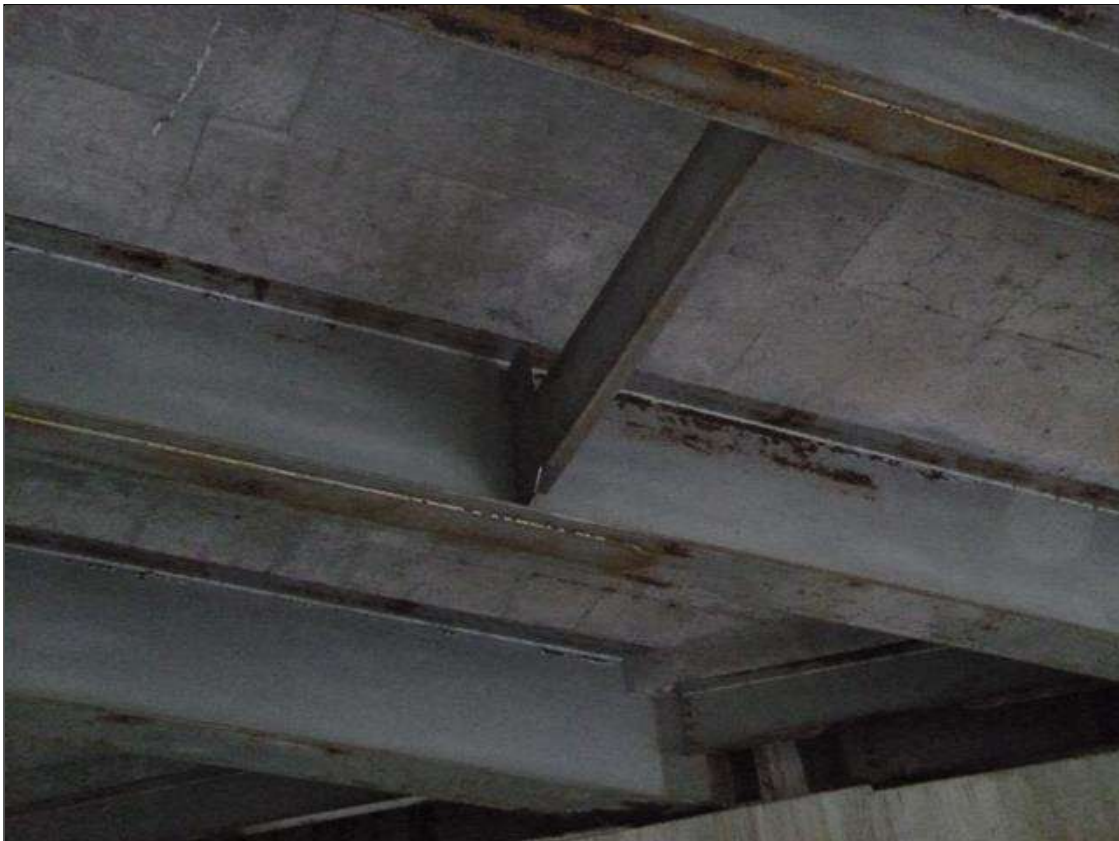
Span 2 Beam 3: 5% OF SURFACE AREA HAS CORROSION WITH RUST SCALE ALONG UNDERSIDE OF TOP AND BOTTOM FLANGES.

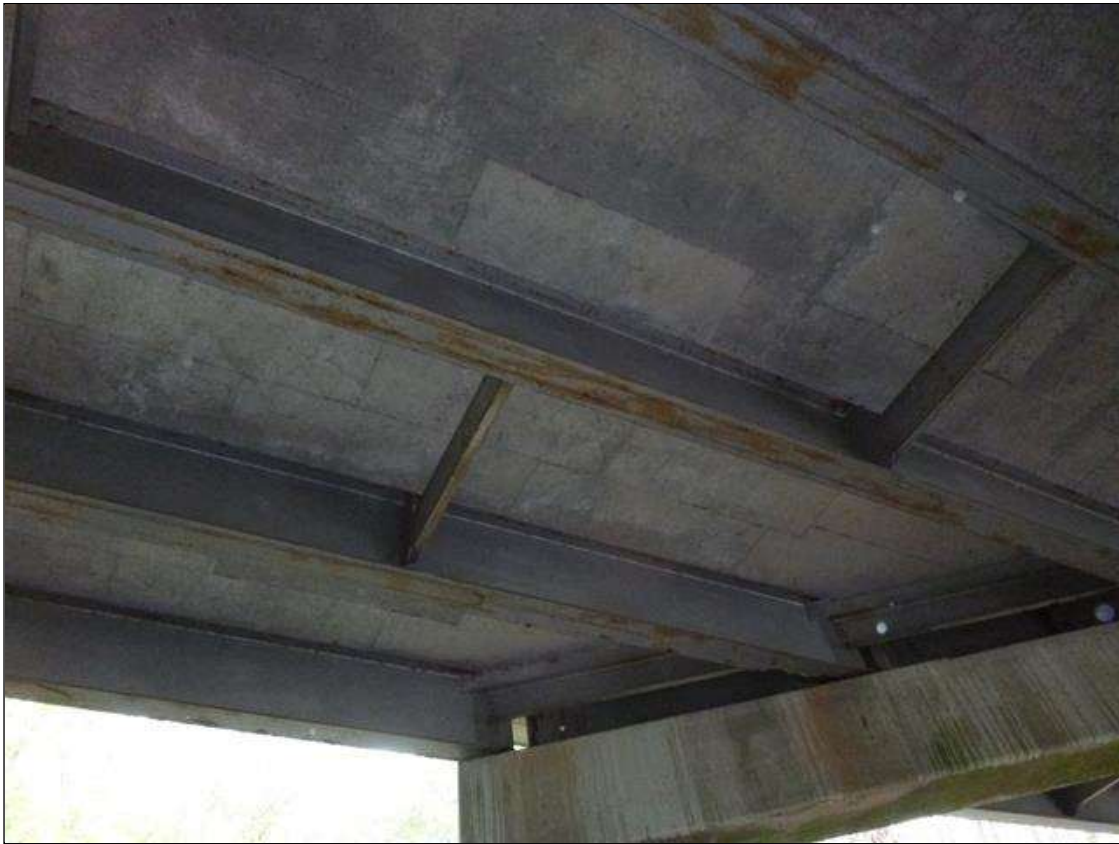
Span 2 Beam 4: 5% OF SURFACE AREA HAS CORROSION WITH RUST SCALE ALONG UNDERSIDE OF TOP AND BOTTOM FLANGES.

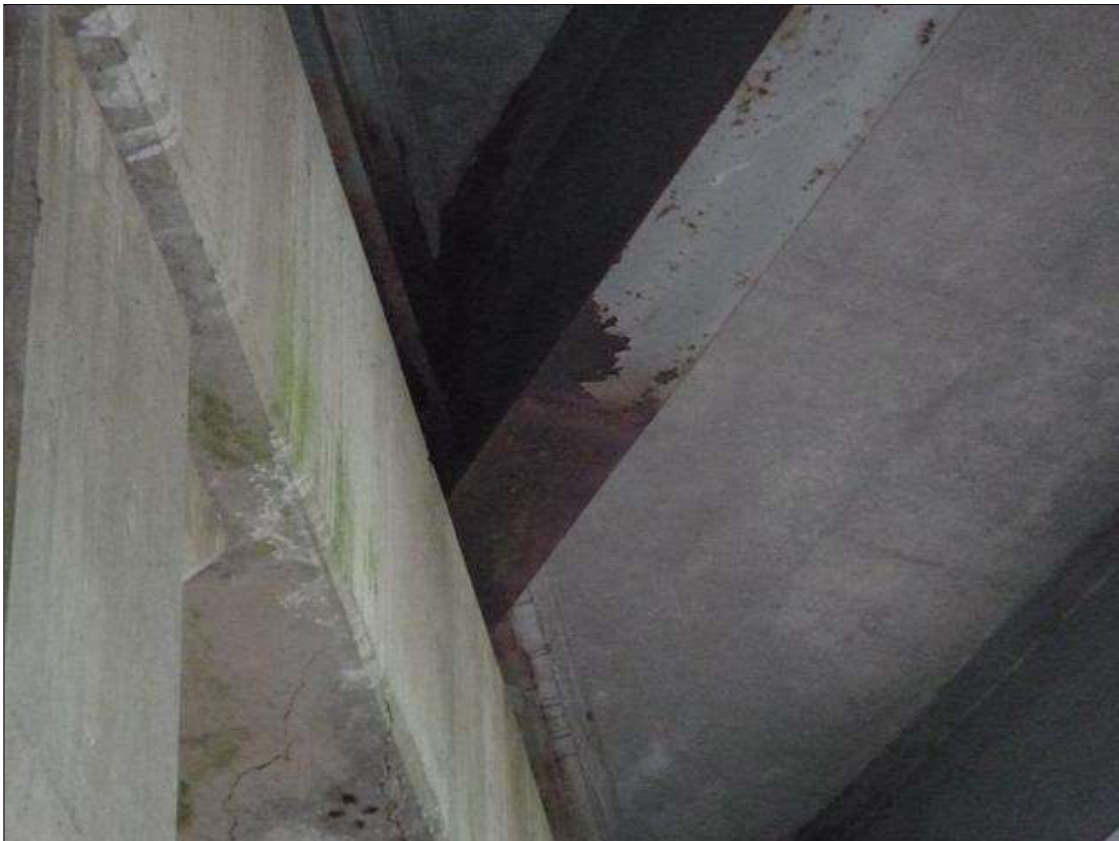
Span 2 Beam 5: 5% OF SURFACE AREA HAS CORROSION WITH RUST SCALE ALONG UNDERSIDE OF TOP AND BOTTOM FLANGES.

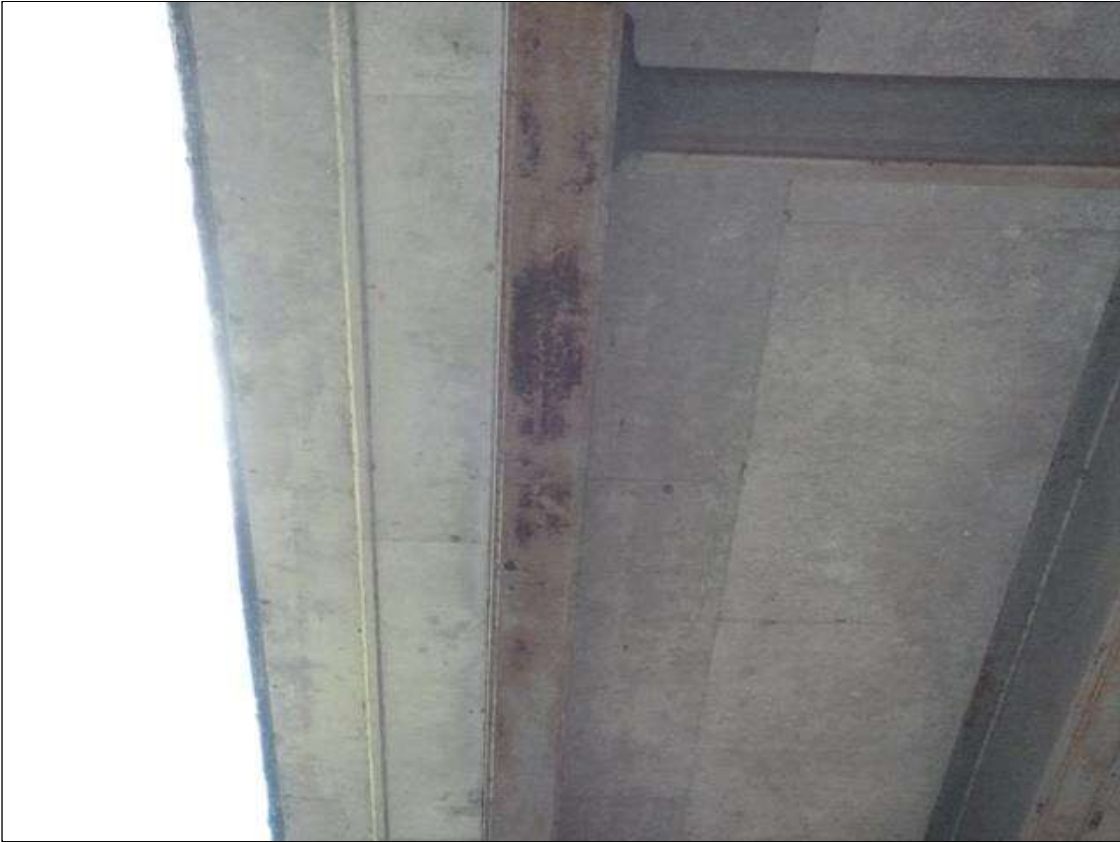
Span 2 Beam 7: 3' TEMPORARY REPAIR TO BOTTOM FLANGE AT BENT 2.

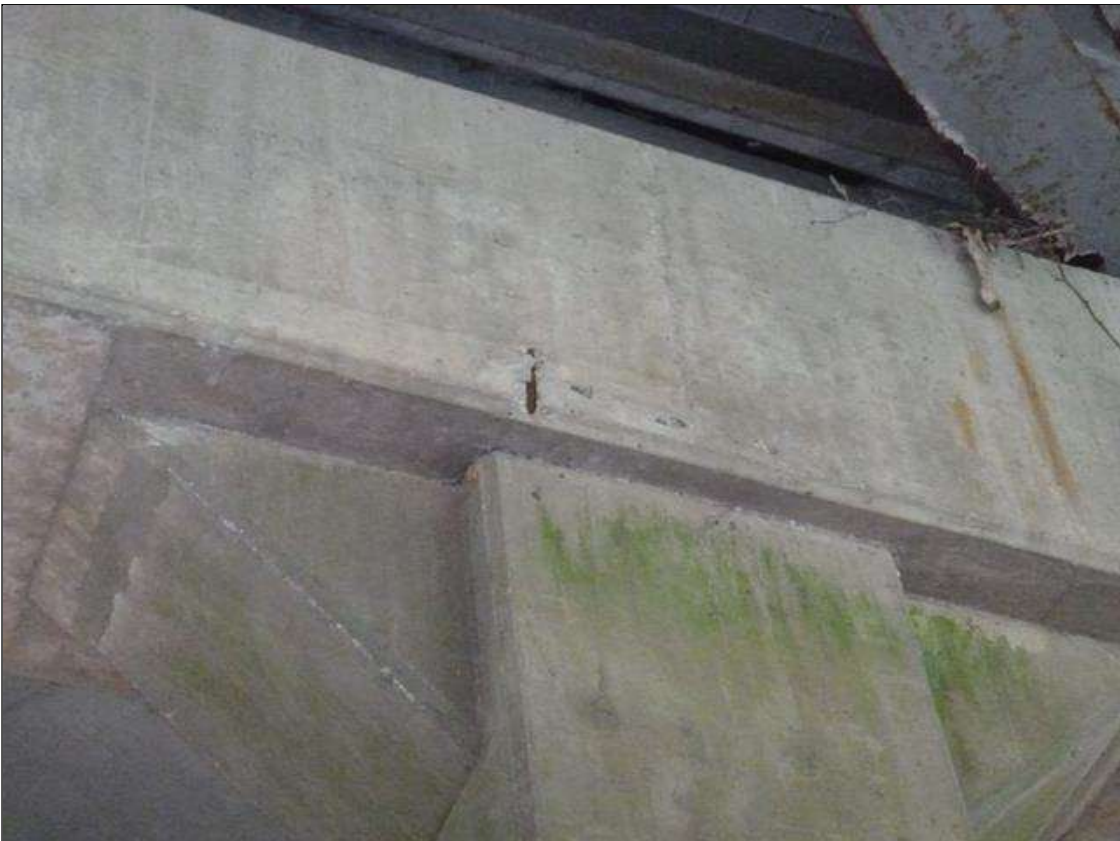
Bent 2 Cap : 10' HORIZONTAL CRACK UP TO 1/4", UNDERSIDE OF CAP, 4" FROM SOUTH FACE, BETWEEN PILES 4 AND 5.

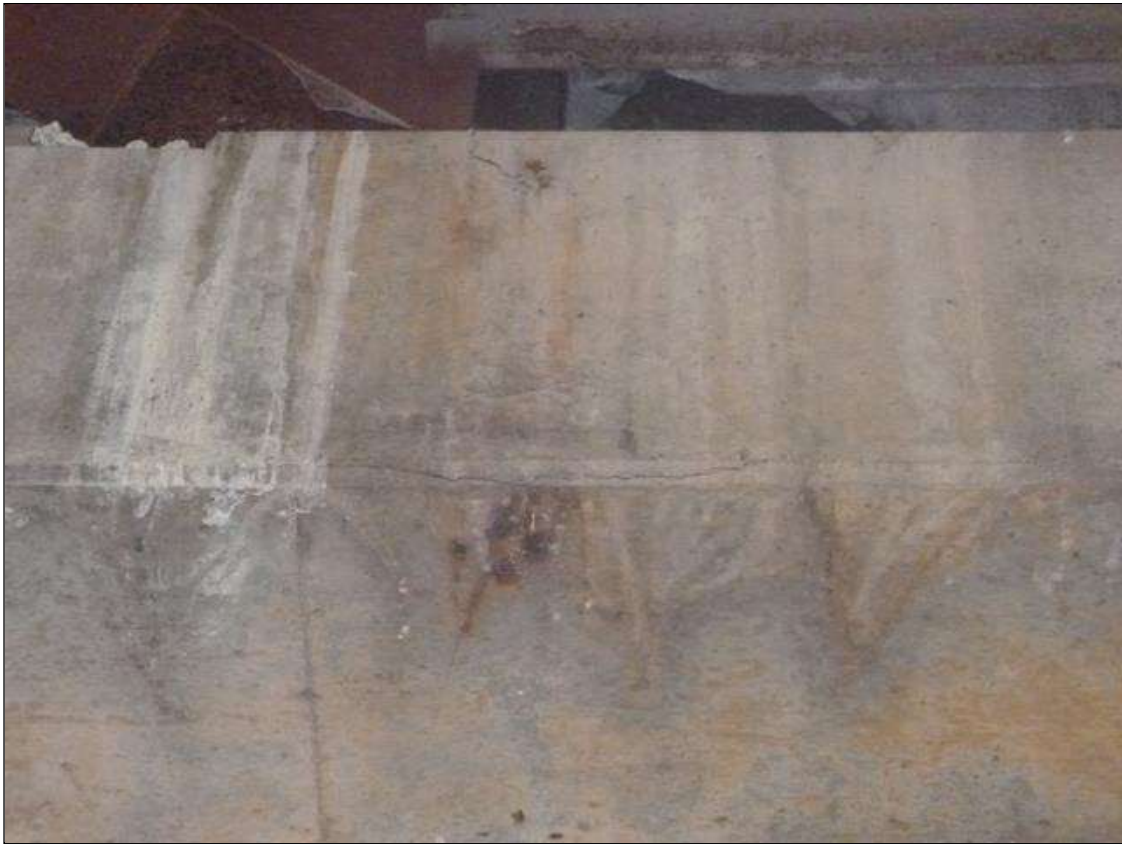
Bent 2 Cap : 7" X 1" X 1/2 SPALL WITH EXPOSED REINFORCING, BOTTOM OF SOUTH FACE, ABOVE PILE 3.

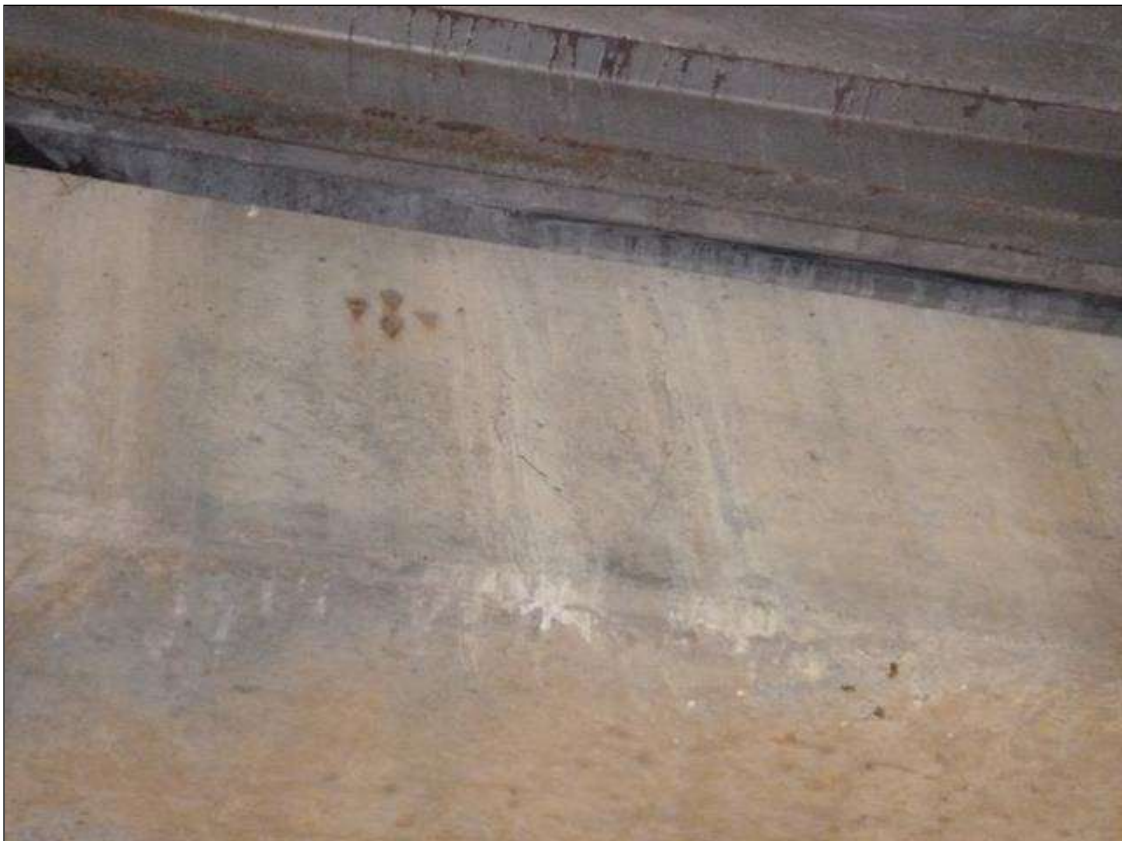
Bent 2 Cap : 16" X 14" DELAMINATION, SOUTH FACE, BETWEEN PILES 1 AND 2.

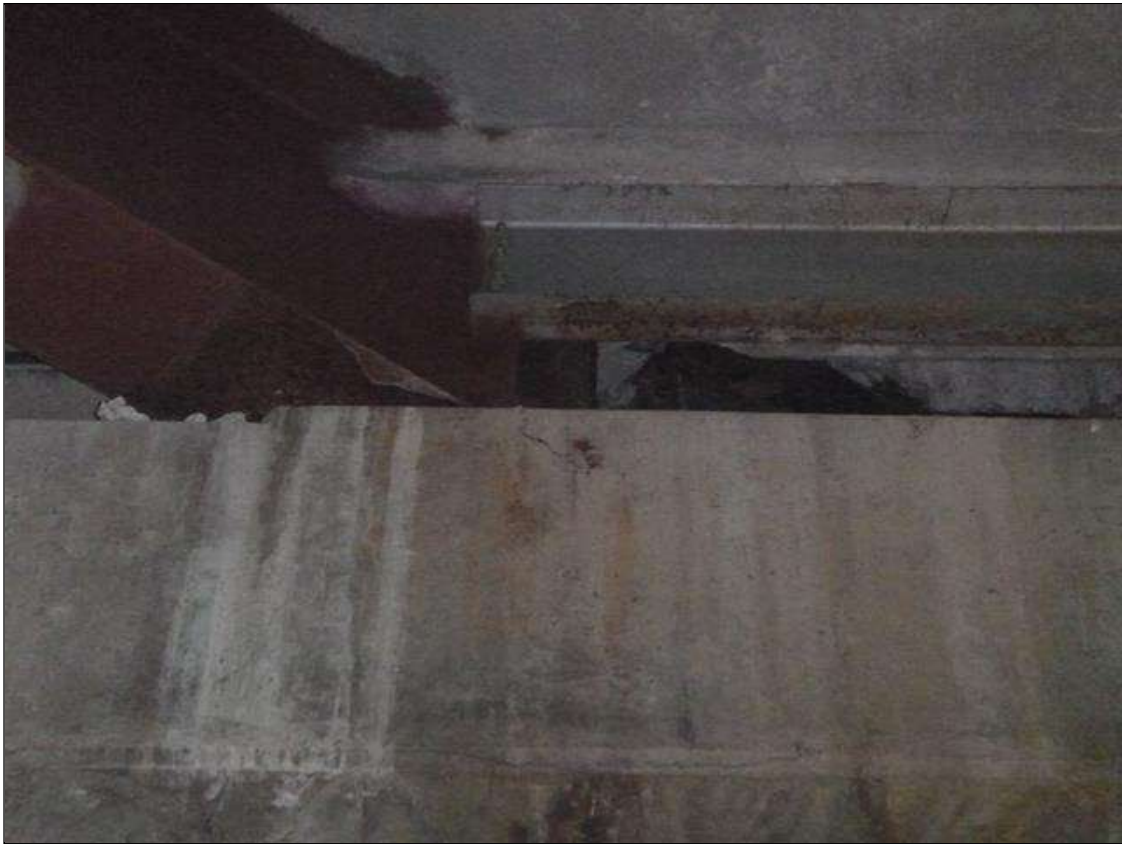
Bent 2 Cap : 10" X 20" DELAMINATION, SOUTH FACE, BETWEEN PILES 1 AND 2.

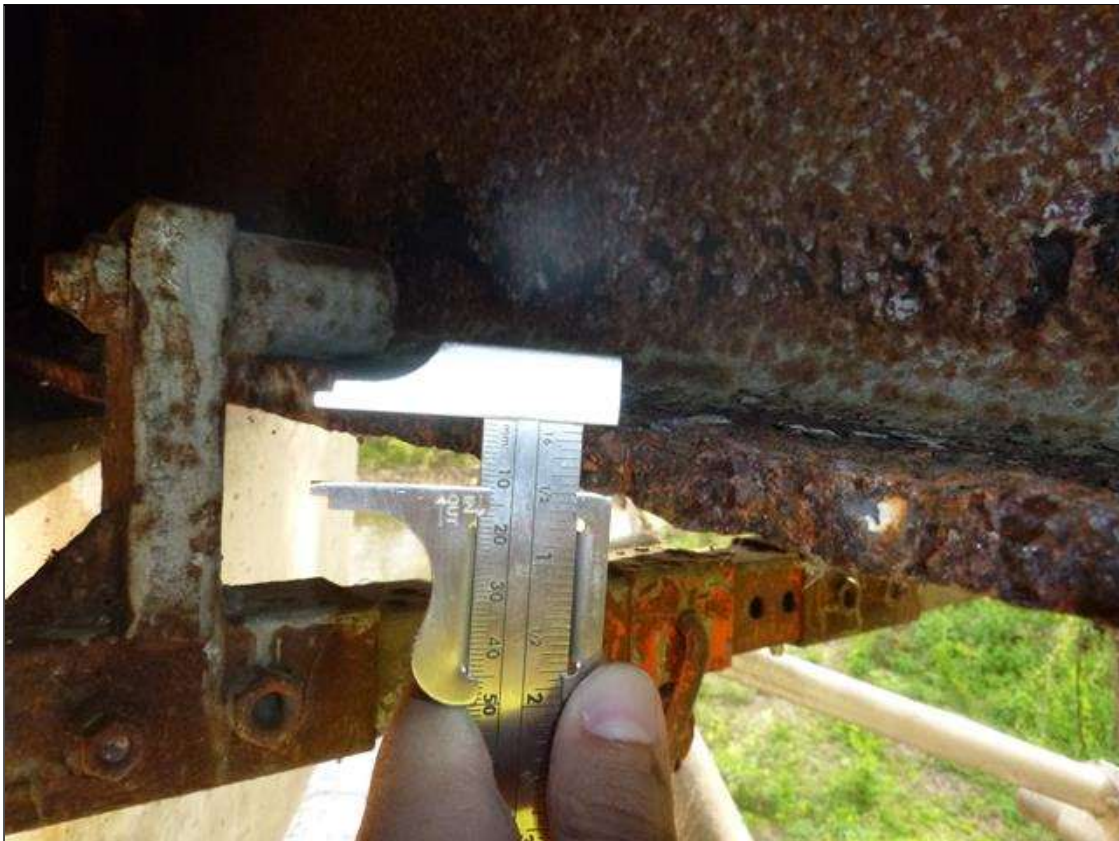
Span 3 Beam 1: 5' OF CORROSION WITH SECTION LOSS, 7/16" REMAINING ALONG BOTTOM FLANGE, 4.5' FROM BENT 2 BEARING. (PM)

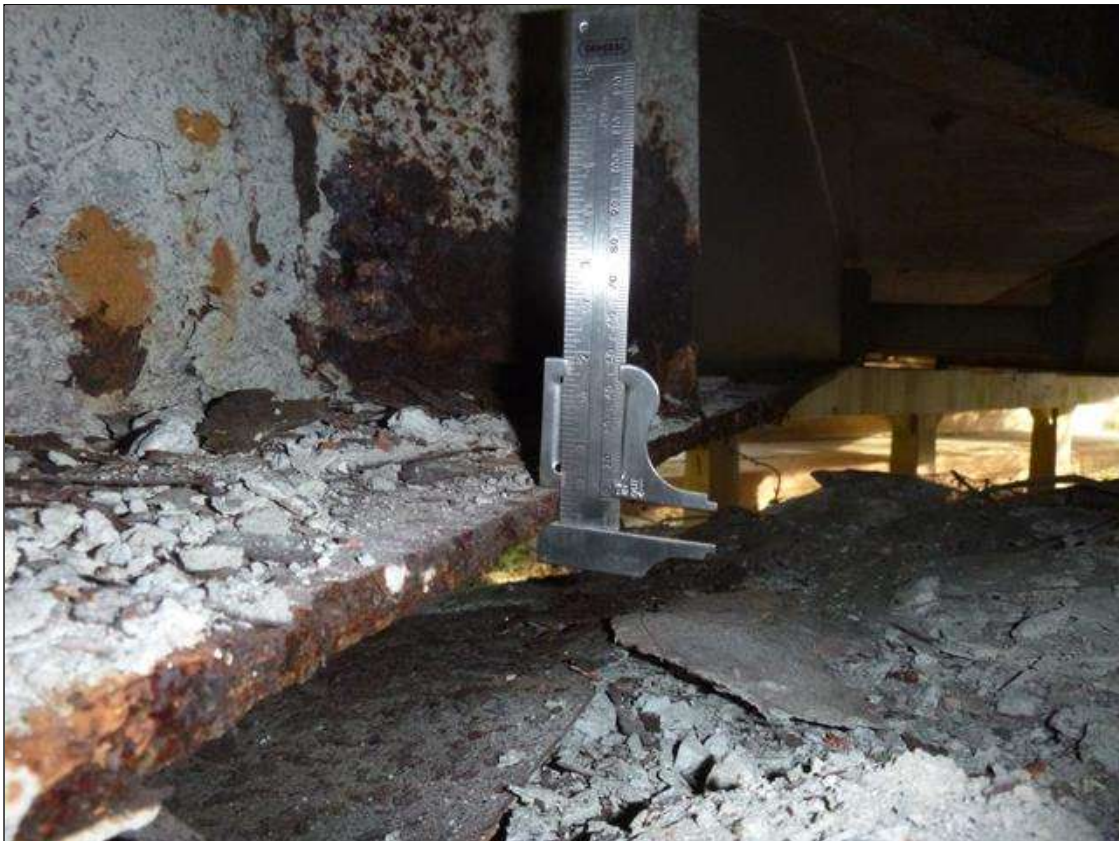
Span 2 Beam 5: 5' OF CORROSION WITH SECTION LOSS, 3/8" REMAINING ALONG BOTTOM FLANGE, 1' FROM BENT 2 BEARING. (PM)

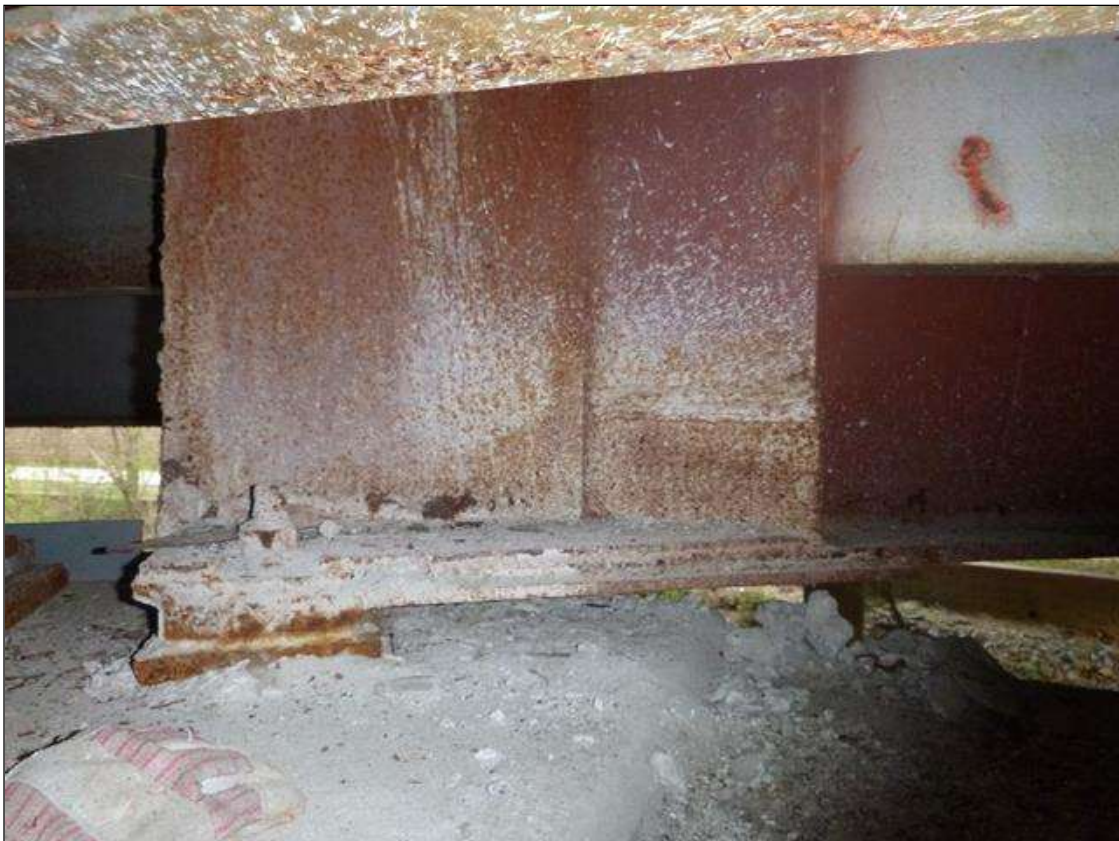
Span 3 Beam 1: TEMPORARY REPAIR TO BOTTOM FLANGE AT BENT 2.

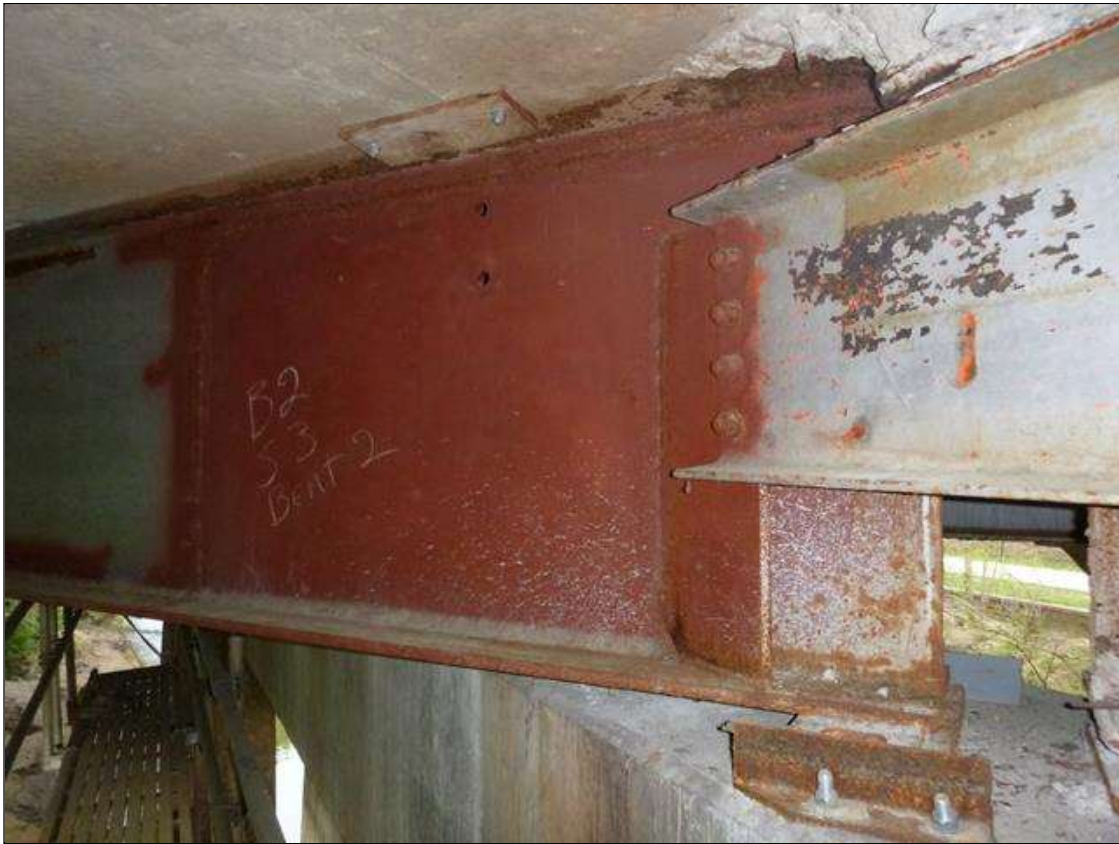
Span 2 Beam 2: TEMPORARY REPAIR TO WEB, BOTTOM FLANGE, AND BEARING STIFFENER AT BENT 2.

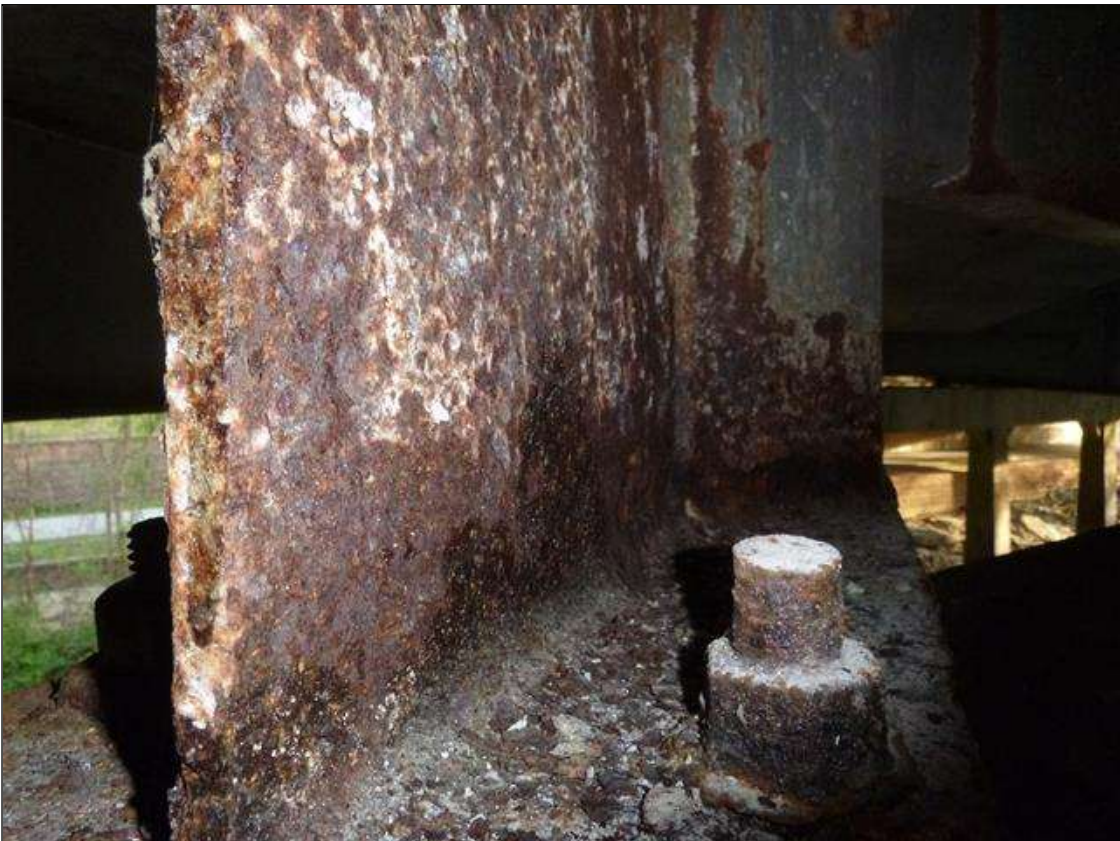
Span 2 Beam 6: 4' OF CORROSION WITH SECTION LOSS, 1/2" REMAINING ALONG BOTTOM FLANGE WITH PITTING IN WEB 8" FROM BEARING, AT BENT 2. (PM)

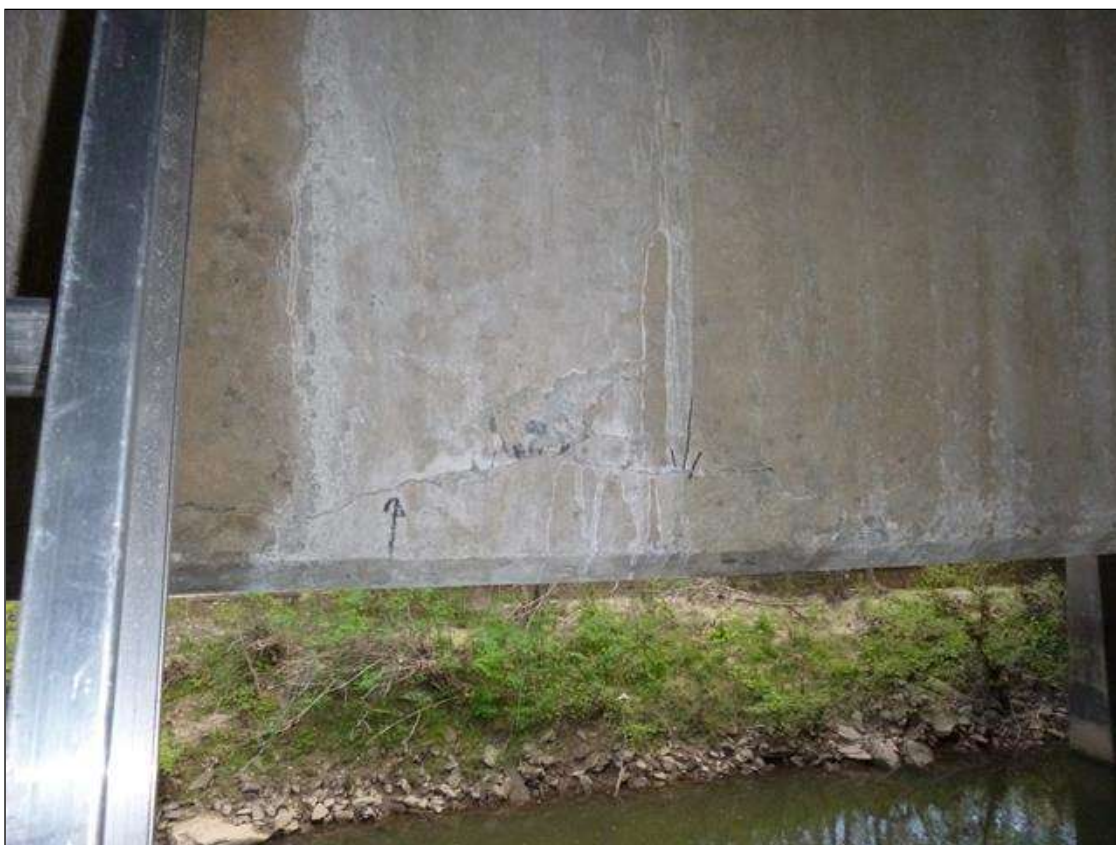
Bent 2 Cap : 32" HORIZONTAL CRACK UP TO 1/16" BOTTOM CORNER OF NORTH FACE, BELOW BEAM 7.
