NC DEPARTMENT OF TRANSPORTATION  
DIVISION OF HIGHWAYS  
STRUCTURE MANAGEMENT UNIT

## Structure Safety Report

### Routine Element Inspection - Contract

COUNTY: WAKE STRUCTURE NUMBER: 910494 FREQUENCY: 24 MONTHS

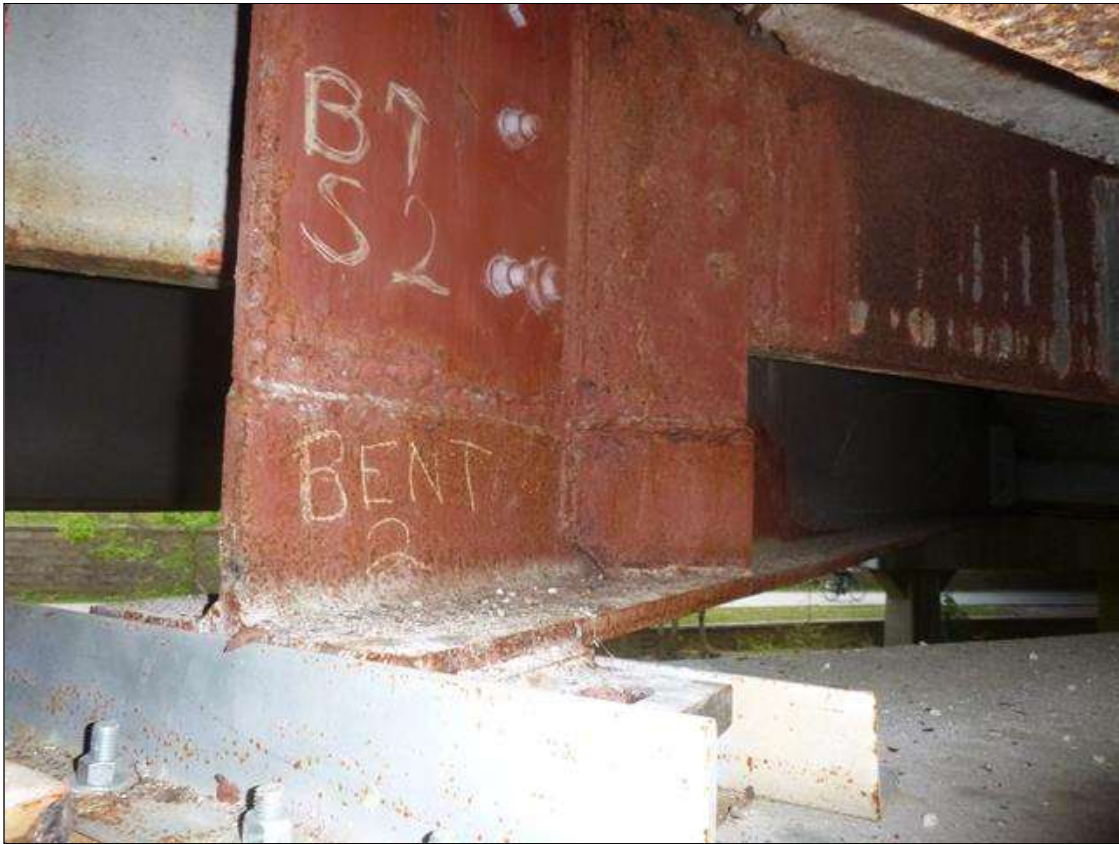
Span 2 Beam 7: TEMPORARY REPAIR TO BOTTOM FLANGE, WEB, BEARING STIFFENER, AND NEW BEARING ASSEMBLY AT BENT 2.

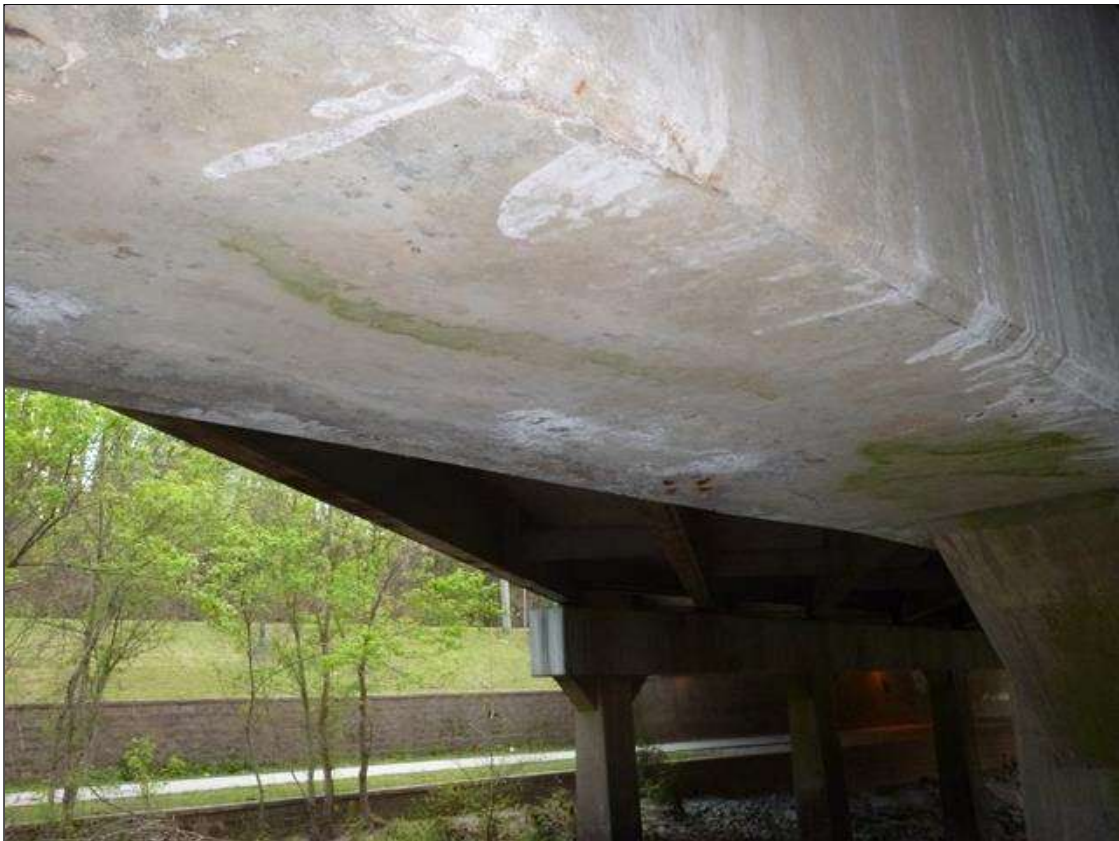
Bent 2 Cap : 6' X 1' DELAMINATION, UNDERSIDE OF CAP, BETWEEN COLUMNS 4 AND 5.

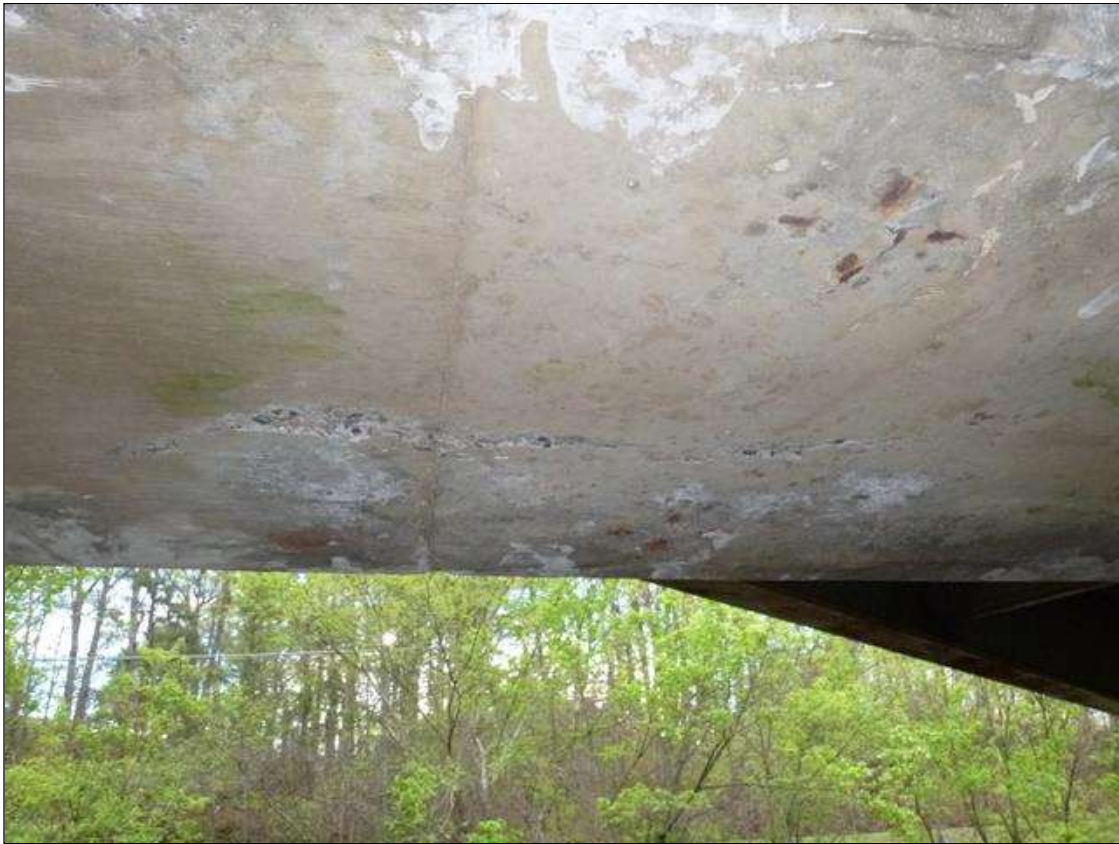
Bent 2 Cap : 6' X 1' DELAMINATION, UNDERSIDE OF CAP , BETWEEN COLUMNS 4 AND 5.

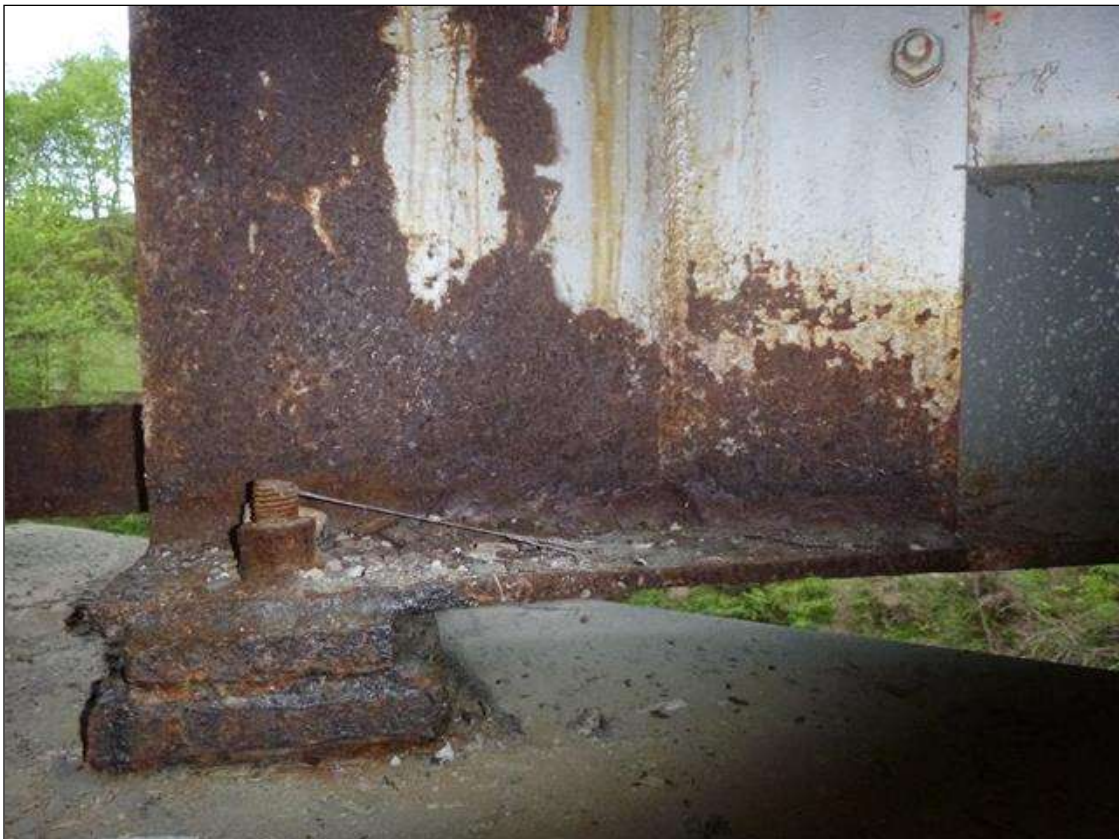
Span 2 Beam 8: 20" OF CORROSION WITH SECTION LOSS, 9/16" REMAINING AT 1' FROM BEARING, AT BENT 2. (PM)

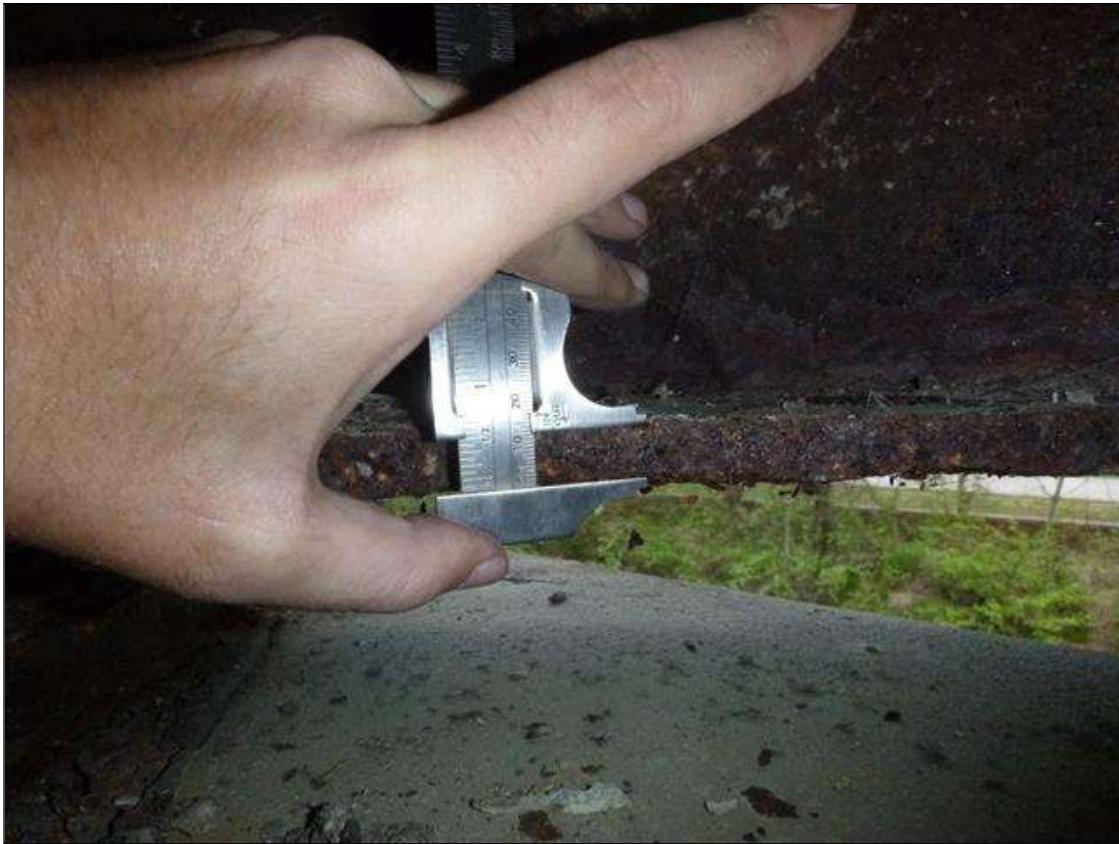
Span 2 Beam 8: 20" OF CORROSION WITH SECTION LOSS, 9/16" REMAINING AT 1' FROM BEARING, AT BENT 2. (PM)

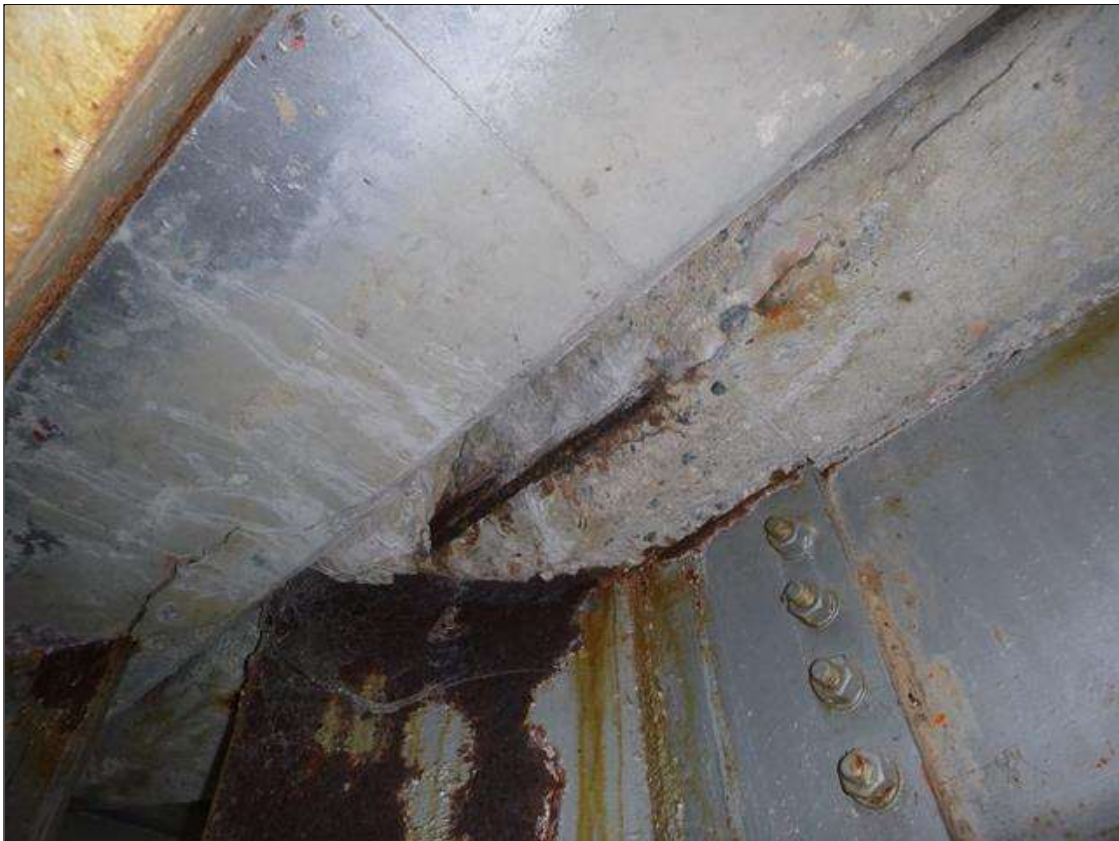
Superstructure : 3' X 10" X 8" SPALL WITH EXPOSED REINFORCING, SPAN 2 CONCRETE END DIAPHRAGM, BAY 7, NEXT TO BEAM 8, AT BENT 2.

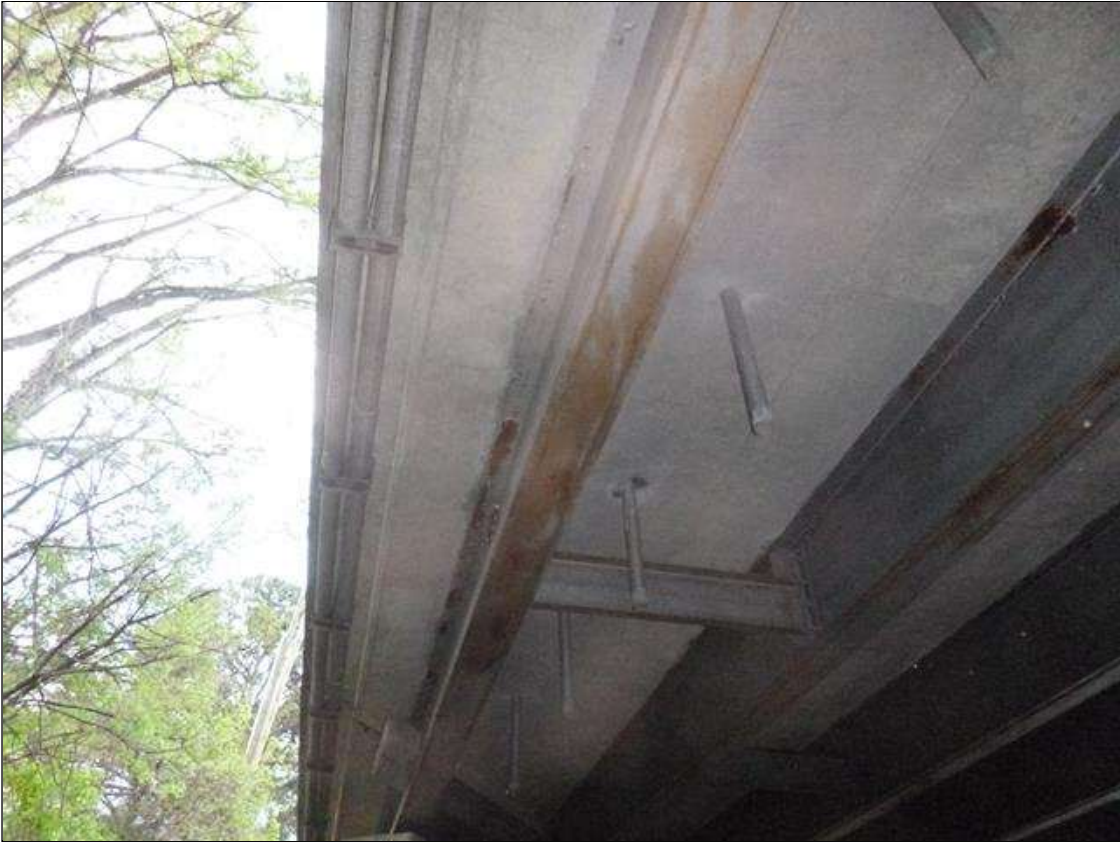
Span 3 Beam 1: 5% OF SURFACE AREA HAS CORROSION WITH RUST SCALE ALONG UNDERSIDE OF TOP AND BOTTOM FLANGES.

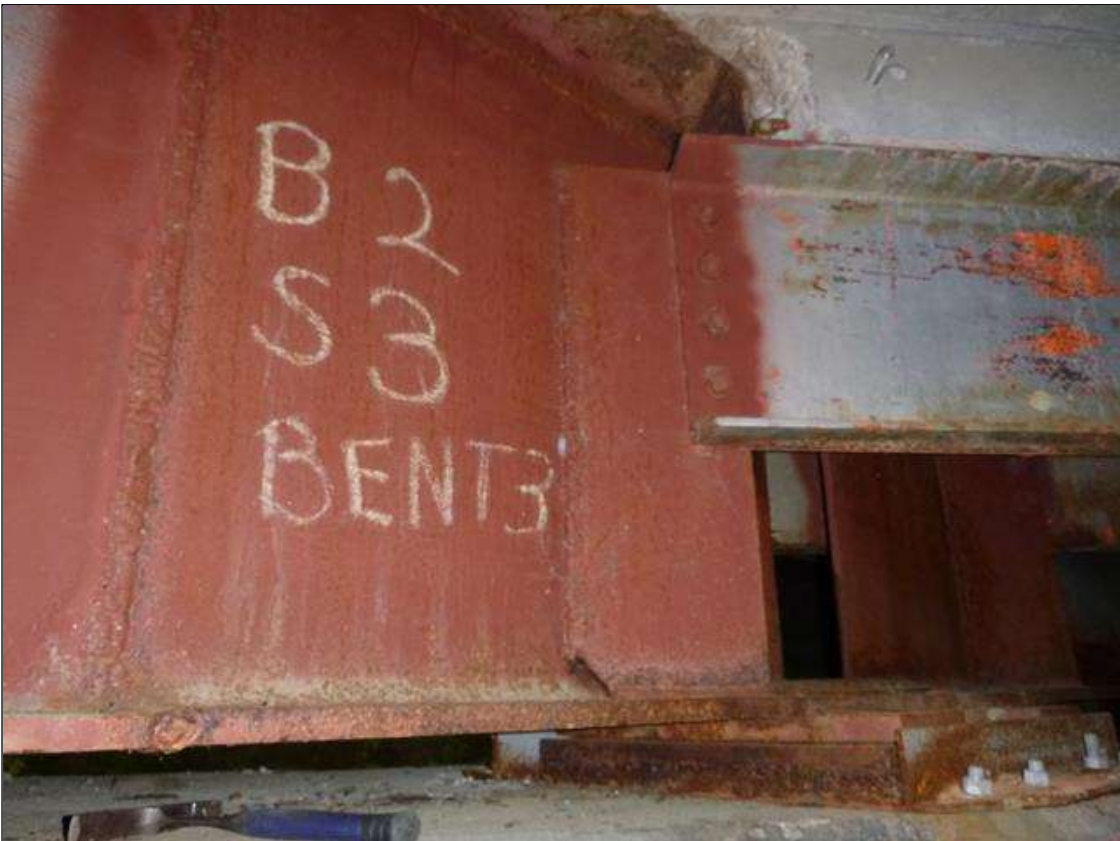
Span 3 Beam 2: TEMPORARY REPAIR TO WEB, BOTTOM FLANGE, BEARING STIFFENER, AND NEW BEARING ASSEMBLY AT BENT 3.

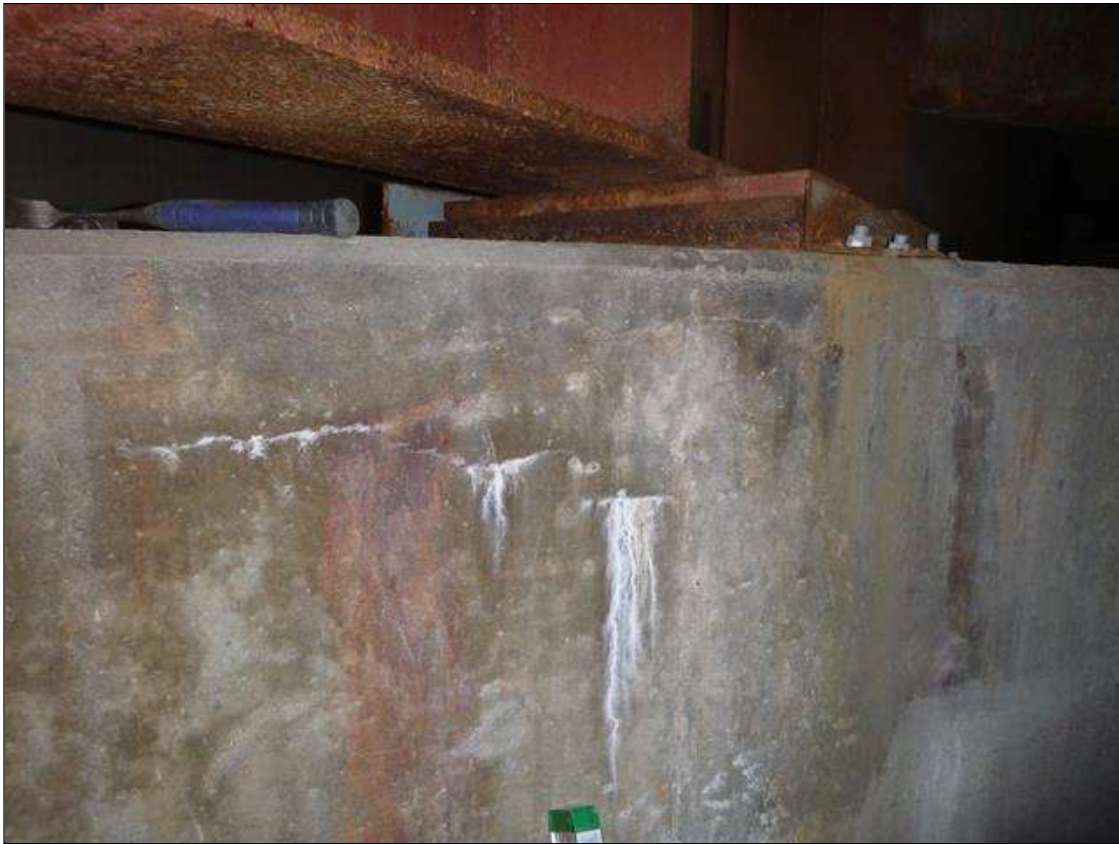
Bent 3 Cap : 4' HORIZONTAL CRACK WITH EFFLORESCENCE, SOUTH FACE, BELOW BEAM 2.

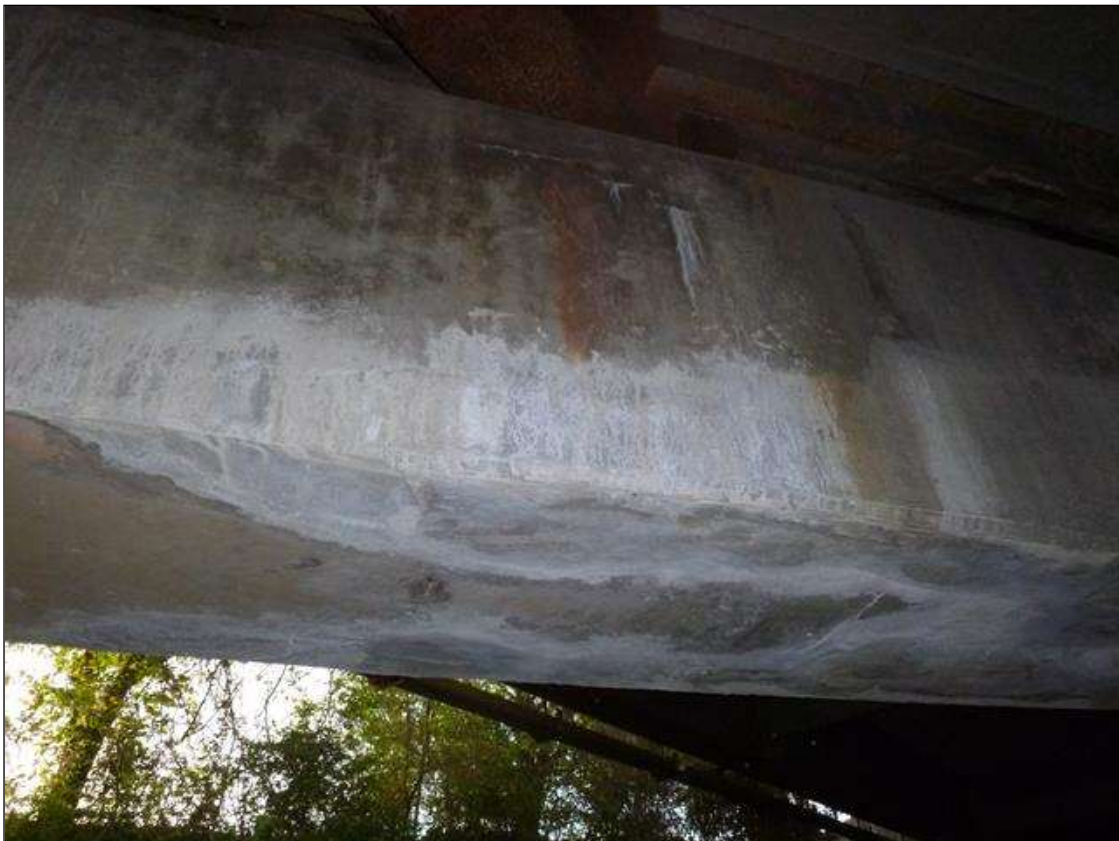
Bent 3 Cap : 3.5' X 8" X 6" TEMPORARY REPAIR, BOTTOM CORNER OF SOUTH FACE, BELOW BEAM 2.

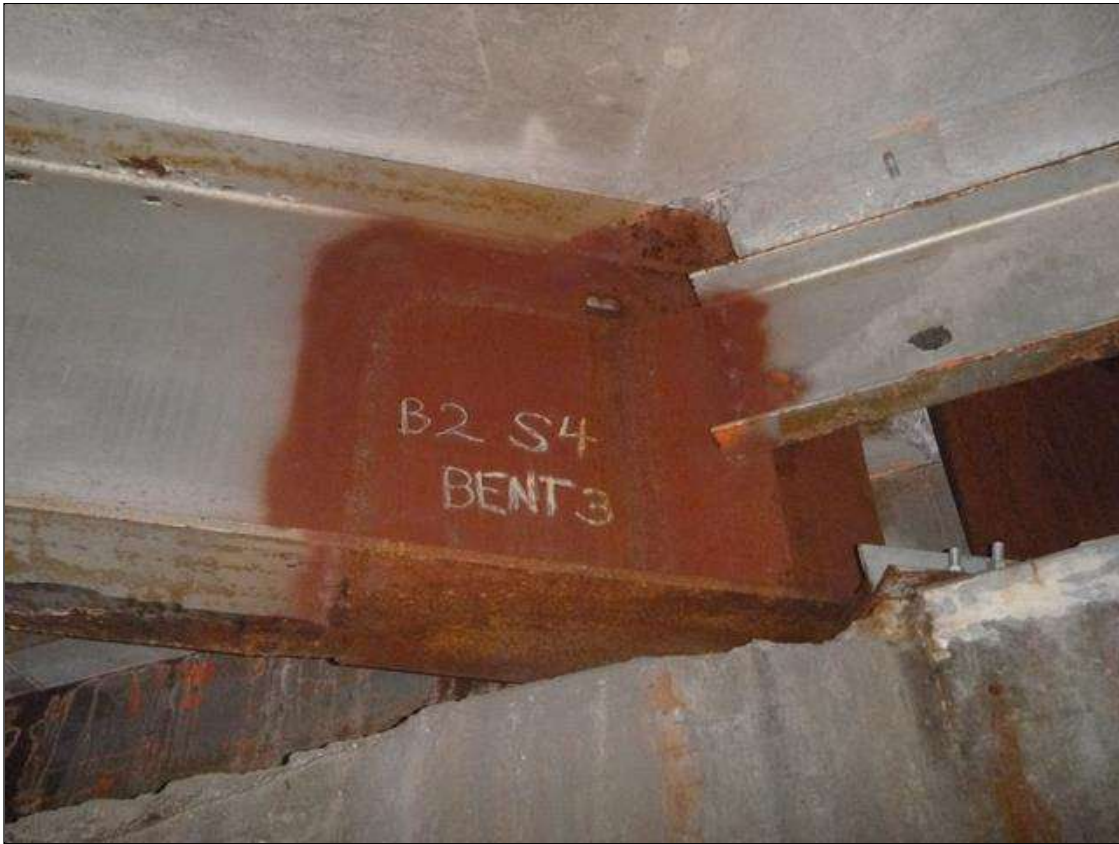
Span 4 Beam 2: TEMPORARY REPAIR TO BOTTOM FLANGE, WEB, BEARING STIFFENER, AND BEARING ASSEMBLY AT BENT 3.

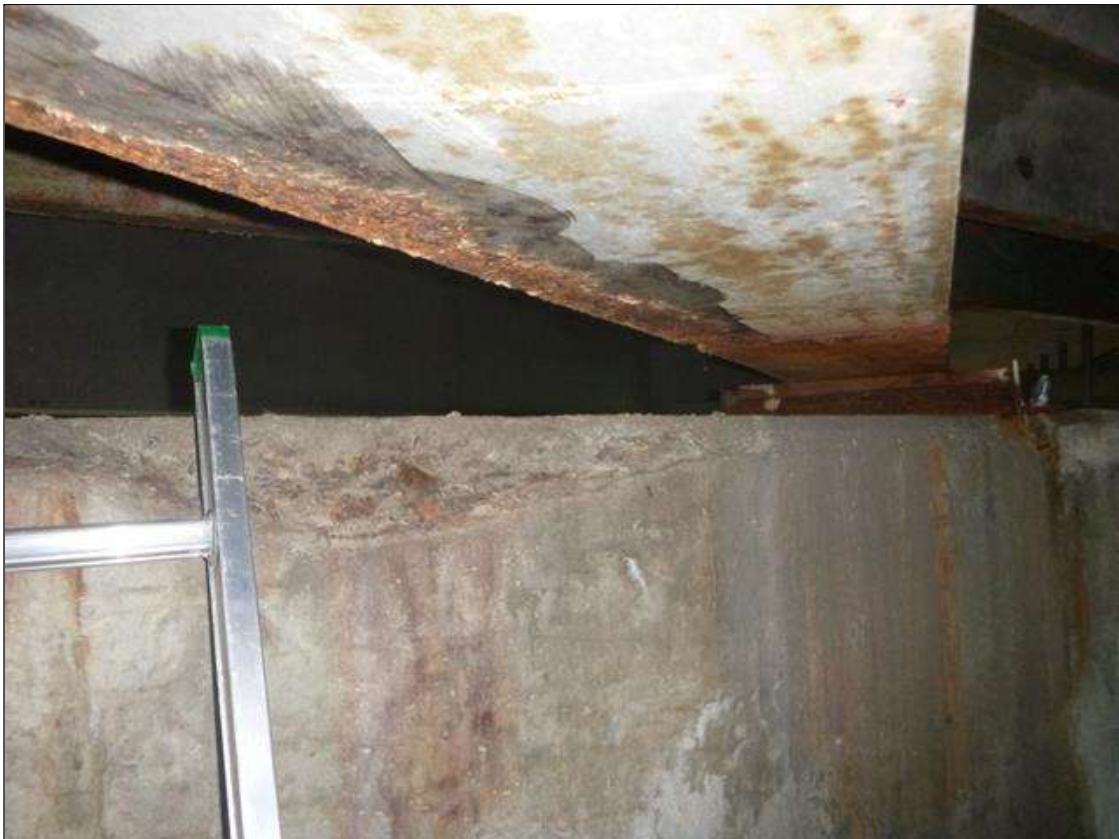
Bent 3 Cap : 72" X 5" X 4" SPALL WITH EXPOSED REINFORCING, TOP CORNER OF NORTH FACE, BELOW BEAM 2.

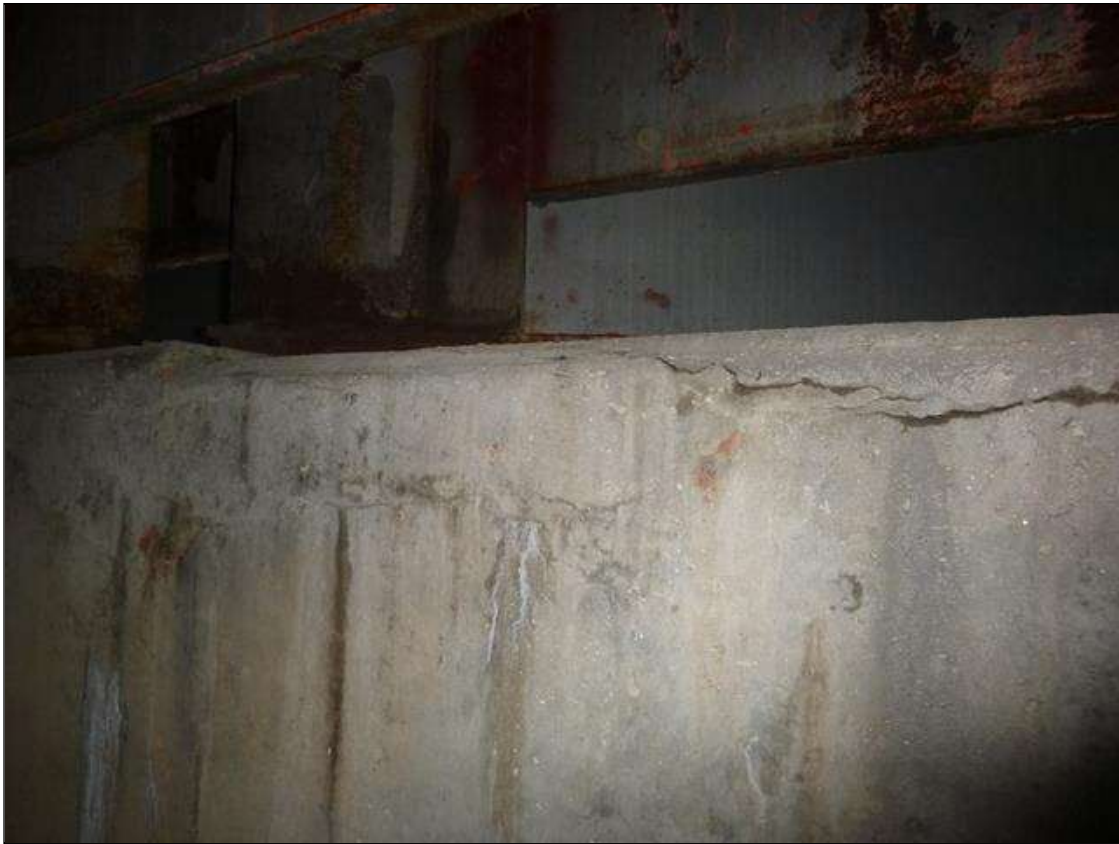
Bent 3 Cap : 4' X 8" TEMPORARY REPAIR, TOP CORNER OF NORTH FACE, ABOVE COLUMN 2.

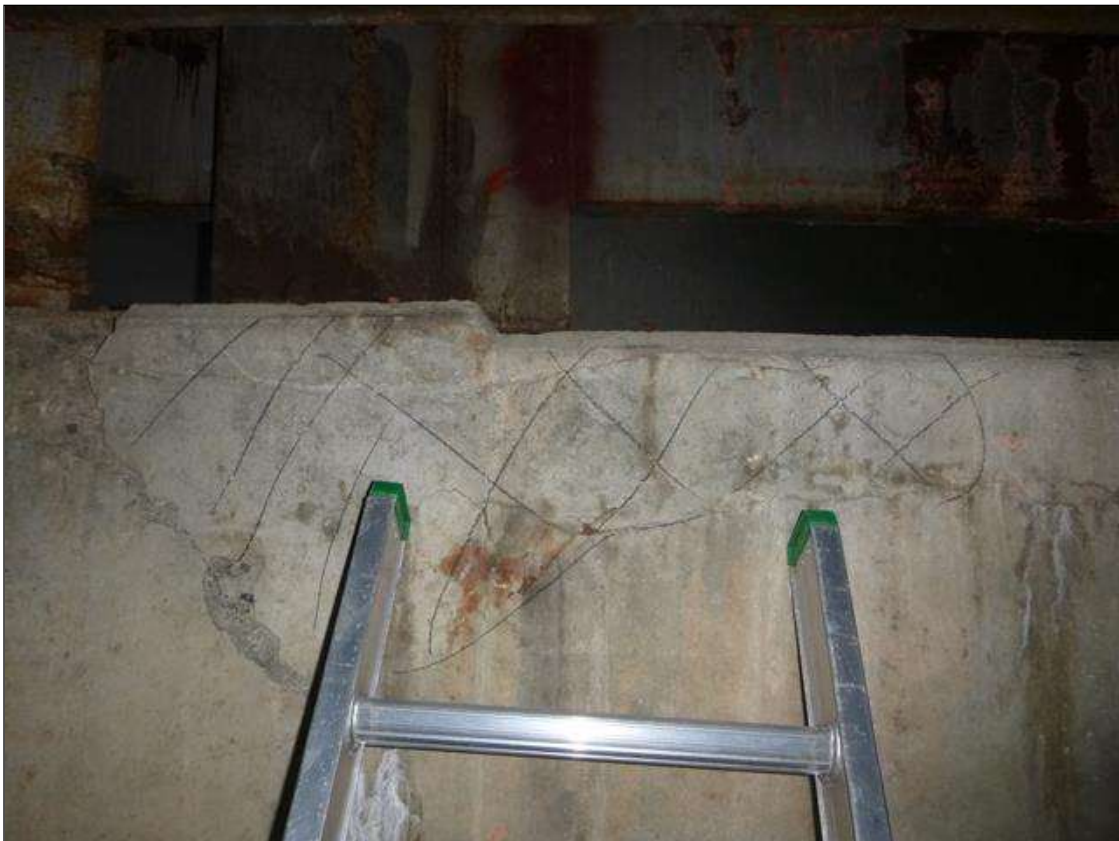
Bent 3 Cap : 32" X 15" OF TEMPORARY REPAIR IS DELAMINATED WITH RUST SCALE, NORTH FACE, ABOVE COLUMN 2.

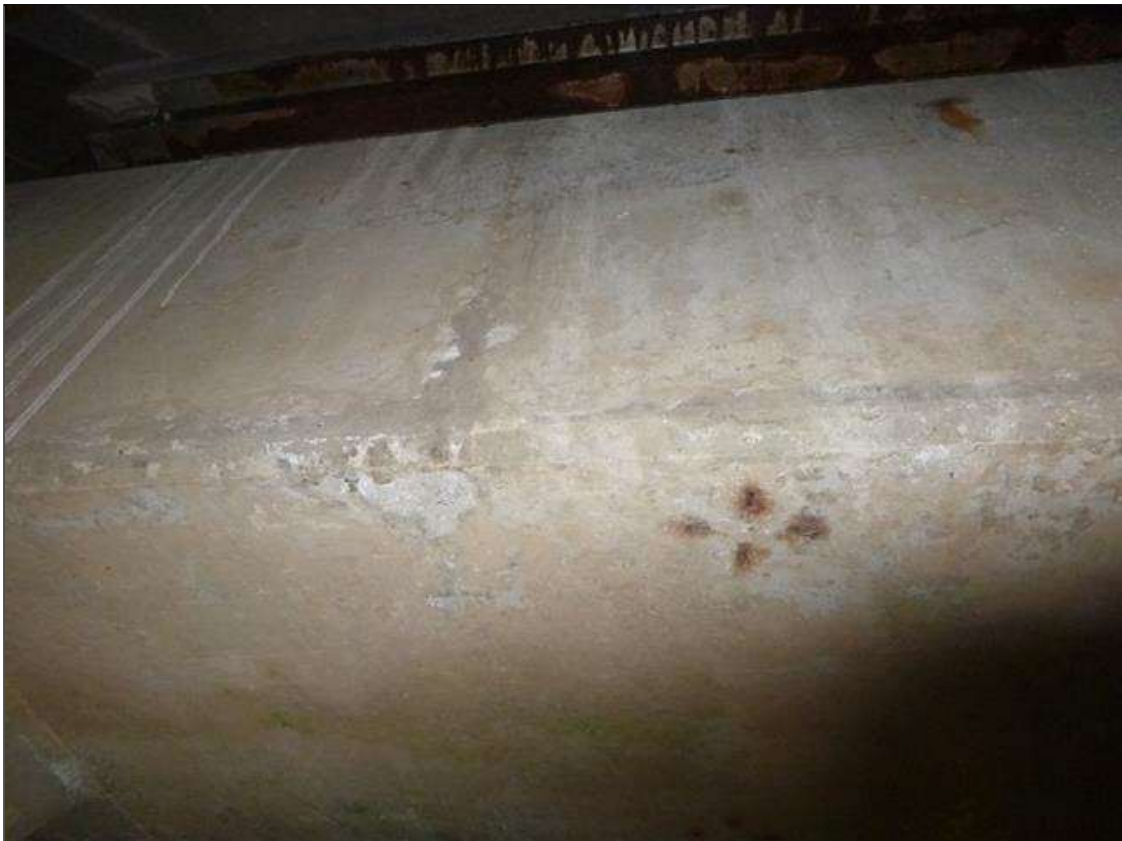
Bent 3 Cap : 24" HORIZONTAL CRACK UP TO 1/16", UNDERSIDE OF CAP, 3' FROM COLUMN 4, BETWEEN COLUMNS 4 AND 5.

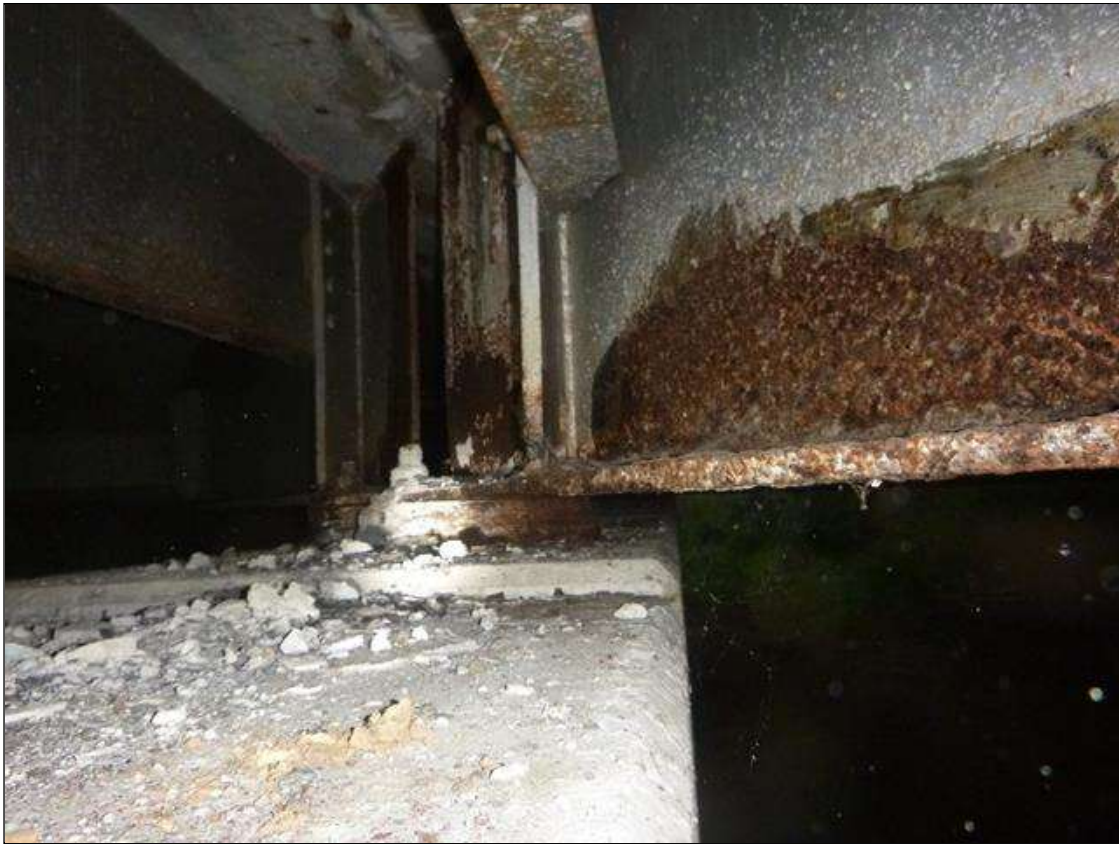
Span 4 Beam 6: 5' OF CORROSION WITH SECTION LOSS, 1/2" REMAINING ALONG BOTTOM FLANGE, 16" FROM BENT 3 BEARING. (PM)

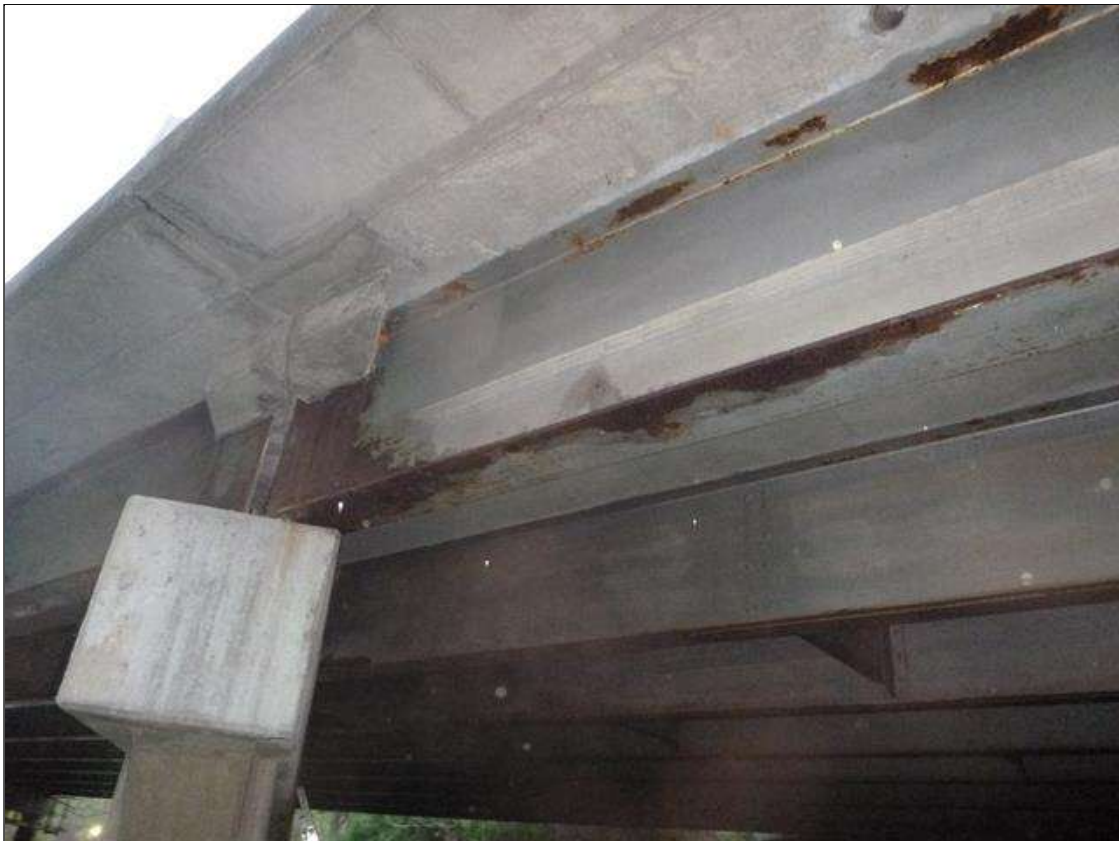
Span 4 Beam 8: 10' OF CORROSION WITH RUST SCALE ALONG BOTTOM FLANGE, EXTENDING 35" INTO WEB, AT BENT 3.

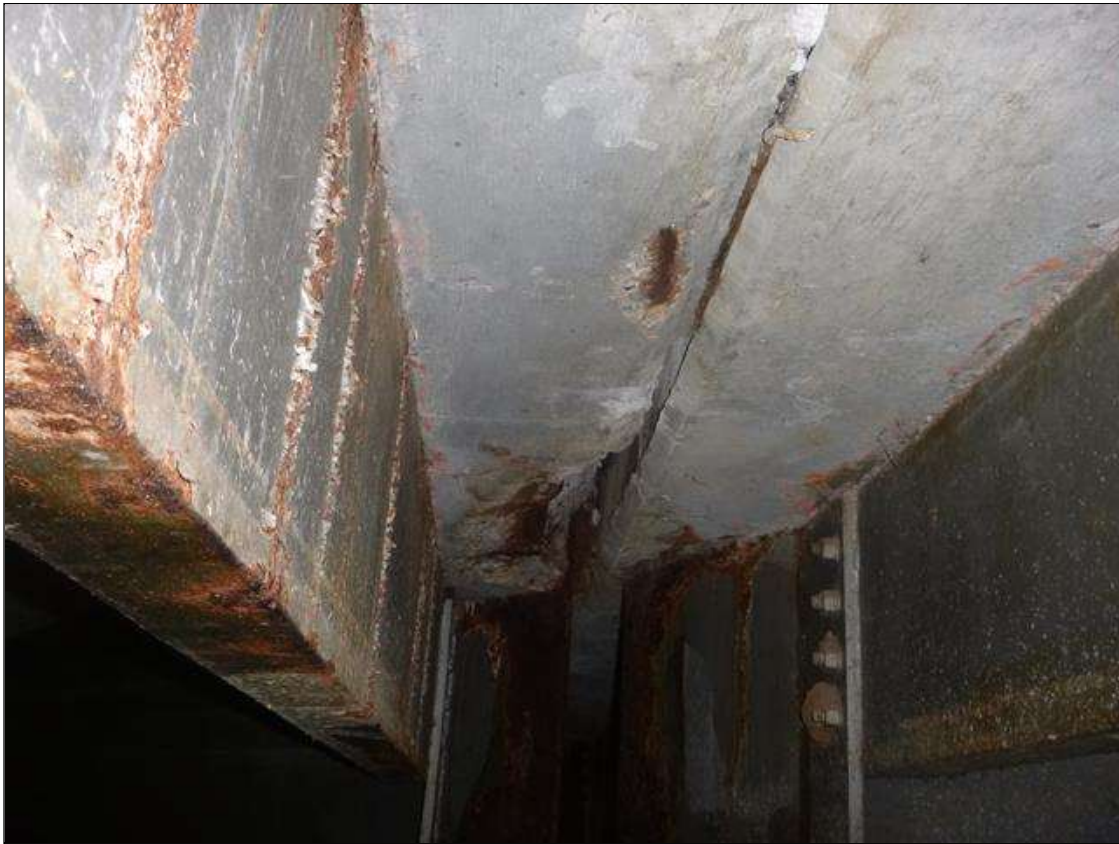
Superstructure : 3' X 10" X 10" SPALL WITH EXPOSED REINFORCING, SPAN 4 CONCRETE END DIAPHRAGM, BETWEEN BEAMS 6 AND 7, AT BENT 3.

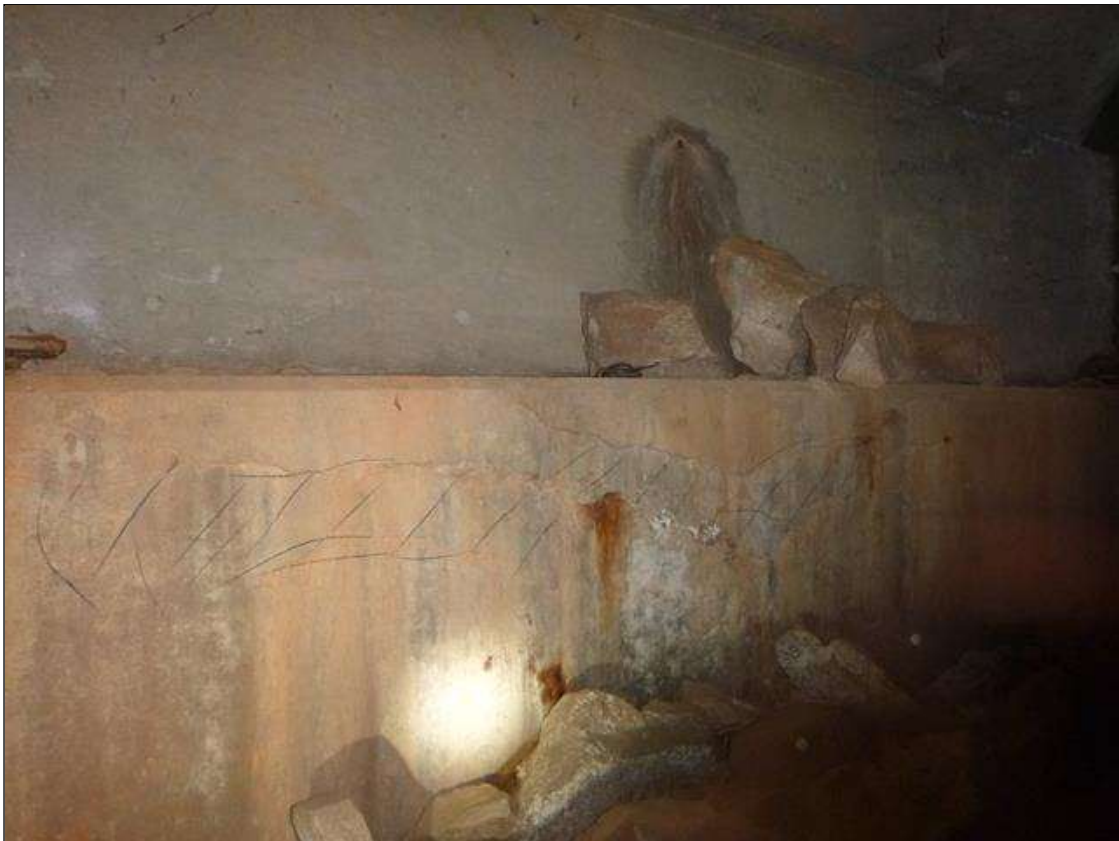
End Bent 2 Cap : 60" X 9" X 1" DELAMINATION/SPALL, SOUTH FACE, BETWEEN BEAMS 1 AND 2.

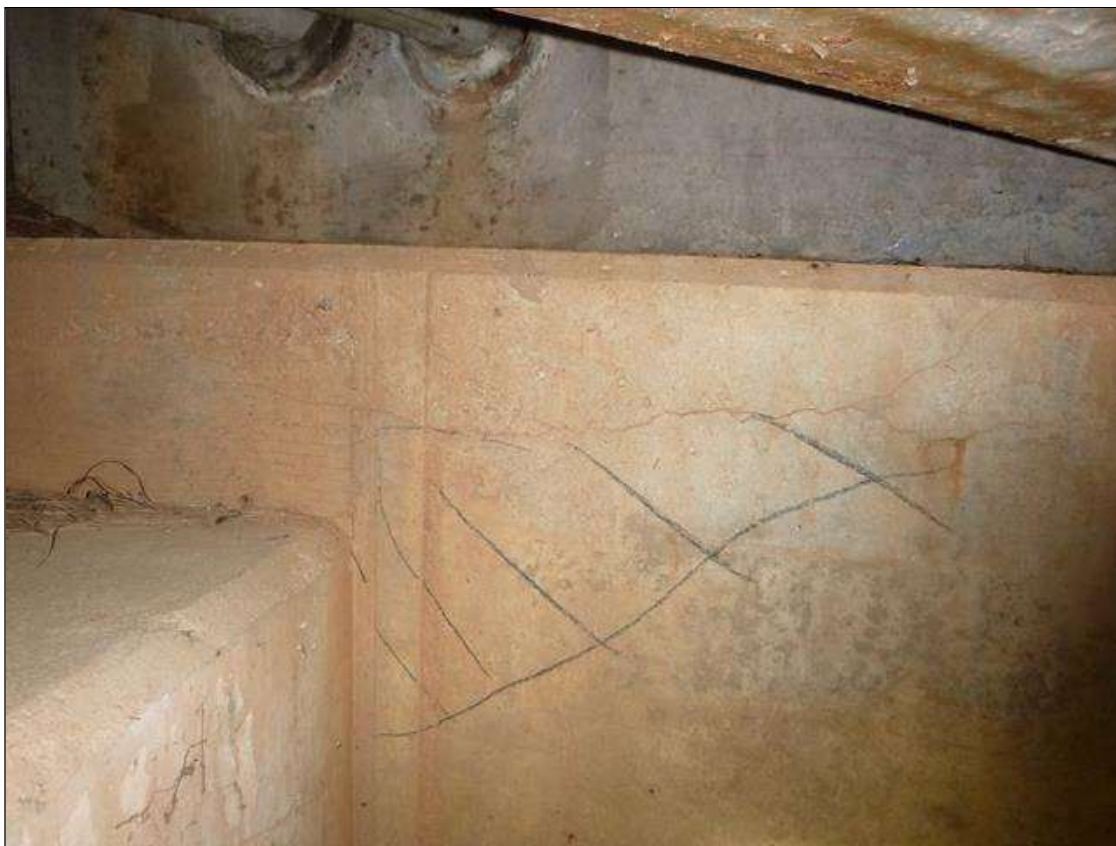
End Bent 2 Cap : 19" X 11" DELAMINATION, SOUTH FACE, BELOW BEAM 1.

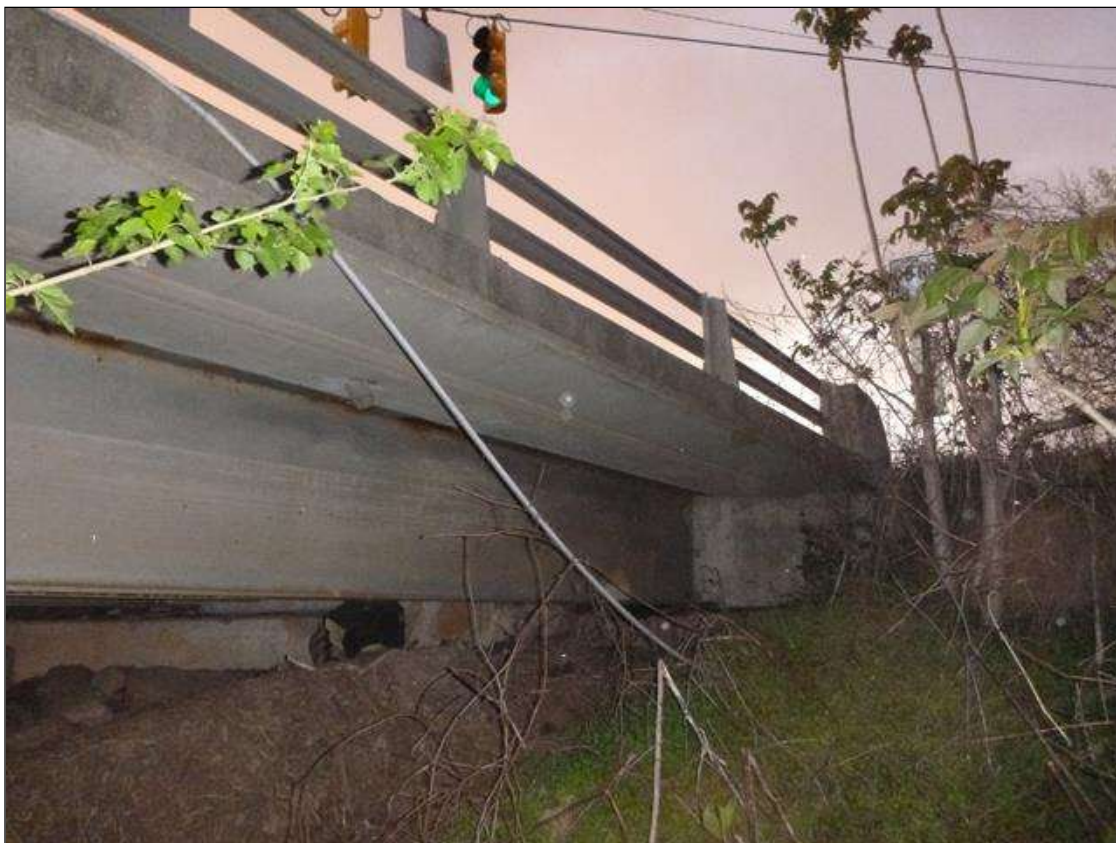
Utilities : BROKEN UTILITY CONDUIT, RIGHT OVERHANG, SPAN 4.

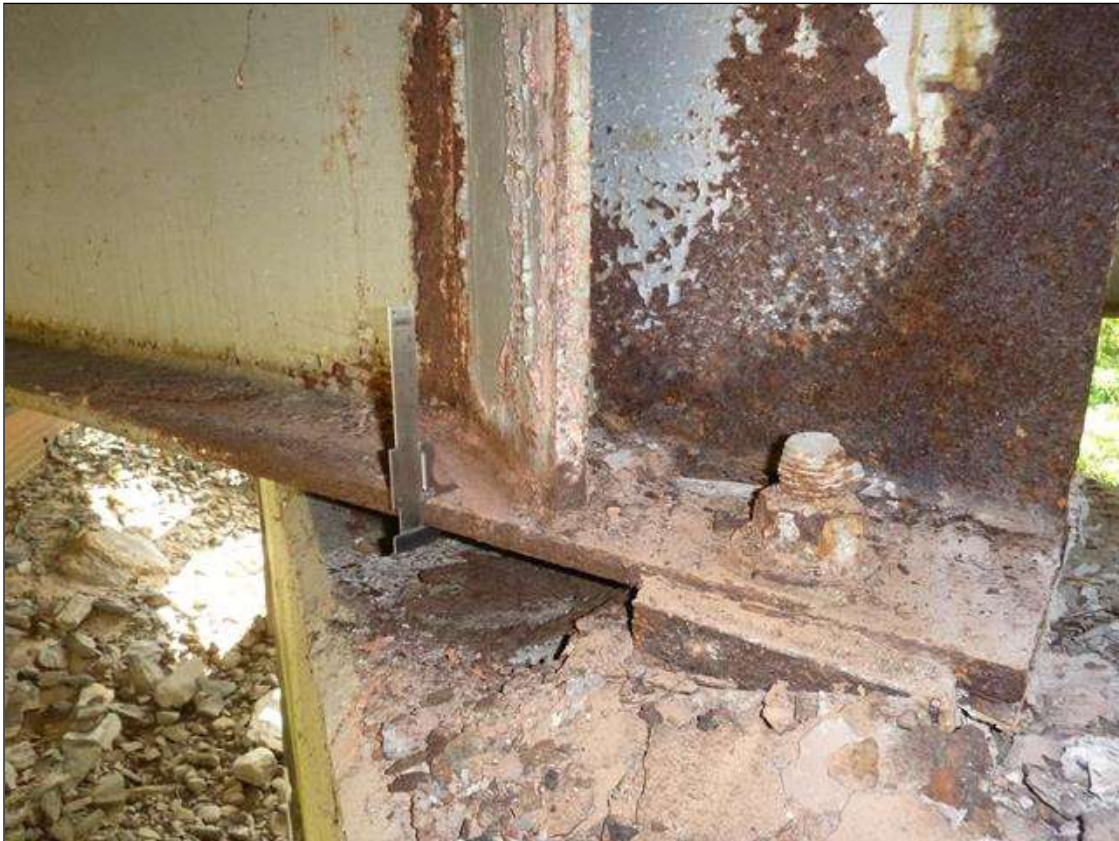
| MMS Code | Description of Function | Unit | Quantity | Remarks | Est. Cost |
|---|---|---|---|---|---|
| 3314 | Maintain Steel Superstructure Components | LF | 2 | SPAN 1 BEAM 6: 2' OF CORROSION WITH SECTION LOSS, 11/16" REMAINING ALONG BOTTOM FLANGE, AT BENT 1. | |

SPAN 1 BEAM 6: 2' OF CORROSION WITH SECTION LOSS, 11/16" REMAINING ALONG BOTTOM FLANGE, AT BENT 1.

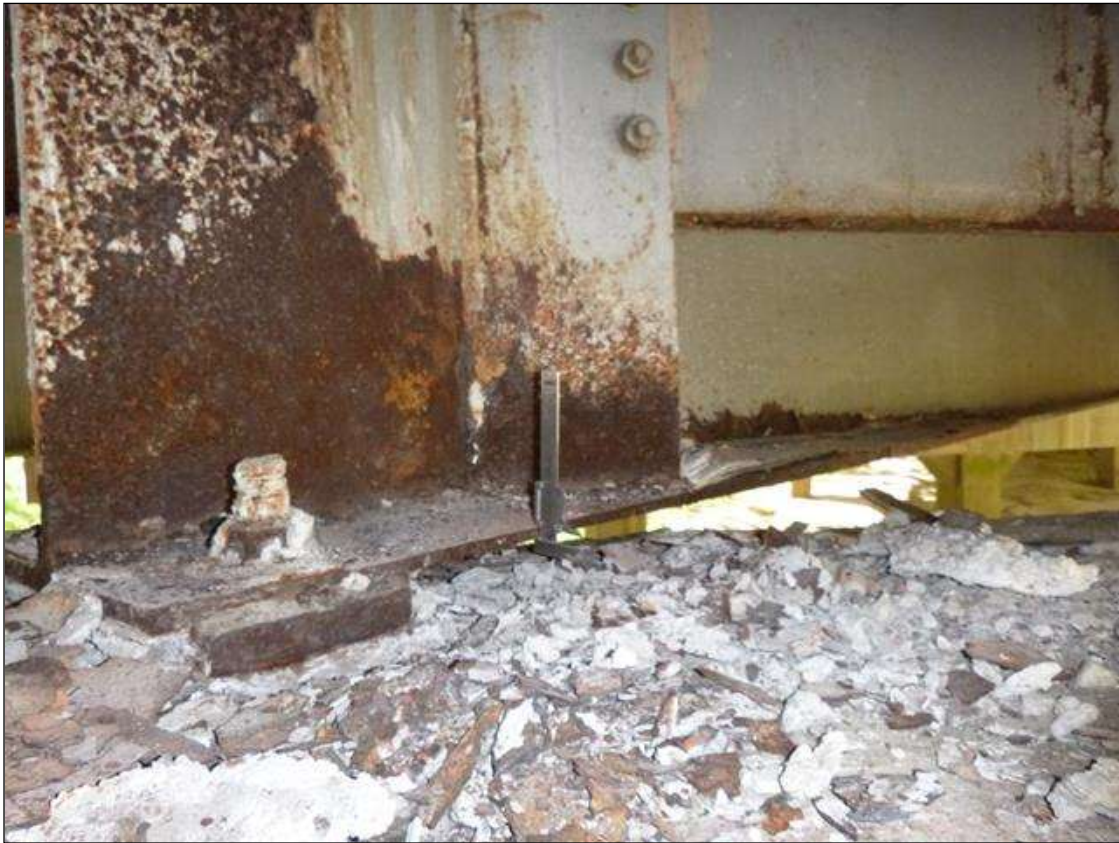
| MMS Code | Description of Function | Unit | Quantity | Remarks | Est. Cost |
|---|---|---|---|---|---|
| 3314 | Maintain Steel Superstructure Components | LF | 8 | SPAN 2 BEAM 6: 7.5' OF CORROSION WITH SECTION LOSS, 3/8" REMAINING ALONG BOTTOM FLANGE, EXTENDING UP TO 12" INTO WEB, AT BENT 1. | |

SPAN 2 BEAM 6: 7.5' OF CORROSION WITH SECTION LOSS, 3/8" REMAINING ALONG BOTTOM FLANGE, EXTENDING UP TO 12" INTO WEB, AT BENT 1.
