NC DEPARTMENT OF TRANSPORTATION  
DIVISION OF HIGHWAYS  
STRUCTURE MANAGEMENT UNIT

## Structure Safety Report

### Routine Element Inspection - Contract

COUNTY: WAKE STRUCTURE NUMBER: 910494 FREQUENCY: 24 MONTHS

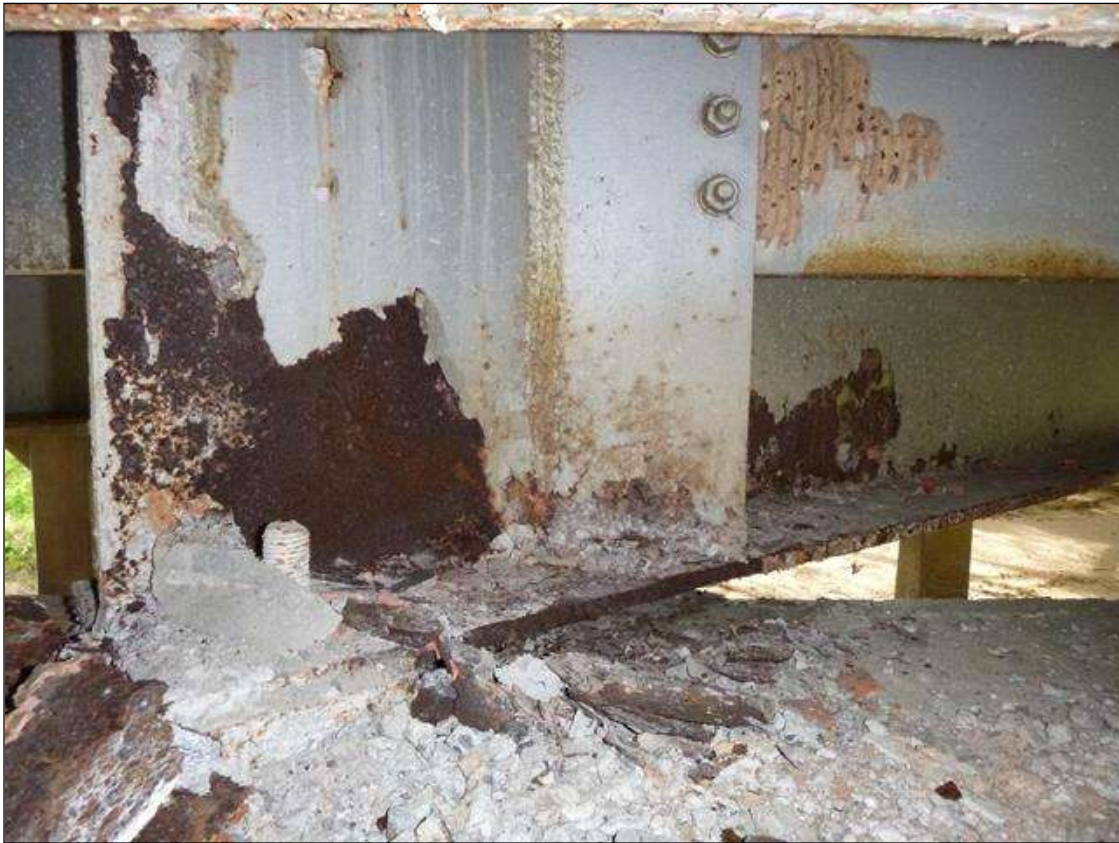
| MMS Code | Description of Function | Unit | Quantity | Remarks | Est. Cost |
|---|---|---|---|---|---|
| 3314 | Maintain Steel Superstructure Components | LF | 5 | SPAN 2 BEAM 7: 5' OF CORROSION WITH SECTION LOSS, 5/8" REMAINING, ALONG BOTTOM FLANGE EXTENDING 6" INTO WEB, AT BENT 1. | |

SPAN 2 BEAM 7: 5' OF CORROSION WITH SECTION LOSS, 5/8" REMAINING, ALONG BOTTOM FLANGE  
EXTENDING 6" INTO WEB, AT BENT 1.

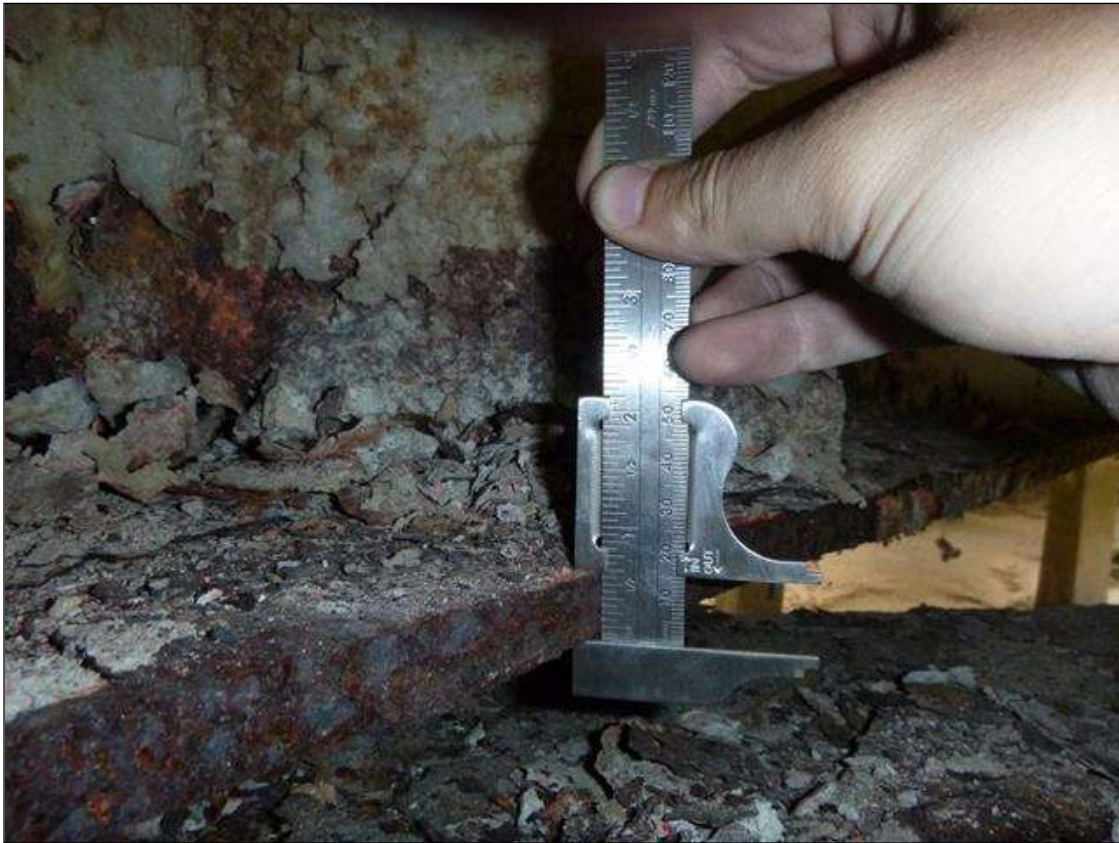
SPAN 2 BEAM 7: 5' OF CORROSION WITH SECTION LOSS, 5/8" REMAINING, ALONG BOTTOM FLANGE  
EXTENDING 6" INTO WEB, AT BENT 1.

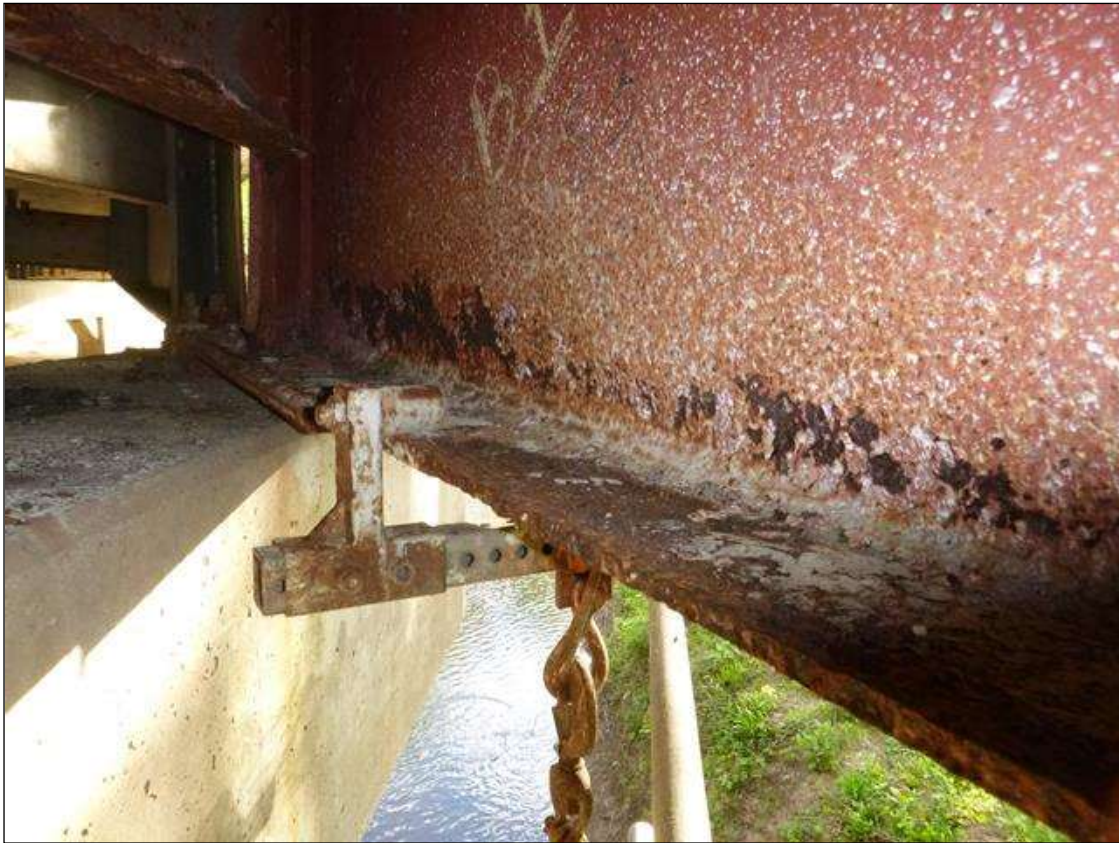
| MMS Code | Description of Function | Unit | Quantity | Remarks | Est. Cost |
|---|---|---|---|---|---|
| 3314 | Maintain Steel Superstructure Components | LF | 5 | SPAN 3 BEAM 1: 5' OF CORROSION WITH SECTION LOSS, 7/16" REMAINING ALONG BOTTOM FLANGE, 4.5' FROM BENT 2 BEARING. | |

SPAN 3 BEAM 1: 5' OF CORROSION WITH SECTION LOSS, 7/16" REMAINING ALONG BOTTOM FLANGE, 4.5' FROM BENT 2 BEARING.

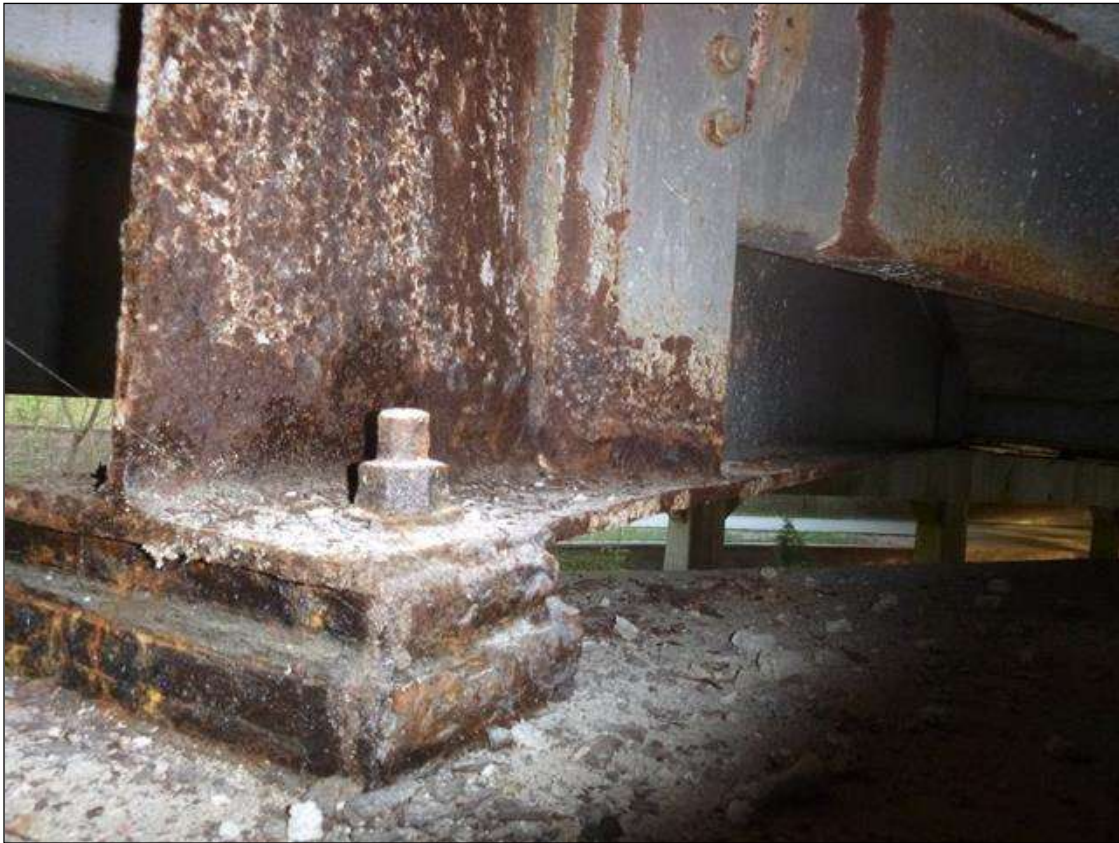
| MMS Code | Description of Function | Unit | Quantity | Remarks | Est. Cost |
|---|---|---|---|---|---|
| 3314 | Maintain Steel Superstructure Components | LF | 4 | SPAN 2 BEAM 6: 4' OF CORROSION WITH SECTION LOSS, 1/2" REMAINING ALONG BOTTOM FLANGE WITH PITTING IN WEB, 8" FROM BEARING, AT BENT 2. | |

SPAN 2 BEAM 6: 4' OF CORROSION WITH SECTION LOSS, 1/2" REMAINING ALONG BOTTOM FLANGE WITH PITTING IN WEB, 8" FROM BEARING, AT BENT 2.

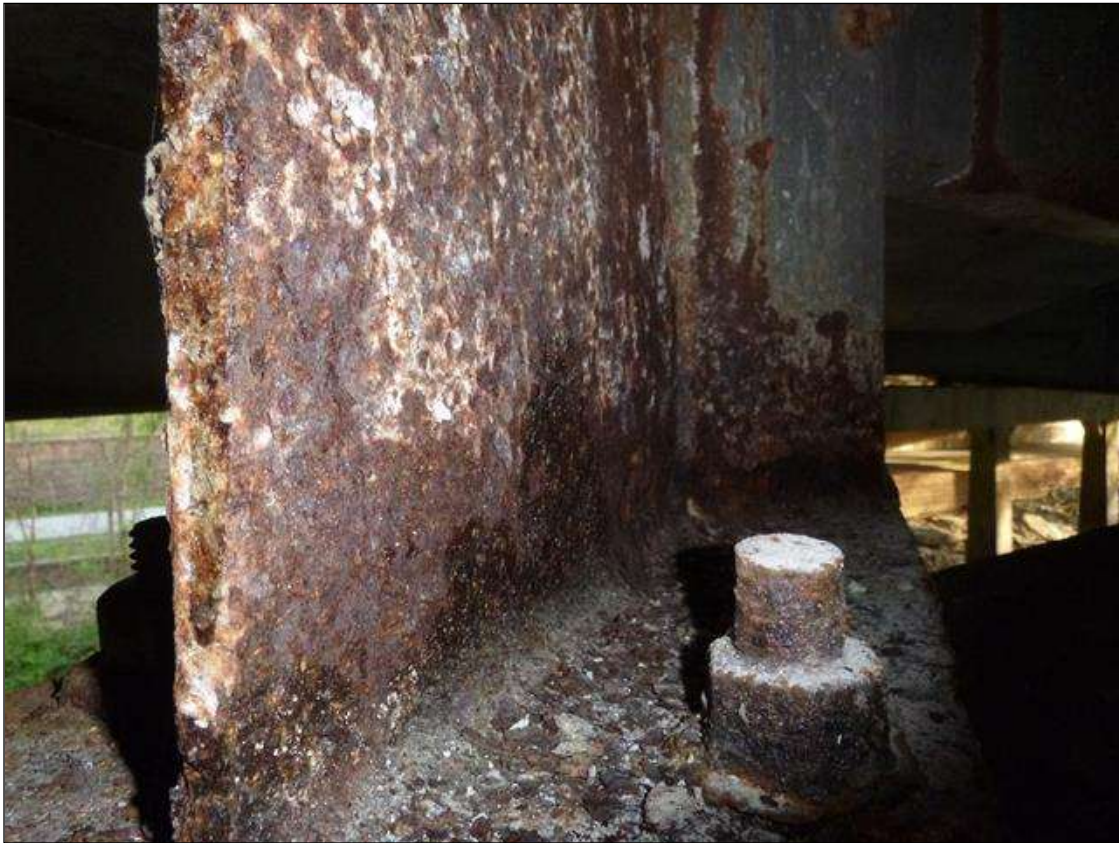
SPAN 2 BEAM 6: 4' OF CORROSION WITH SECTION LOSS, 1/2" REMAINING ALONG BOTTOM FLANGE WITH PITTING IN WEB, 8" FROM BEARING, AT BENT 2.

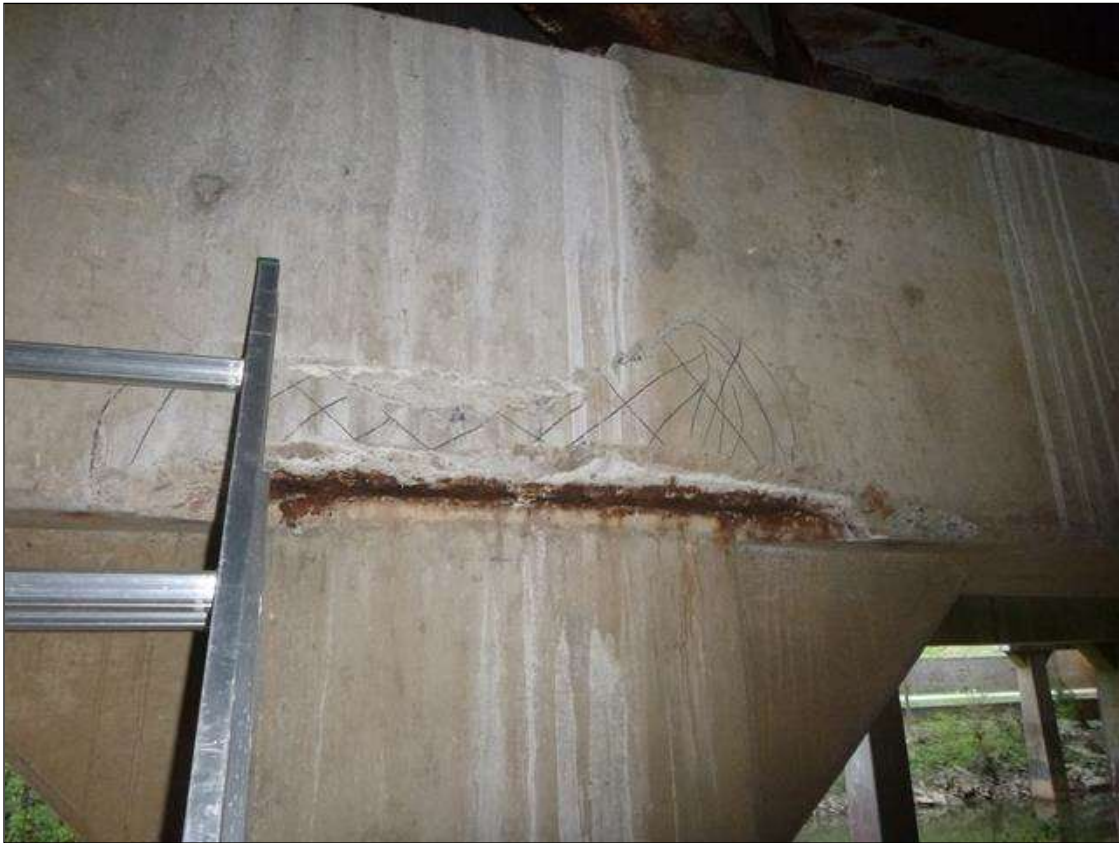
| MMS Code | Description of Function | Unit | Quantity | Remarks | Est. Cost |
|---|---|---|---|---|---|
| 3348 | Maintain Concrete Substructure Components | LF | 4 | BENT 3 CAP : 48" X 15" X 4" DELAMINATION/SPALL WITH EXPOSED MAIN REINFORCING, BOTTOM CORNER OF NORTH FACE, ABOVE COLUMN 4. | |

BENT 3 CAP : 48" X 15" X 4" DELAMINATION/SPALL WITH EXPOSED MAIN REINFORCING, BOTTOM CORNER OF NORTH FACE, ABOVE COLUMN 4.

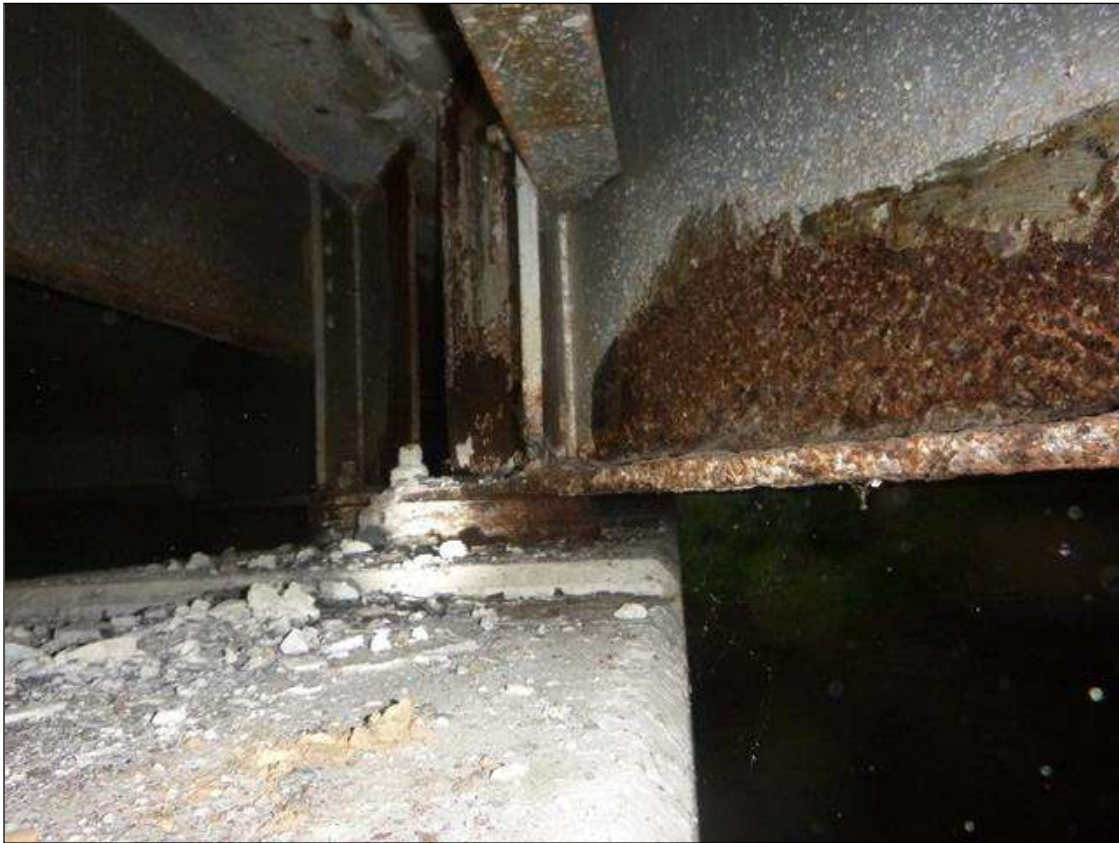
| MMS Code | Description of Function | Unit | Quantity | Remarks | Est. Cost |
|---|---|---|---|---|---|
| 3314 | Maintain Steel Superstructure Components | LF | 5 | SPAN 4 BEAM 6: 5' OF CORROSION WITH SECTION LOSS, 1/2" REMAINING ALONG BOTTOM FLANGE, 16" FROM BENT 3 BEARING. | |

SPAN 4 BEAM 6: 5' OF CORROSION WITH SECTION LOSS, 1/2" REMAINING ALONG BOTTOM FLANGE, 16" FROM BENT 3 BEARING.

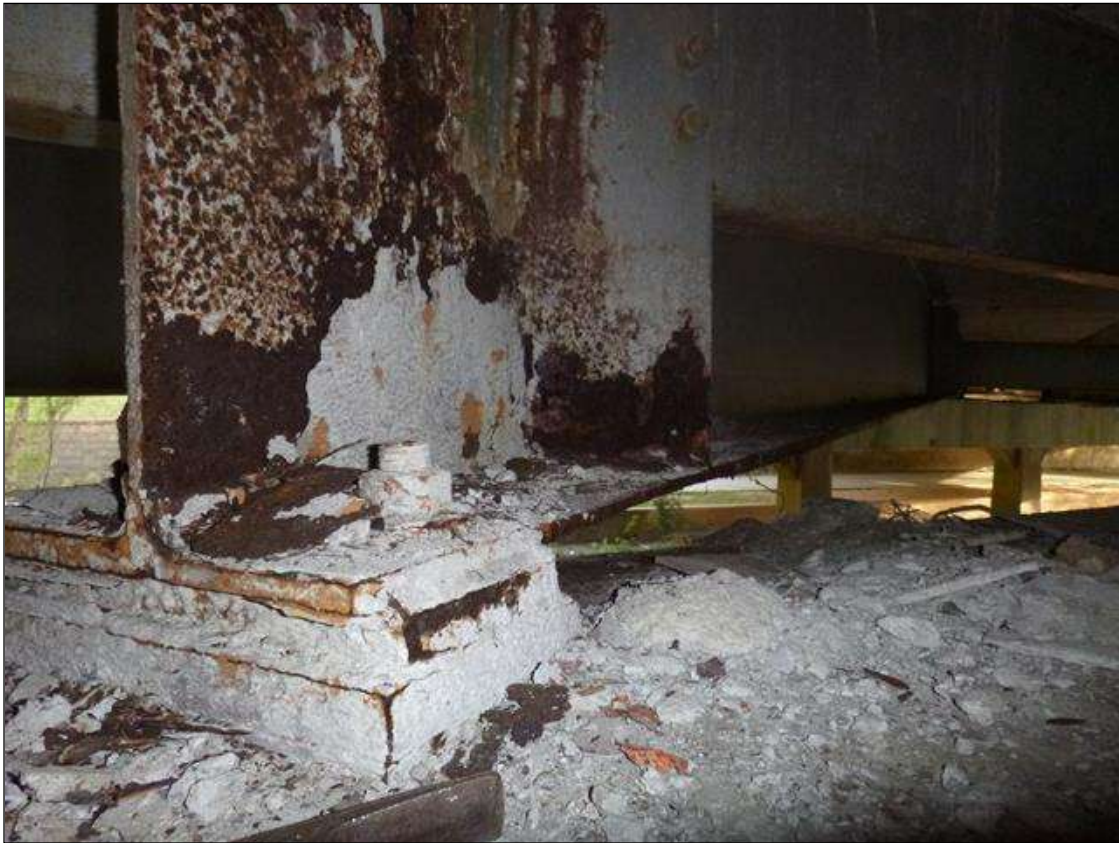
| MMS Code | Description of Function | Unit | Quantity | Remarks | Est. Cost |
|---|---|---|---|---|---|
| 3314 | Maintain Steel Superstructure Components | LF | 5 | SPAN 2 BEAM 5: 5' OF CORROSION WITH SECTION LOSS, 3/8" REMAINING ALONG BOTTOM FLANGE, 1' FROM BENT 2 BEARING. | |

SPAN 2 BEAM 5: 5' OF CORROSION WITH SECTION LOSS, 3/8" REMAINING ALONG BOTTOM FLANGE, 1' FROM BENT 2 BEARING.

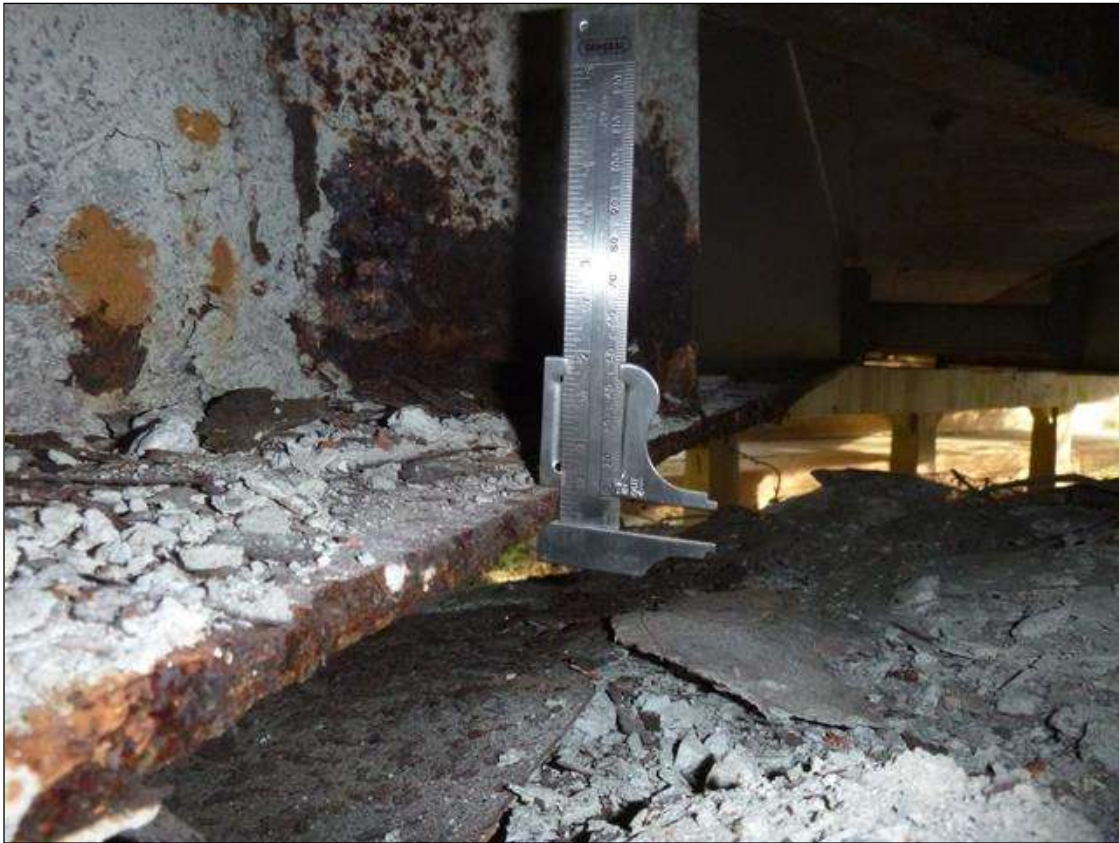
SPAN 2 BEAM 5: 5' OF CORROSION WITH SECTION LOSS, 3/8" REMAINING ALONG BOTTOM FLANGE, 1' FROM BENT 2 BEARING.
