NC DEPARTMENT OF TRANSPORTATION
DIVISION OF HIGHWAYS
STRUCTURE MANAGEMENT UNIT

Structure Safety Report

Routine Element Inspection - Contract

FACILITY CARRIED: I-40 MILE POST: 29.3

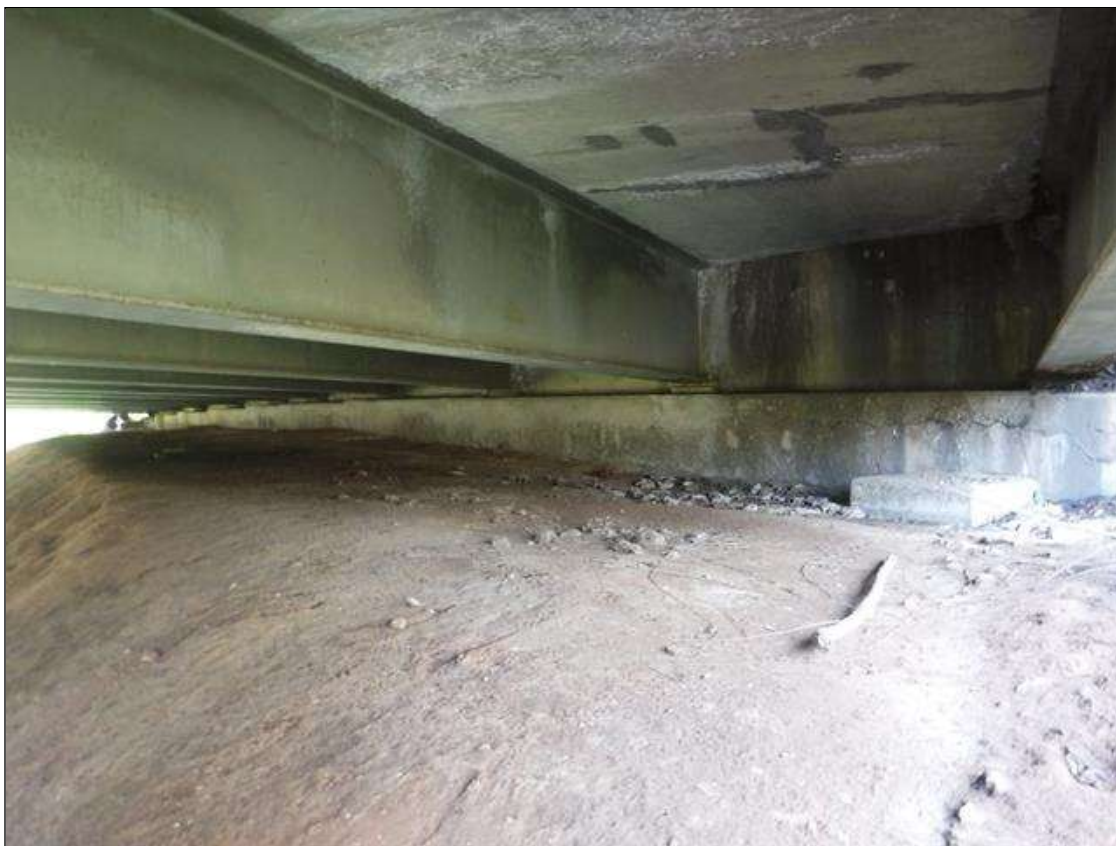
Bent 1 Cap 1: PAR: UP TO 64" X 42" X 3" DEEP SPALLS WITH EXPOSED REBAR, 16' X 24" AREAS OF DELAMINATION AND UP TO 1 1/2" LONGITUDINAL, TRANSVERSE, DIAGONAL AND HORIZONTAL CRACKS IN TOP, BOTTOM, RIGHT END AND BOTH FACES OF CAP FROM BENEATH BEAM 8 TO RIGHT END, CONDITION IN SPAN 2 FACE SHOWN

END BENT 1, END BENT 2 SIMILAR

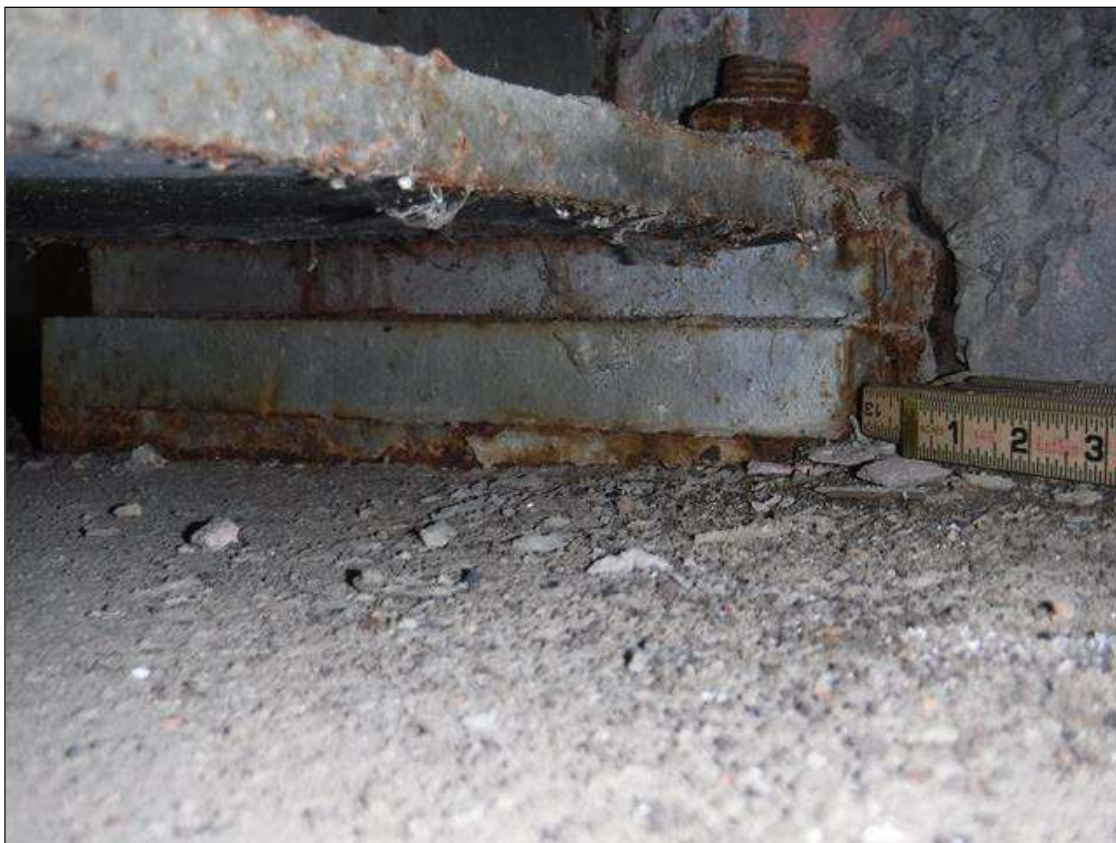
BEAM 3 BEARING AT END BENT 2, OTHERS SIMILAR AT END BENTS

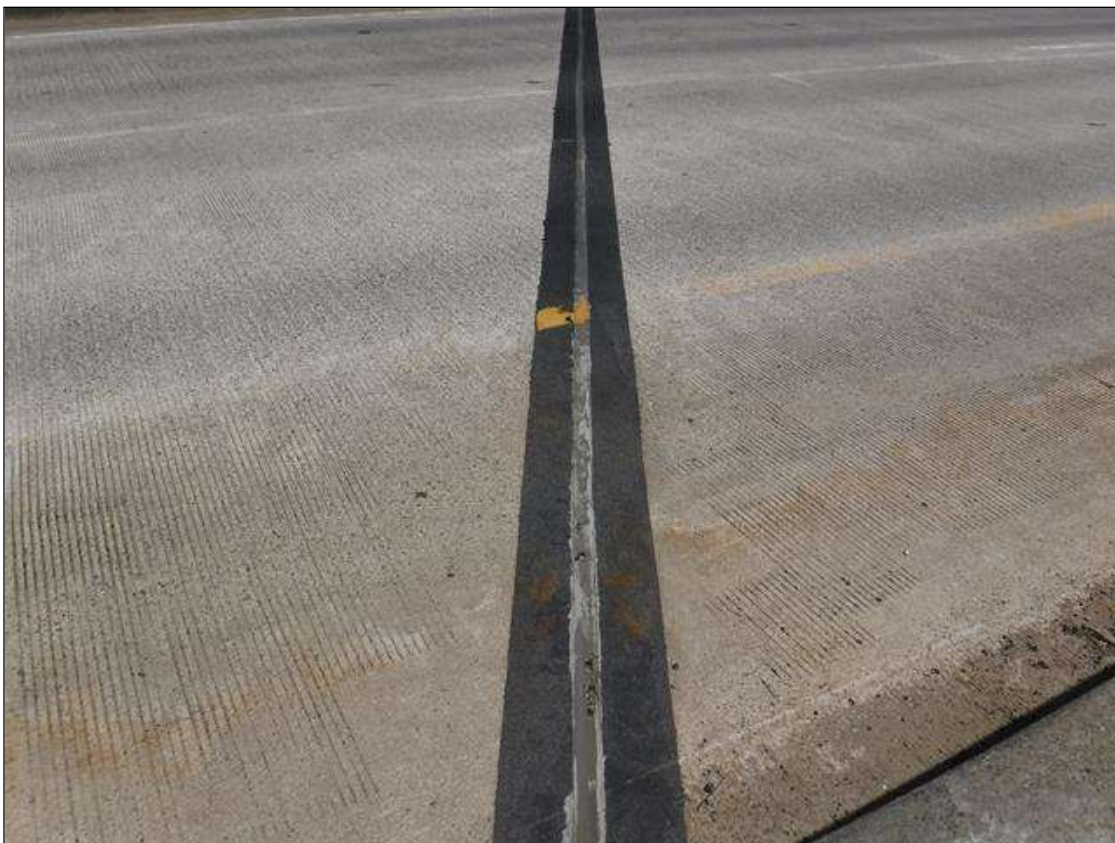
BENT 3 JOINT IN WESTBOUND LANES, BENT 2 JOINT SIMILAR

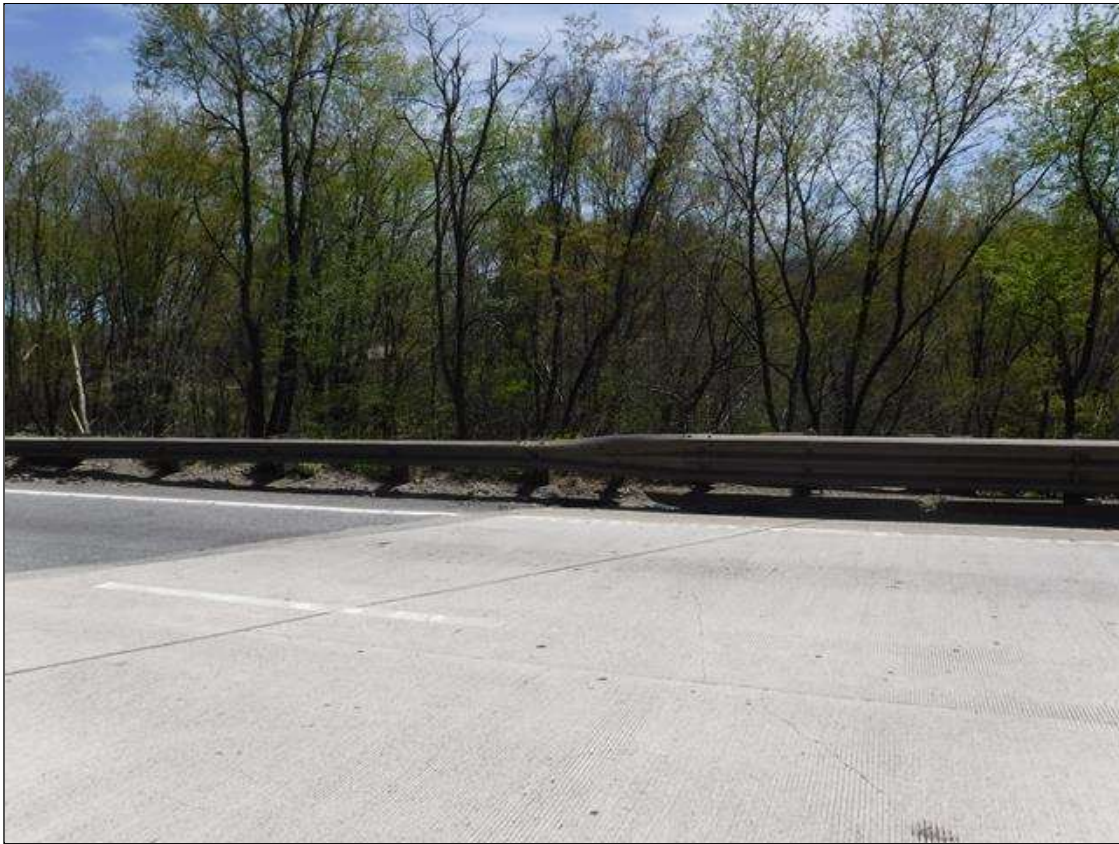
GUARDRAIL TO BARRIER RAIL TRANSITION AT SOUTHEAST CORNER, NORTHEAST AND SOUTHWEST CORNERS SIMILAR

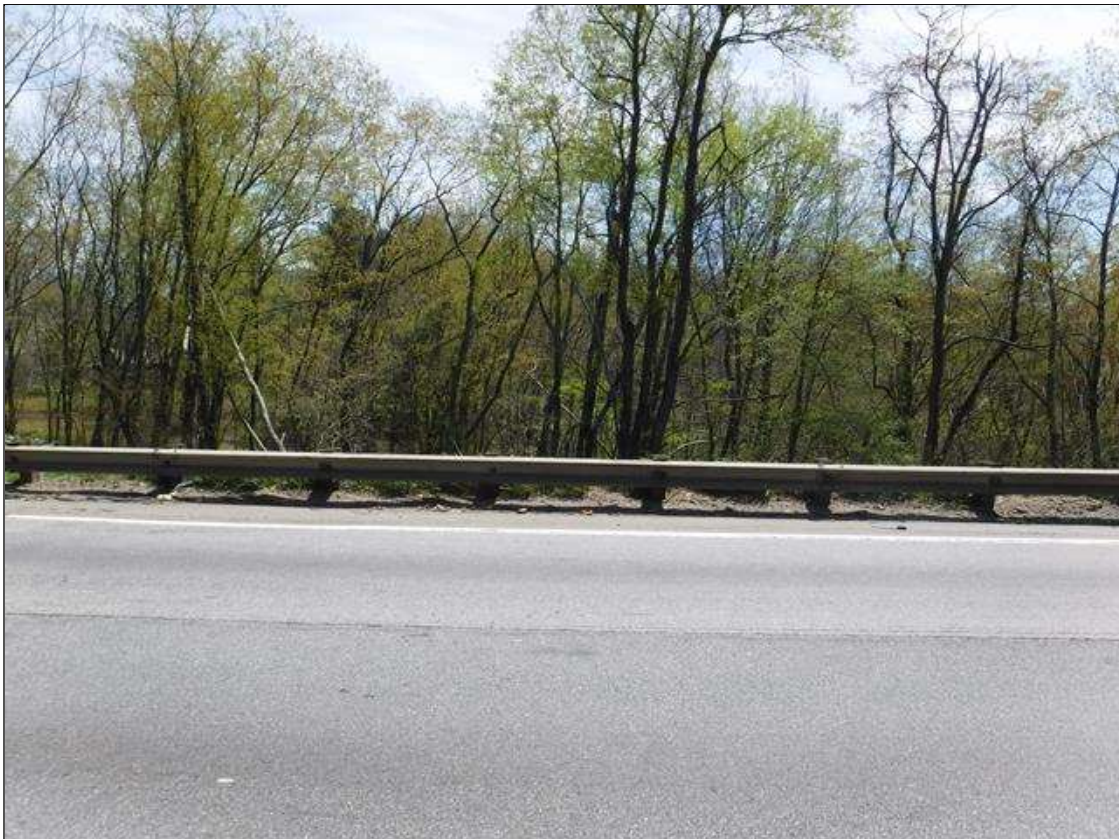
POST SPACING AT MIDSPAN AT SOUTHEAST CORNER, NORTHEAST AND SOUTHWEST CORNERS SIMILAR

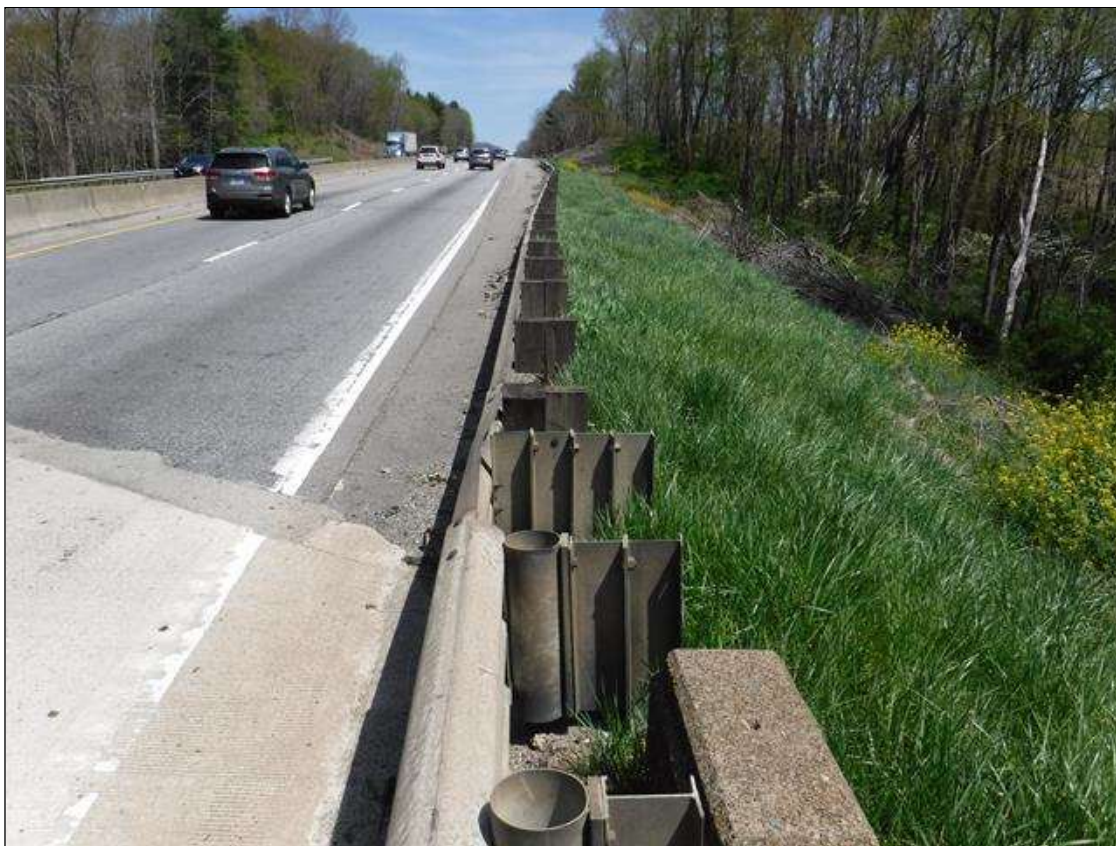
POST SPACING AT BRIDGE AT SOUTHEAST CORNER, NORTHEAST AND SOUTHWEST CORNERS SIMILAR

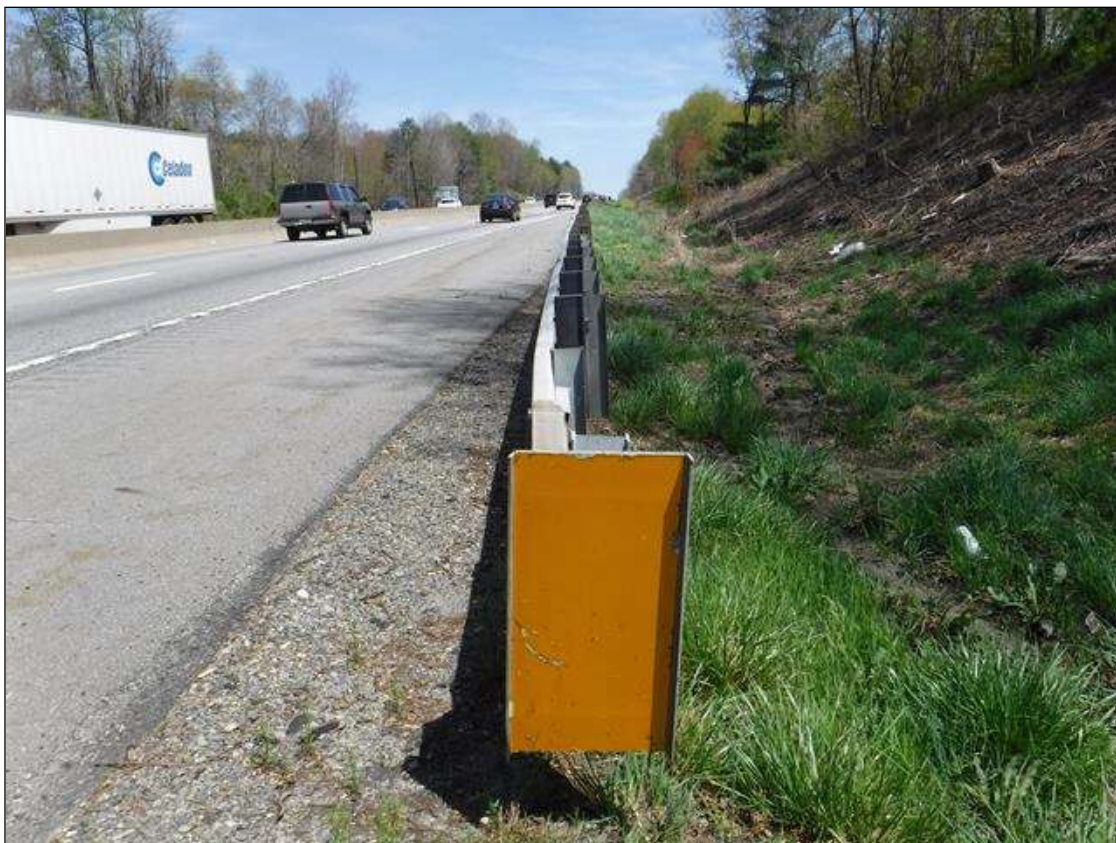
GUARDRAIL END TREATMENT AT SOUTHWEST CORNER, NORTHEAST AND SOUTHEAST CORNERS SIMILAR

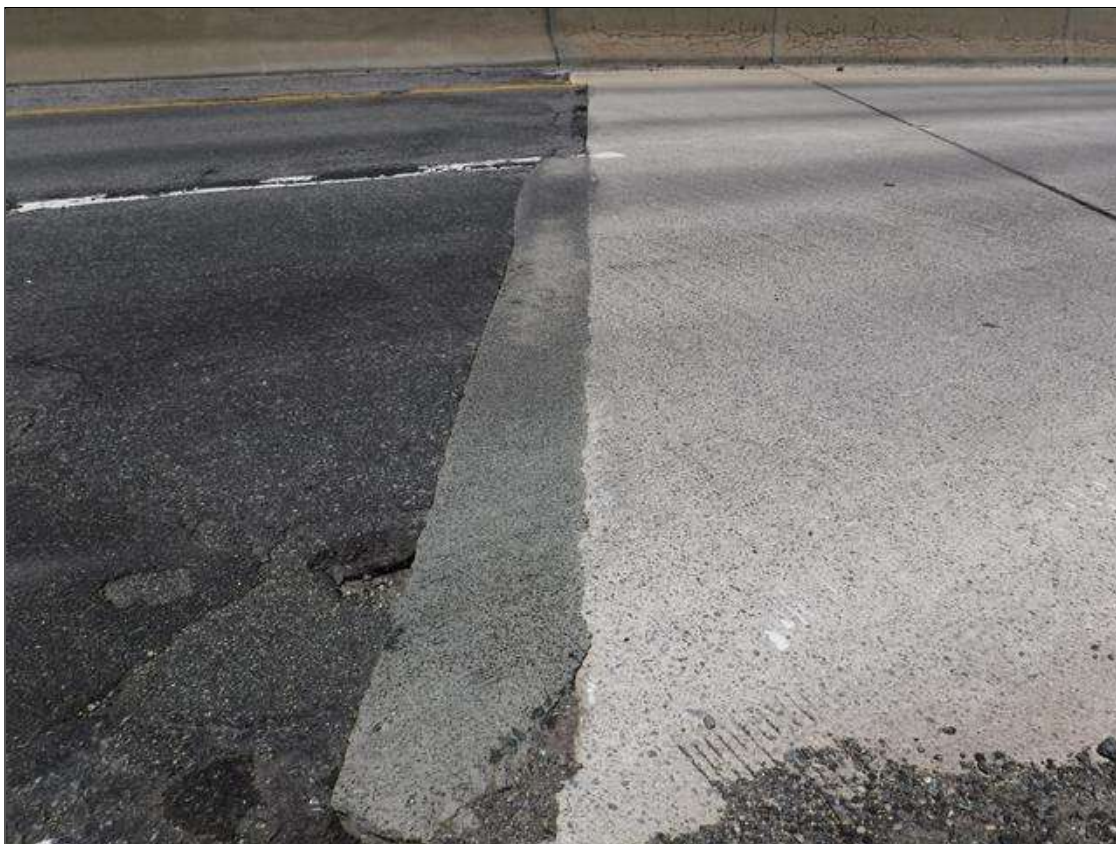
TRANSITION ALONG WEST APPROACH SLAB IN EASTBOUND LANES, TRANSITION ALONG EAST APPROACH SLAB SIMILAR

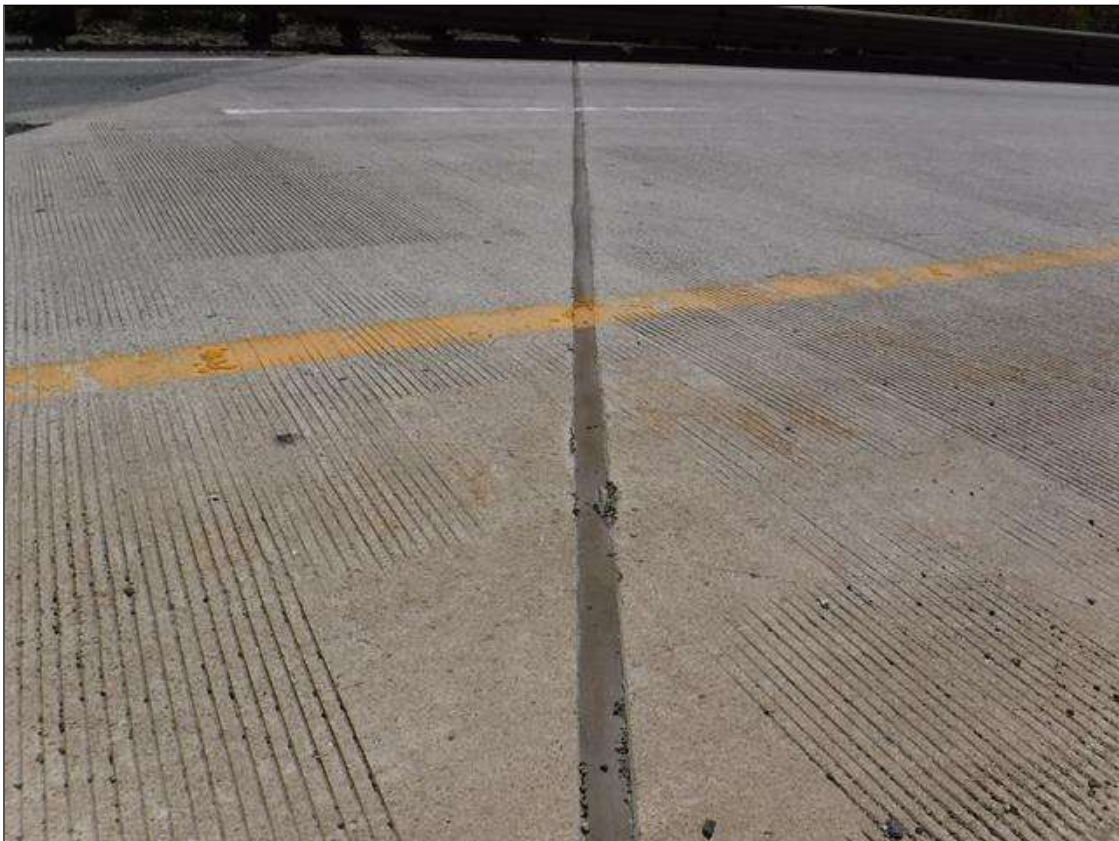
END BENT 2 JOINT IN EASTBOUND LANES, END BENT 1 JOINT SIMILAR

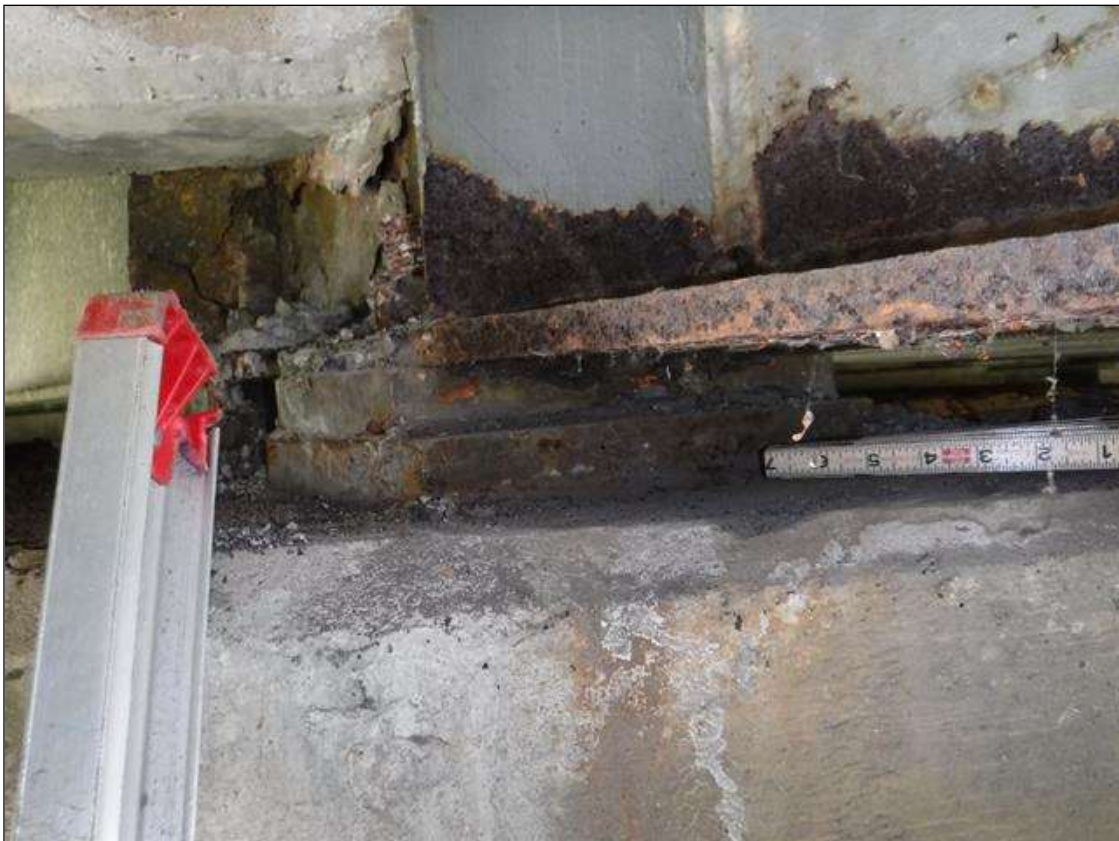
BEAM 3 BEARING AT BENT 2 IN SPAN 2, OTHERS SIMILAR AT BENTS
