**BRIDGE INSPECTION RECORD AND SUMMARY
FOR SHORED OR TEMPORARY REPAIRED
STRUCTURES TO KEEP A BRIDGE OPEN**

BRIDGE: 780176
3/7/2024

Structure Safety Report

Routine Element Inspection - Contract

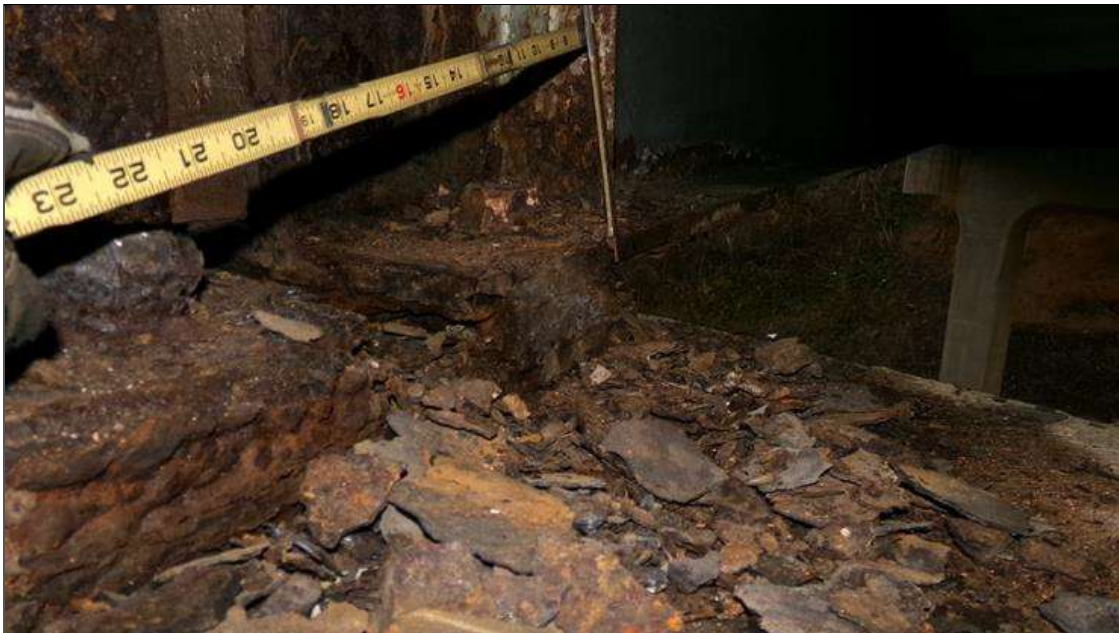
Span 2 Beam 4: BOTTOM FLANGE SECTION LOSS (21 PERCENT SECTION LOSS, 3/16 INCH SECTION LOSS,
11/16 INCH REMAINS) FULL WIDTH FOR 16 INCHES AT FAR END. SECTION LOSS UP TO 1/16 INCH (3/16 INCH
REMAINS) ON THE LEFT STIFFENER FOR 2 INCHES HIGH AT BOTTOM. (PAR)

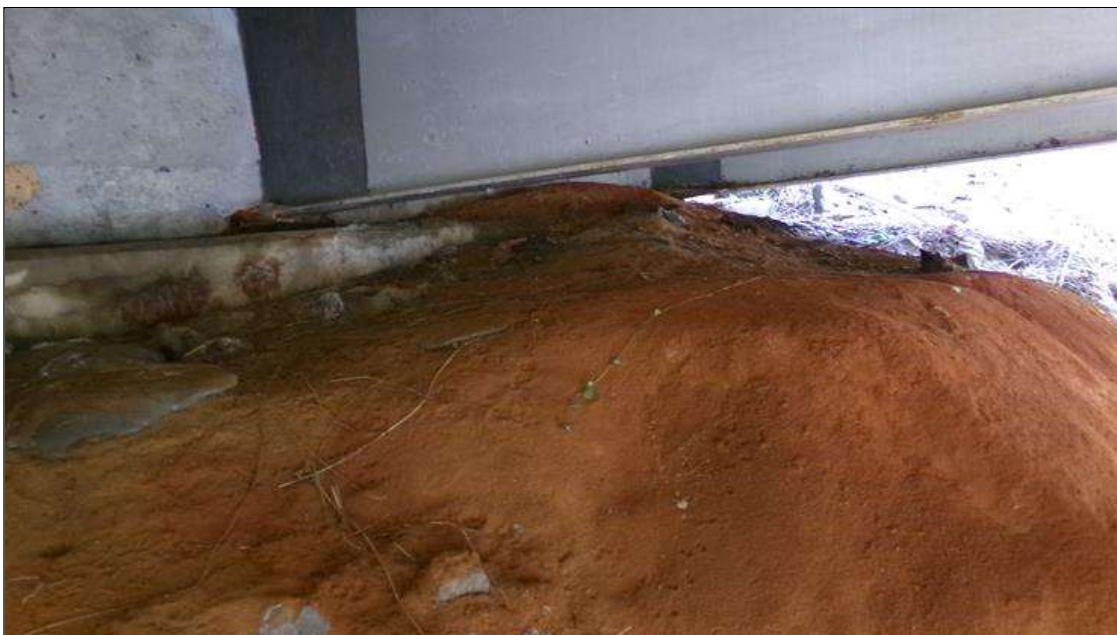
SOIL BUILD UP AT END BENT 2 UNDER BAYS 2 AND 3

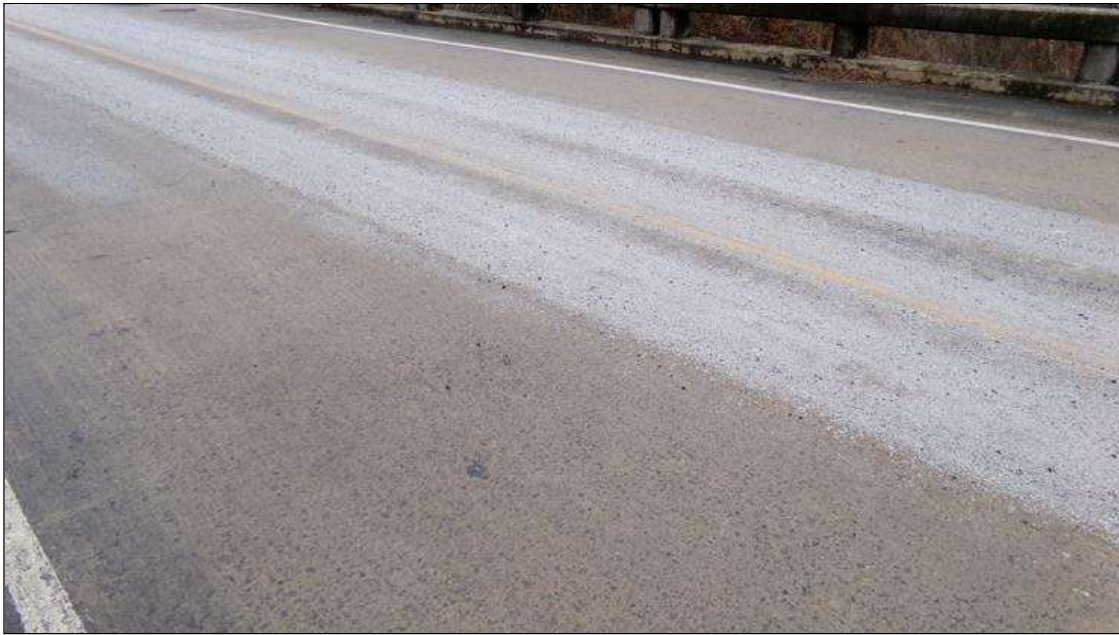
SPAN 1 TOP OF DECK (SALT BRINE ON TOP OF DECK) SPANS 2 AND 3 TYPICAL

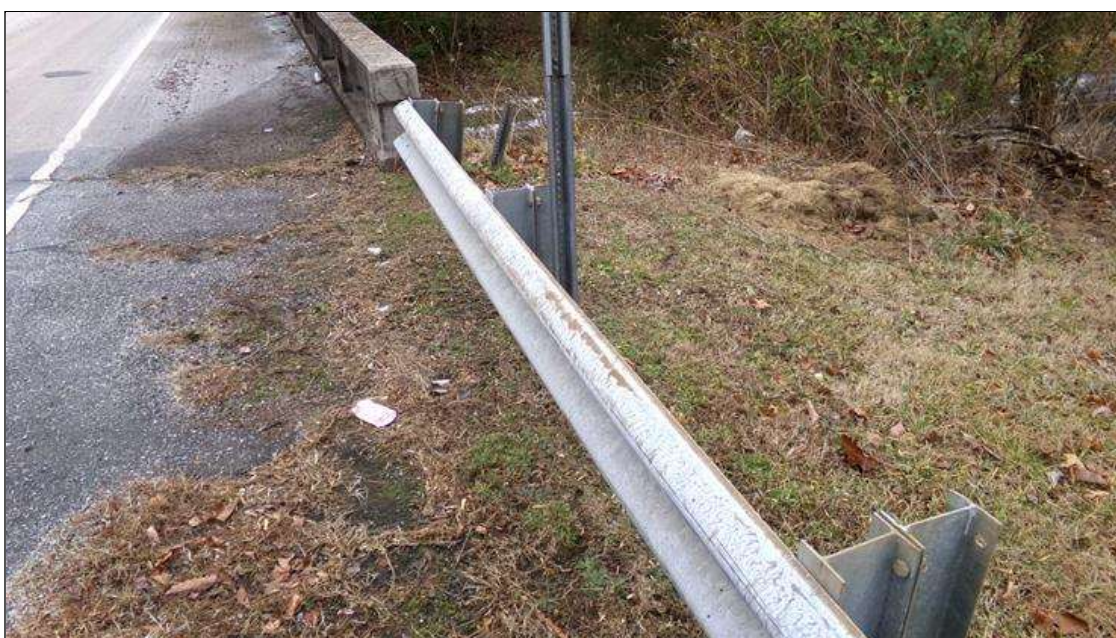
NORTHWEST CORNER GUARDRAIL POST SPACES AT BRIDGE ALL CORNERS SIMILAR

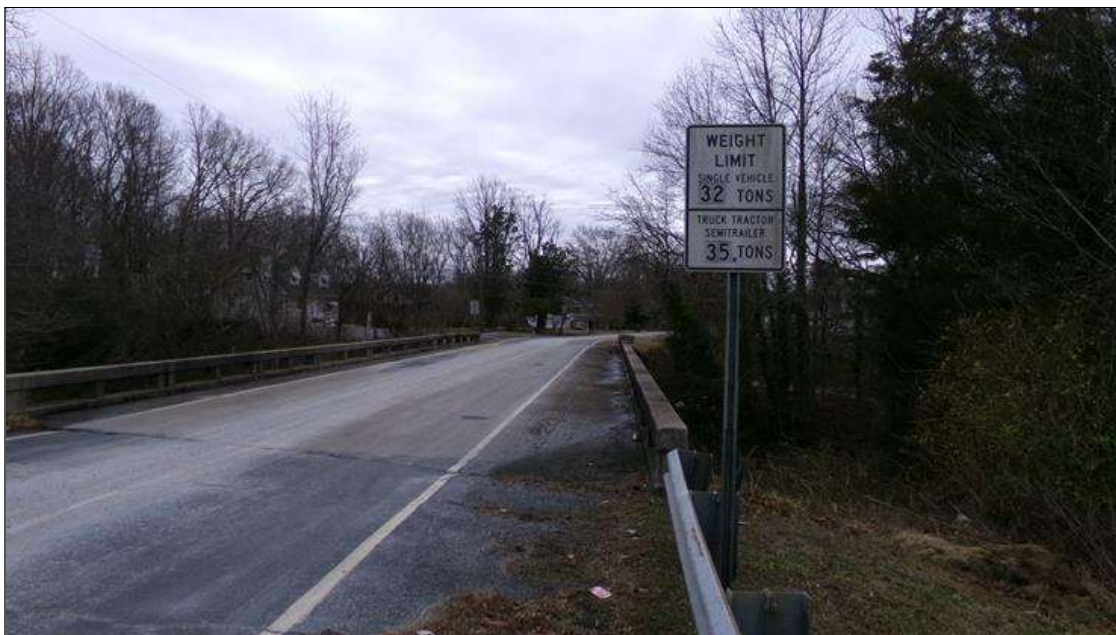
LOAD POSTING SIGN AT SOUTHEAST CORNER
